Republic of Lebanon - Council for Development and Reconstruction

Road and Employment Project (REP)

Environmental and Social Management Plan (ESMP)  
Final Report

LOT 1: Caza of Metn

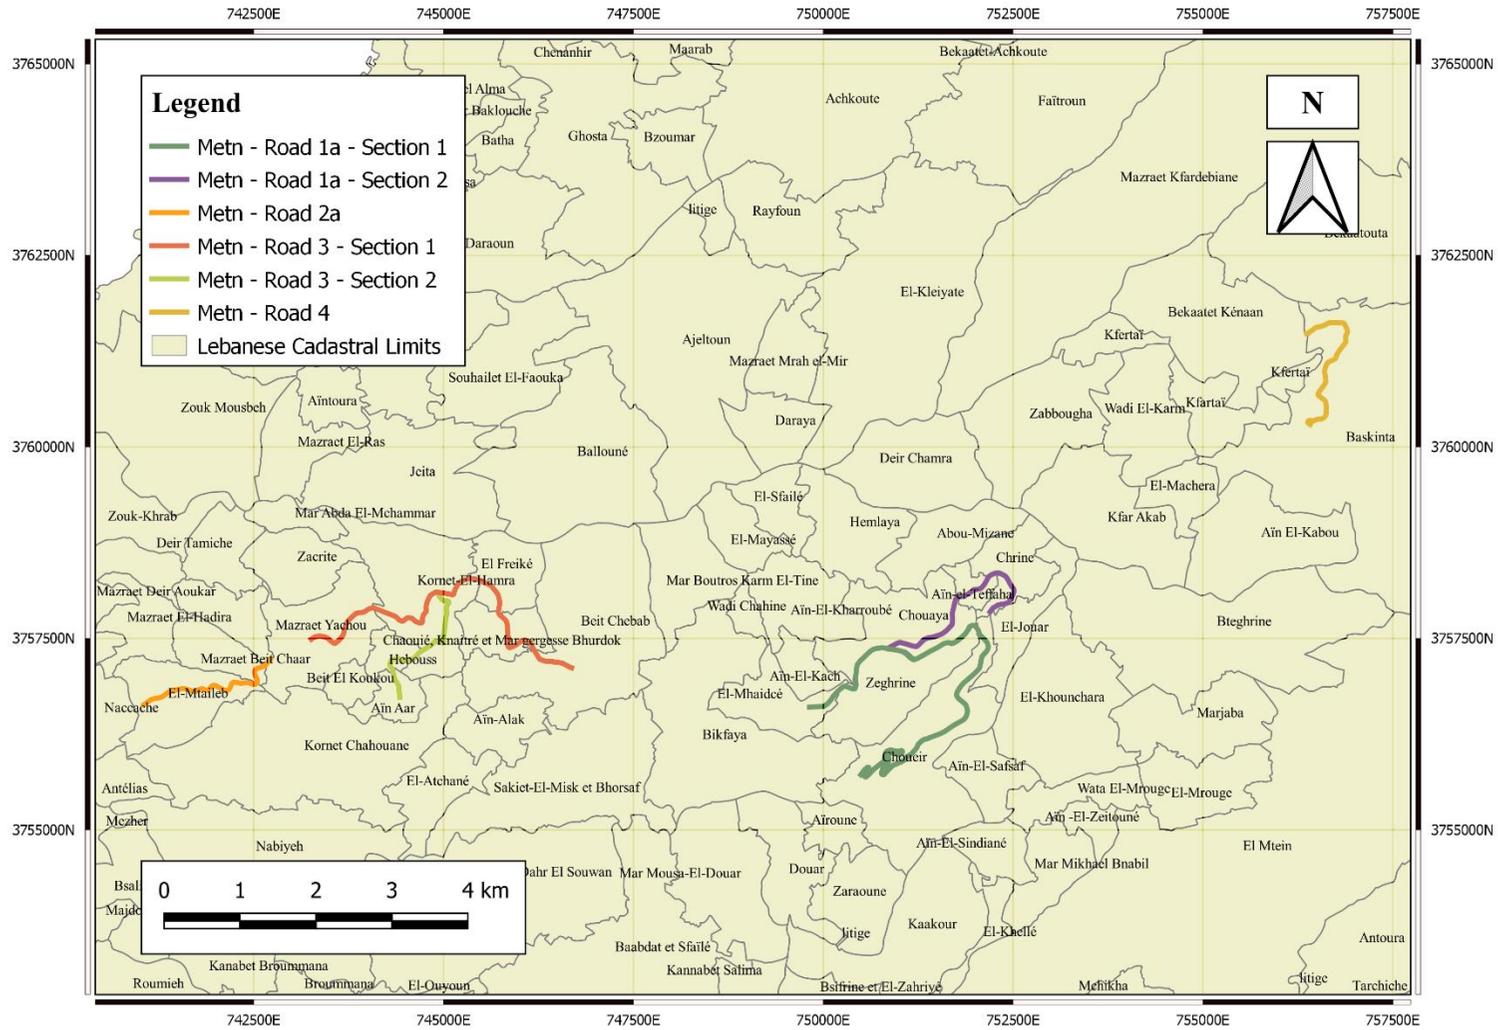
**Figure 1-1 Lot 1 – Roads Key Plan Drawing (Metn roads)**

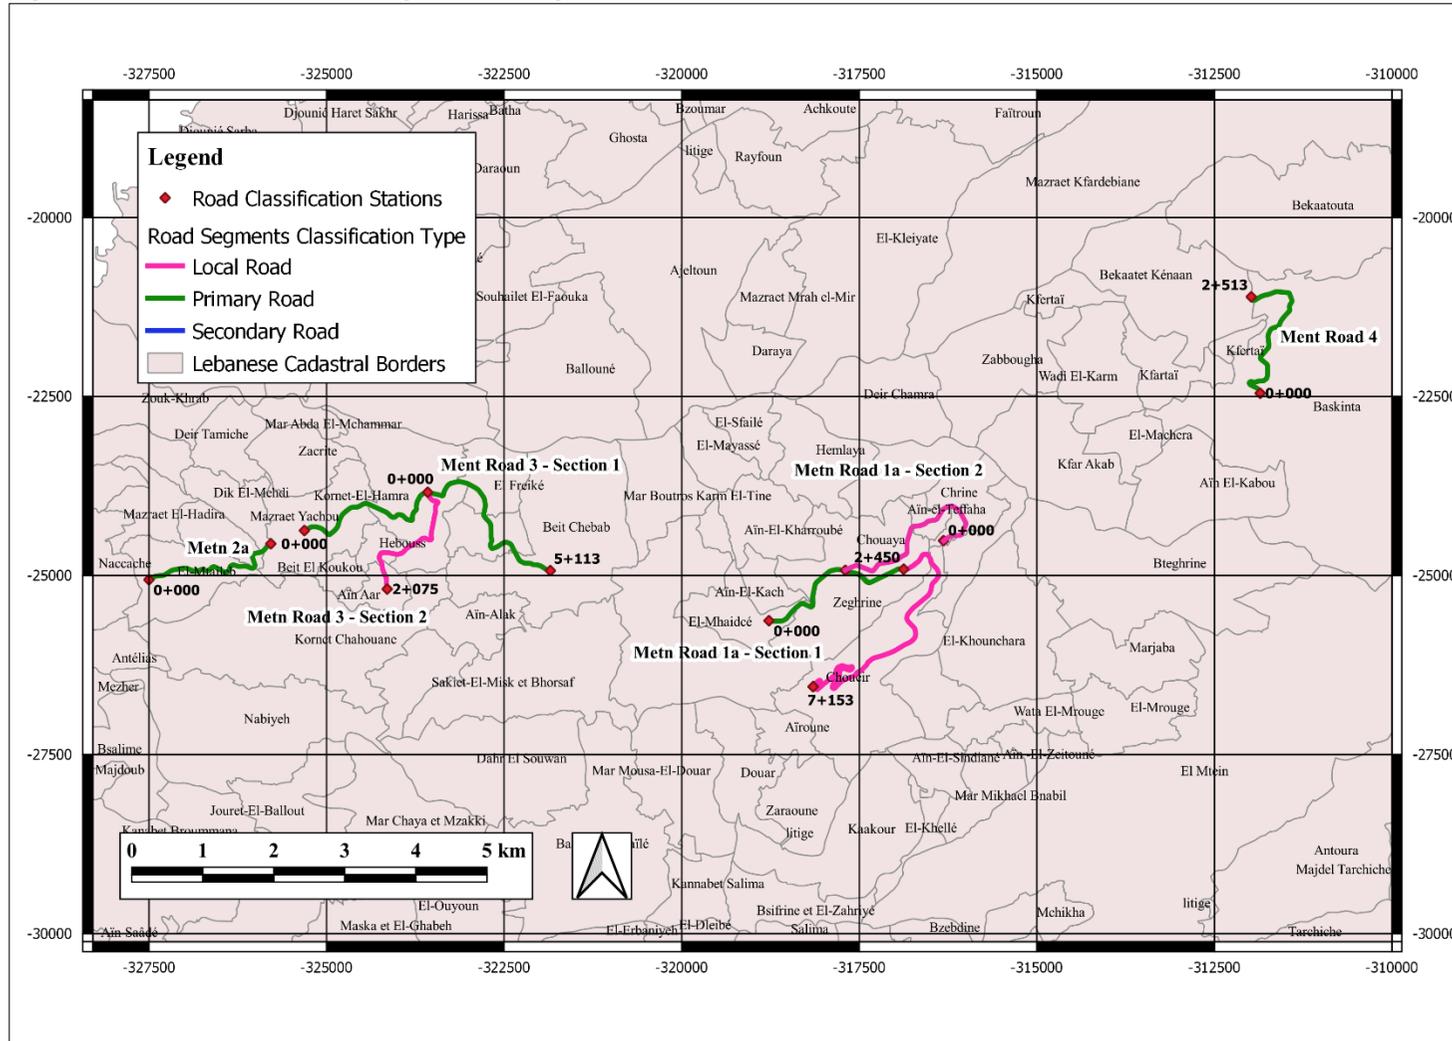
**Figure 3-1 Classification of road segments among Metn roads**

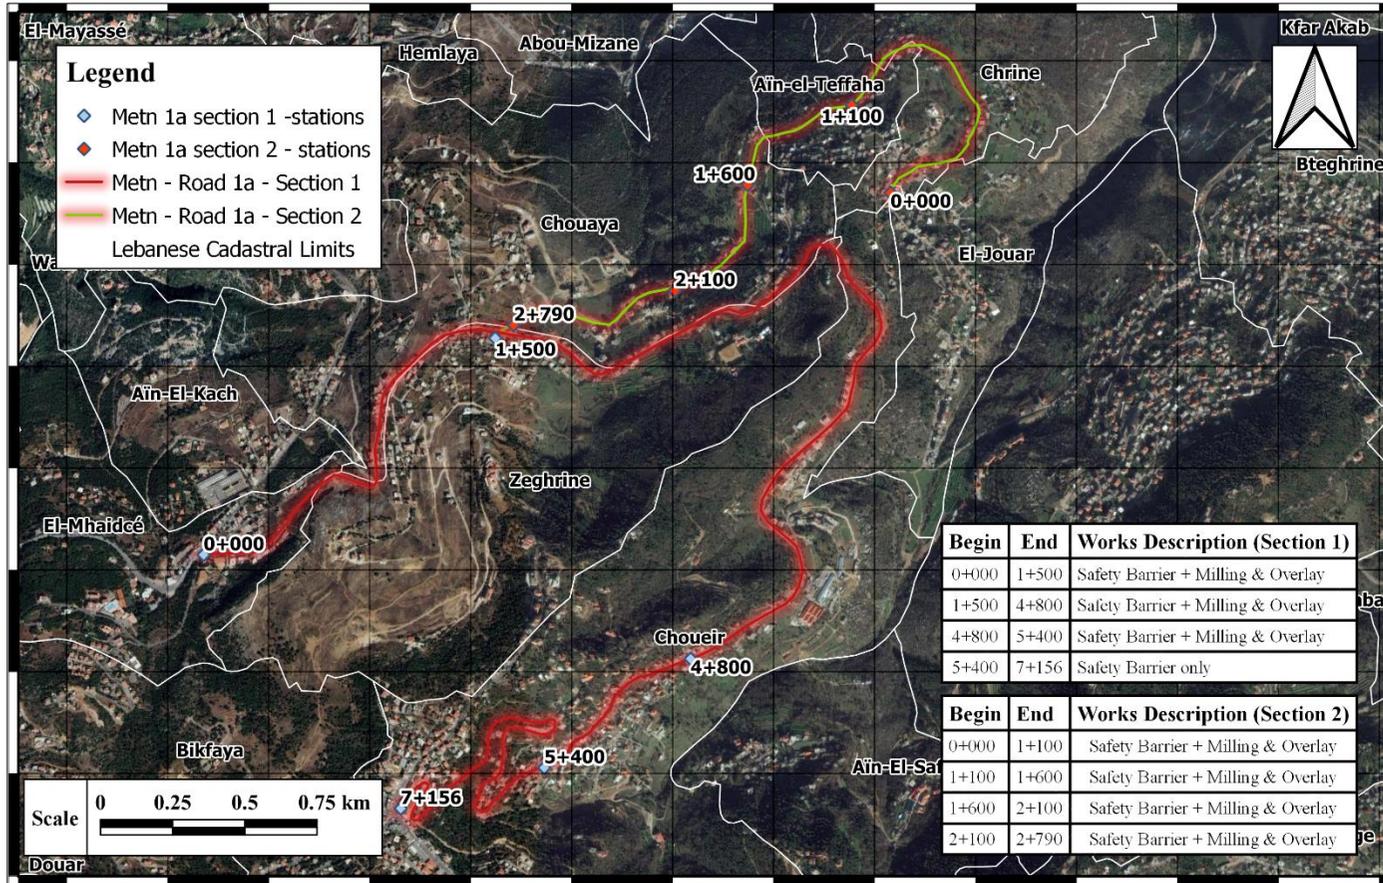
Figure 3-6 Work stations along with road rehabilitation activities along Metn R1a (sections 1 and 2) alignment

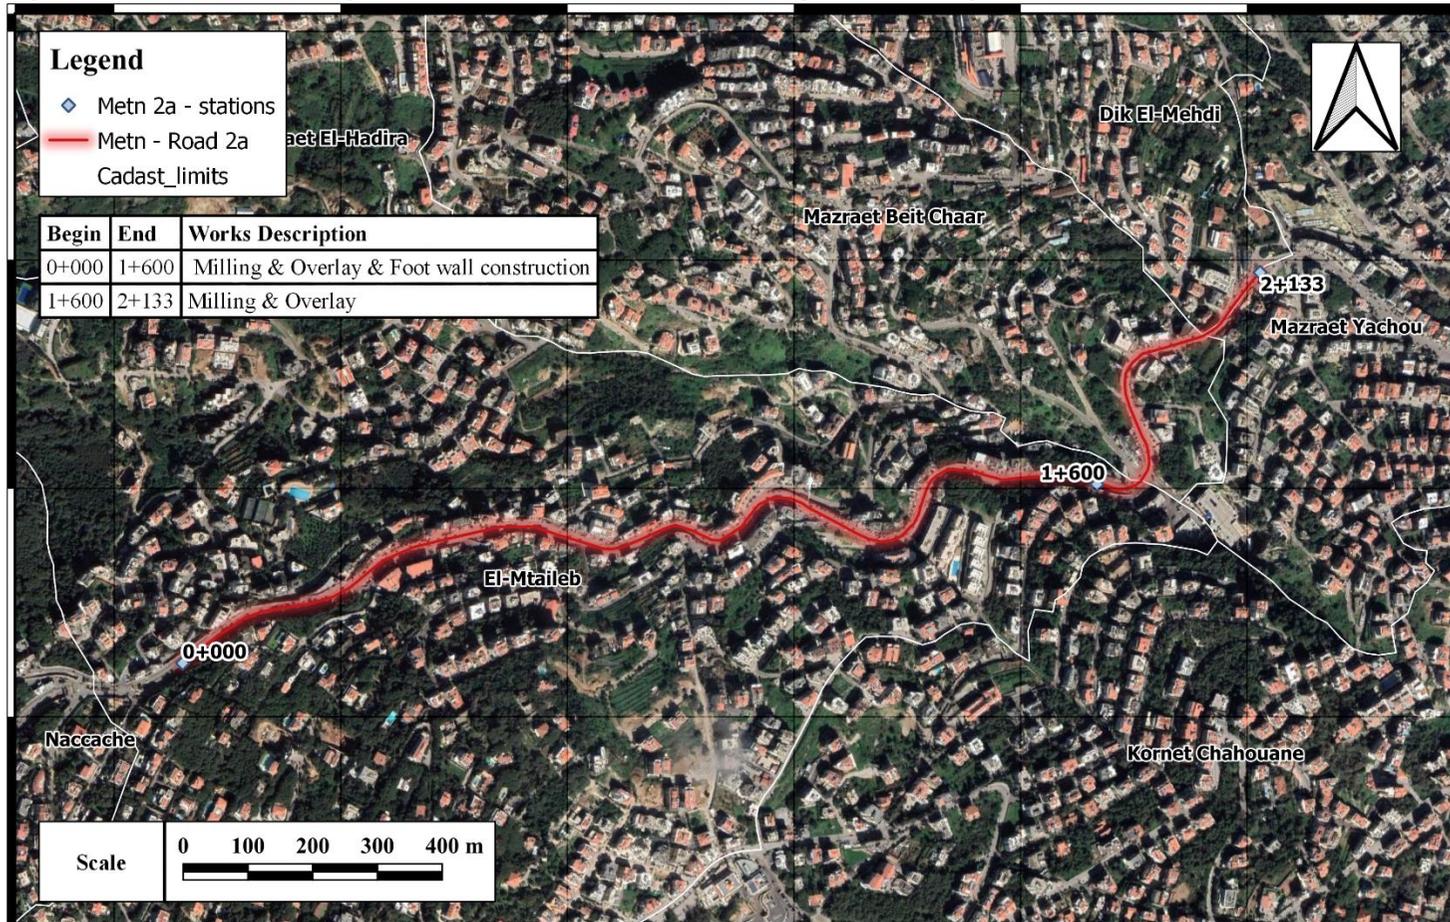
**Figure 3-7 Work stations along with road rehabilitation activities along Metn R2a alignment**

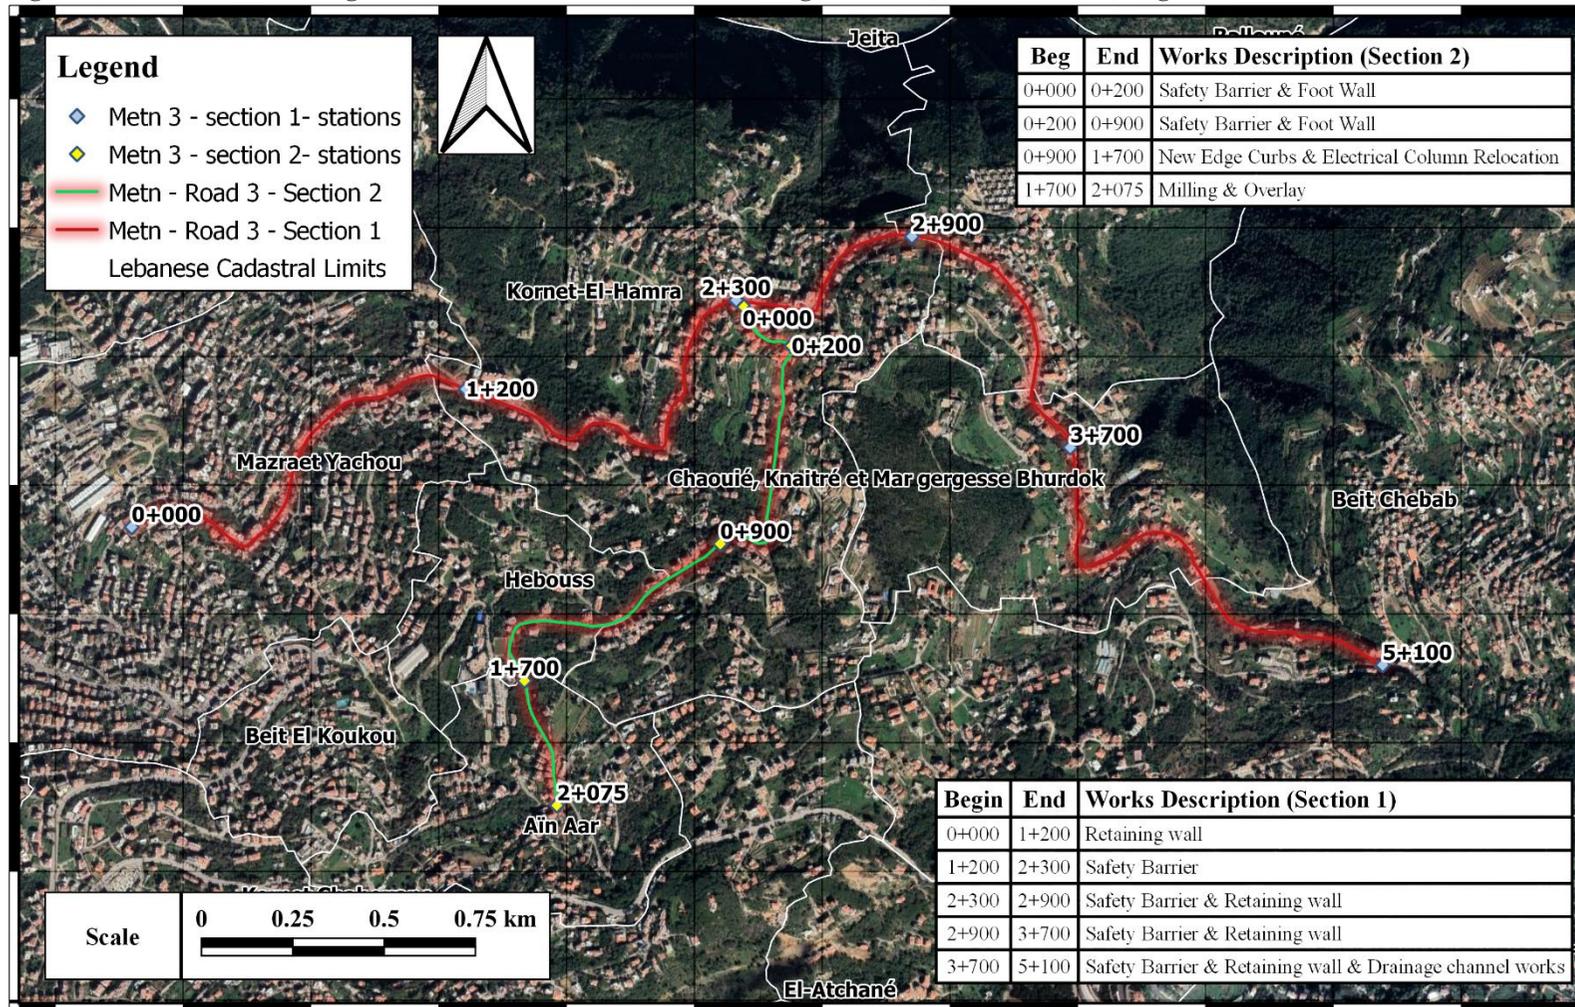
Figure 3-8 Work stations along with road rehabilitation activities along Metn R3 (sections 1 and 2) alignment

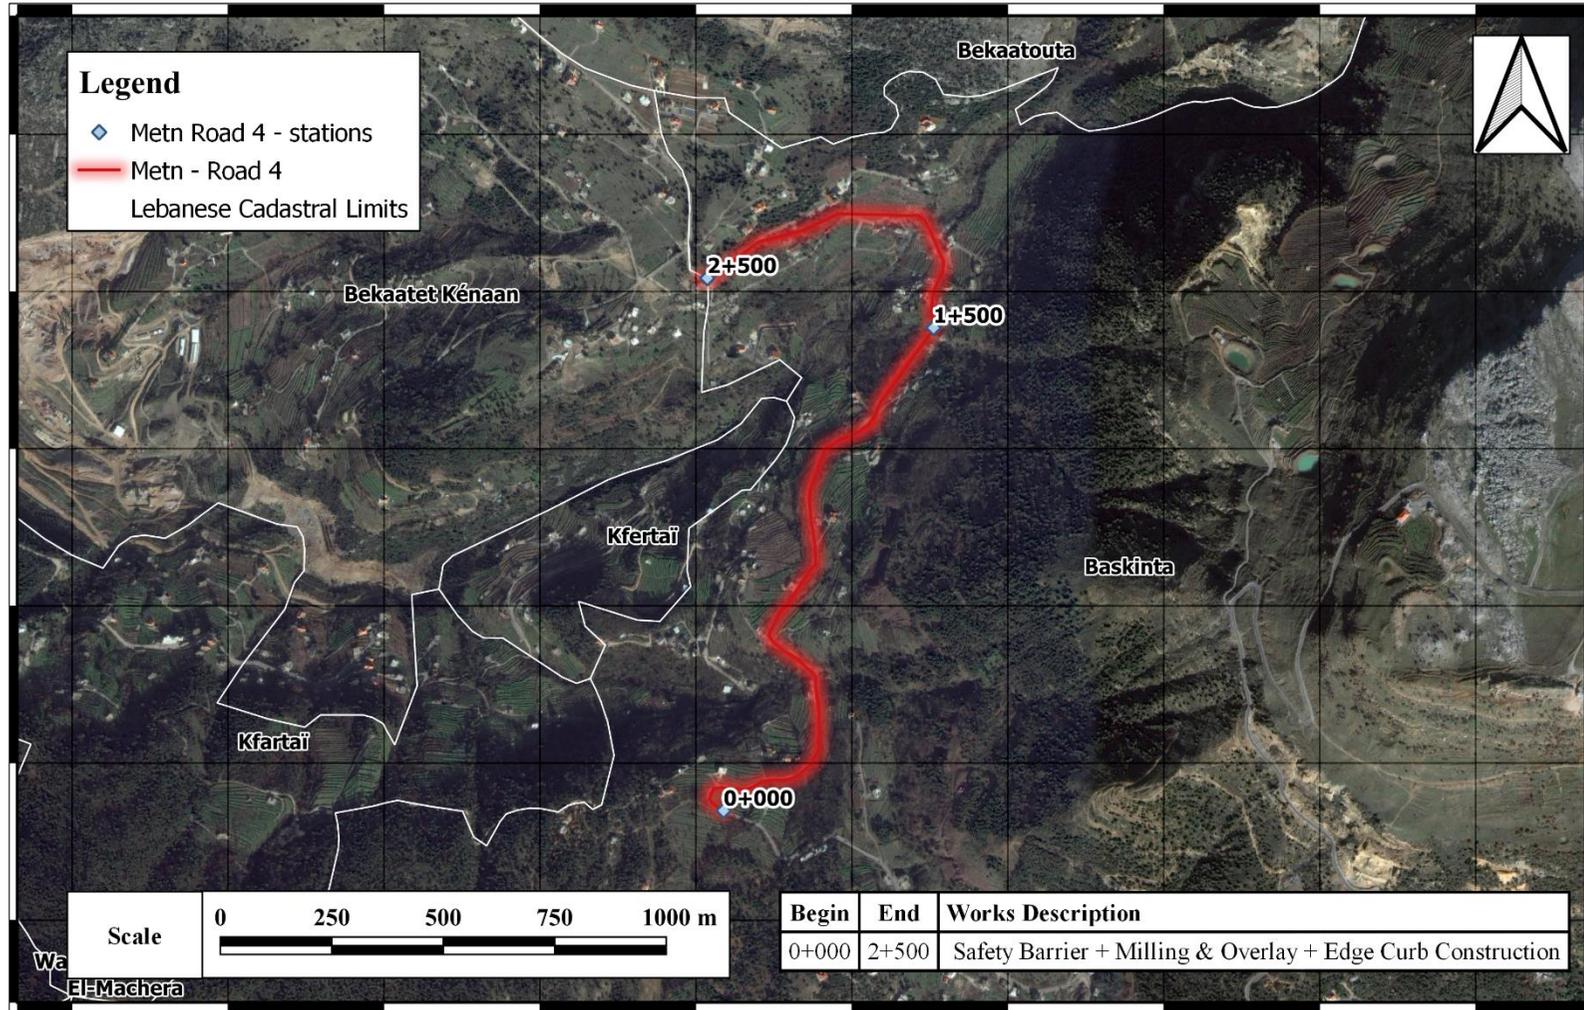
**Figure 3-9 Work stations along with road rehabilitation activities along Metn R4 alignment**

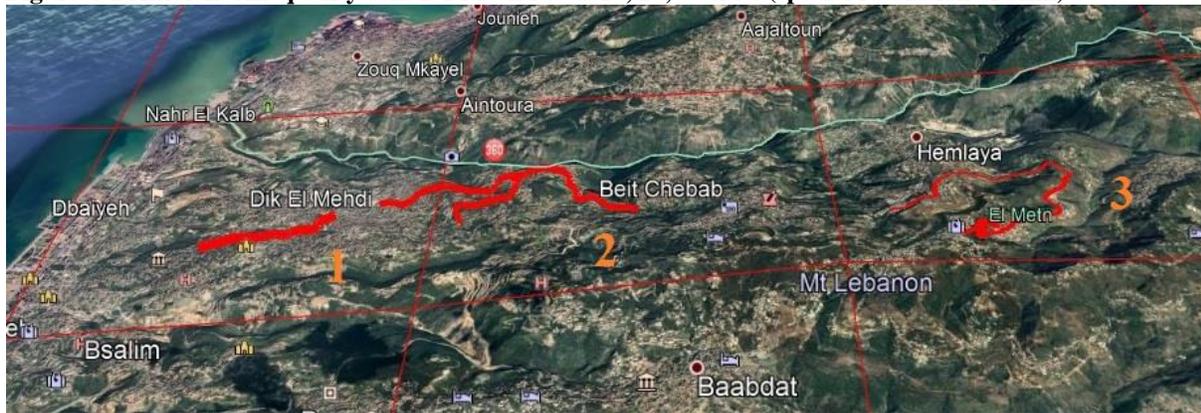
**Figure 4-1 Ambient Air quality cells for Metn roads 1a, 2a, 3 and 4 (spatial resolution of 5km)**

**Table 4-10 Ambient air quality in µg/m<sup>3</sup> for Metn roads R1a, R2a, R3 and R4 (roads fall in cells 1, 2, 3) – refer to Figure 4-1**

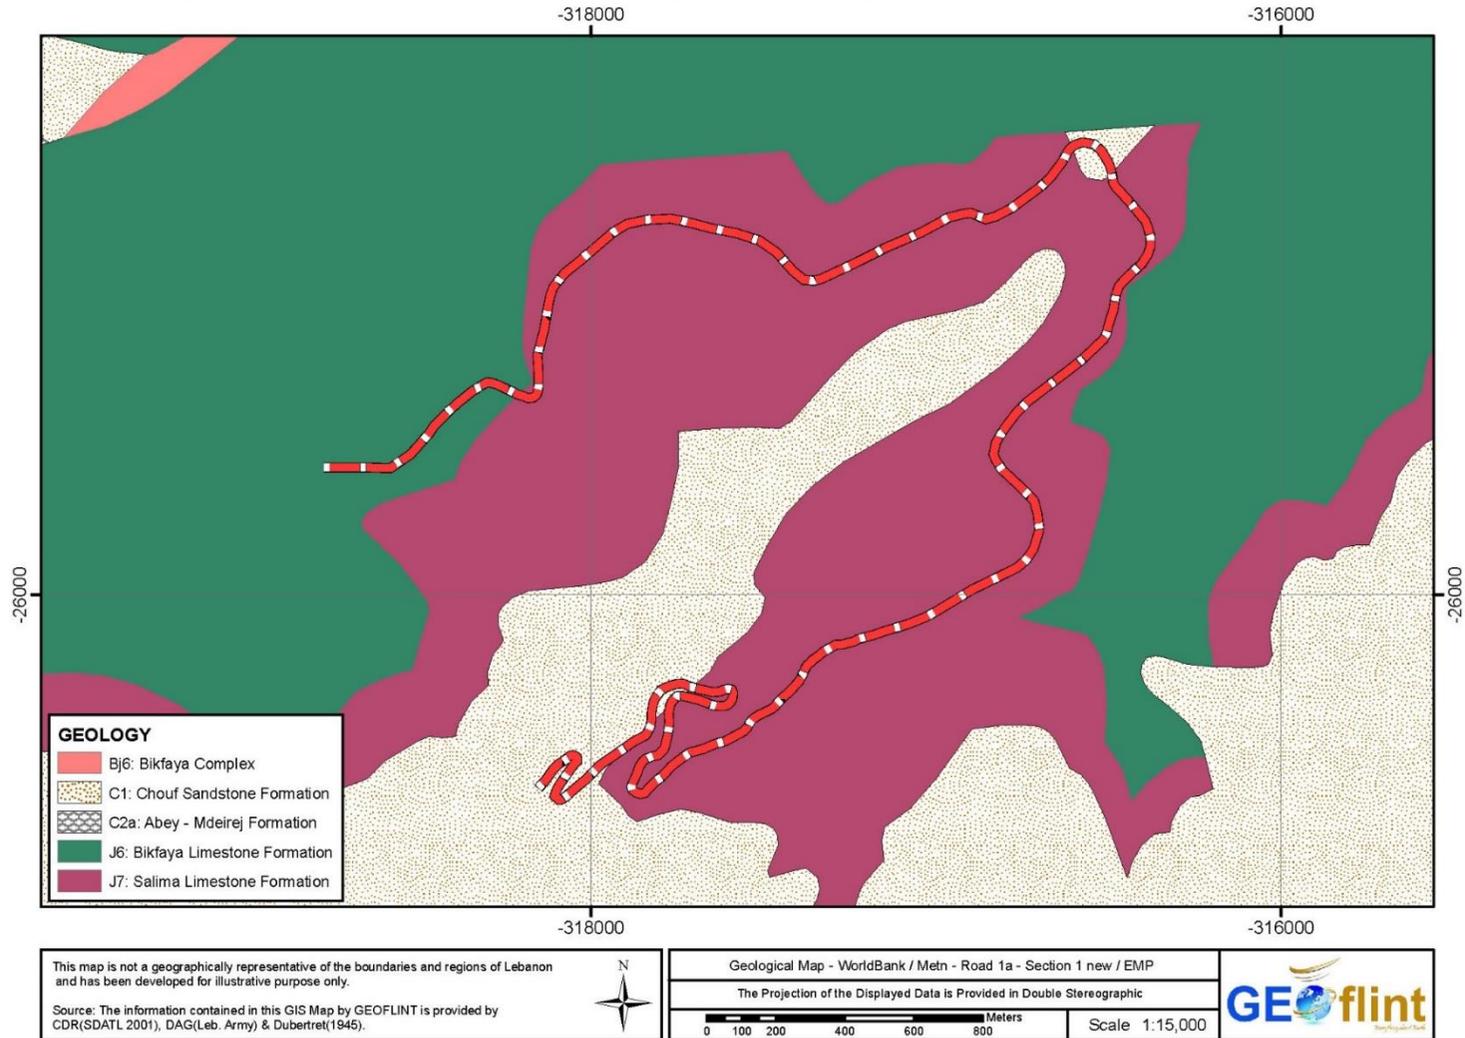
**Figure G General Geological map of Metn R1a section 1 and its surrounding (surface outcrops)**

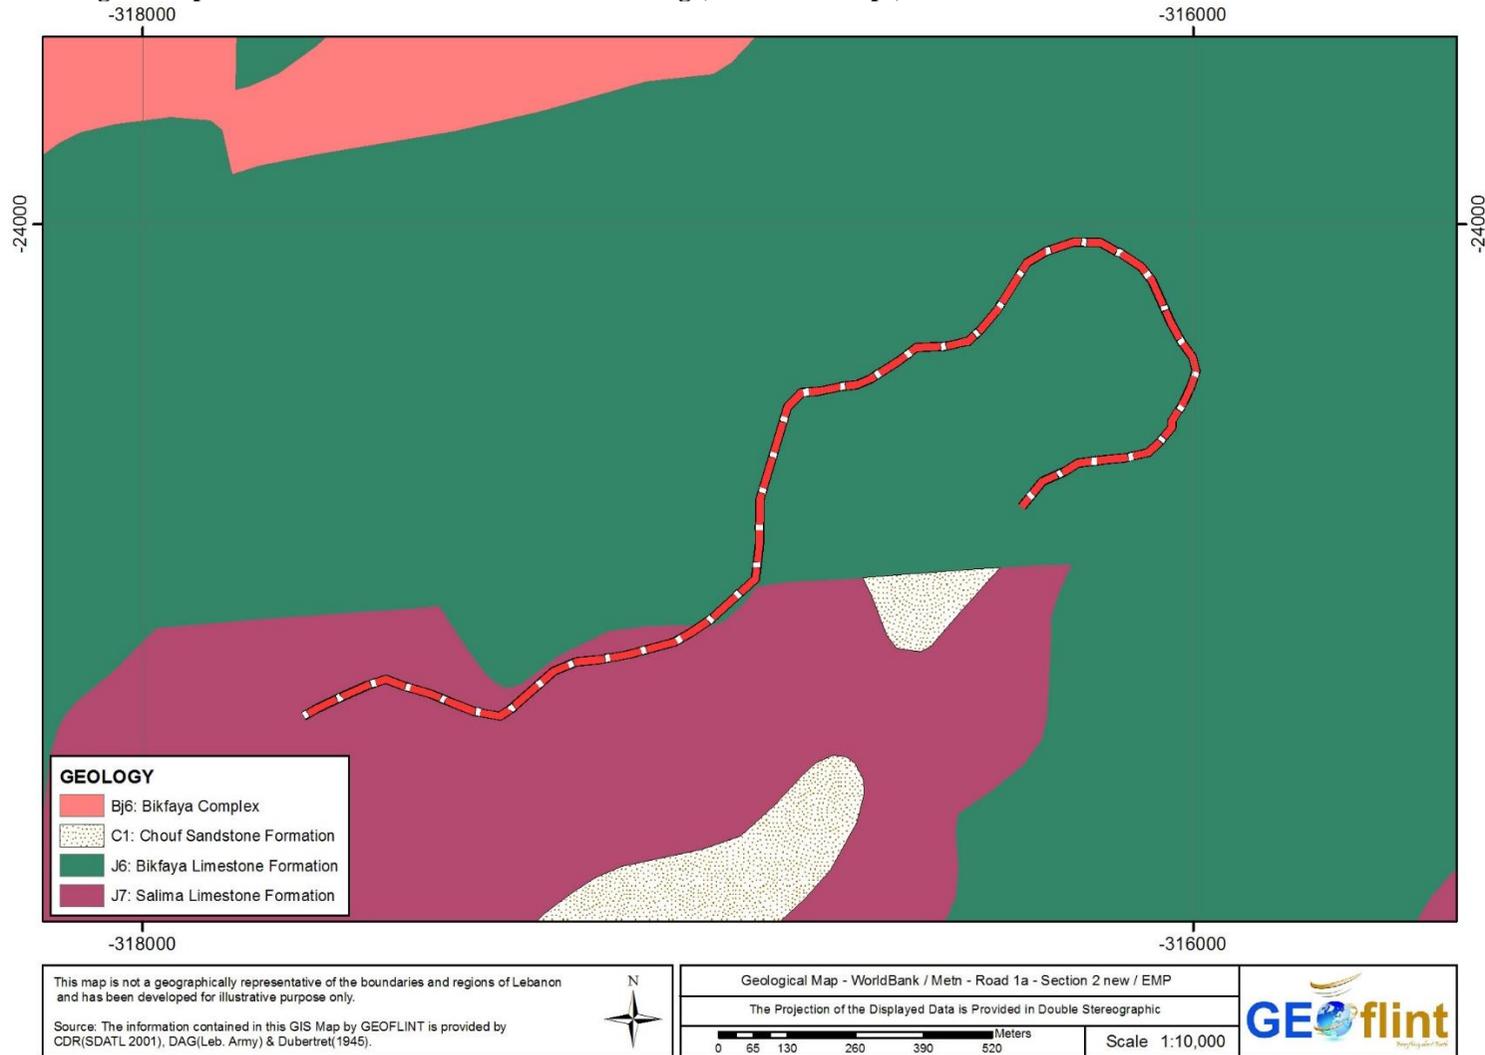
**Figure H General Geological map of Metn R1a section 2 and its surrounding (surface outcrops)**

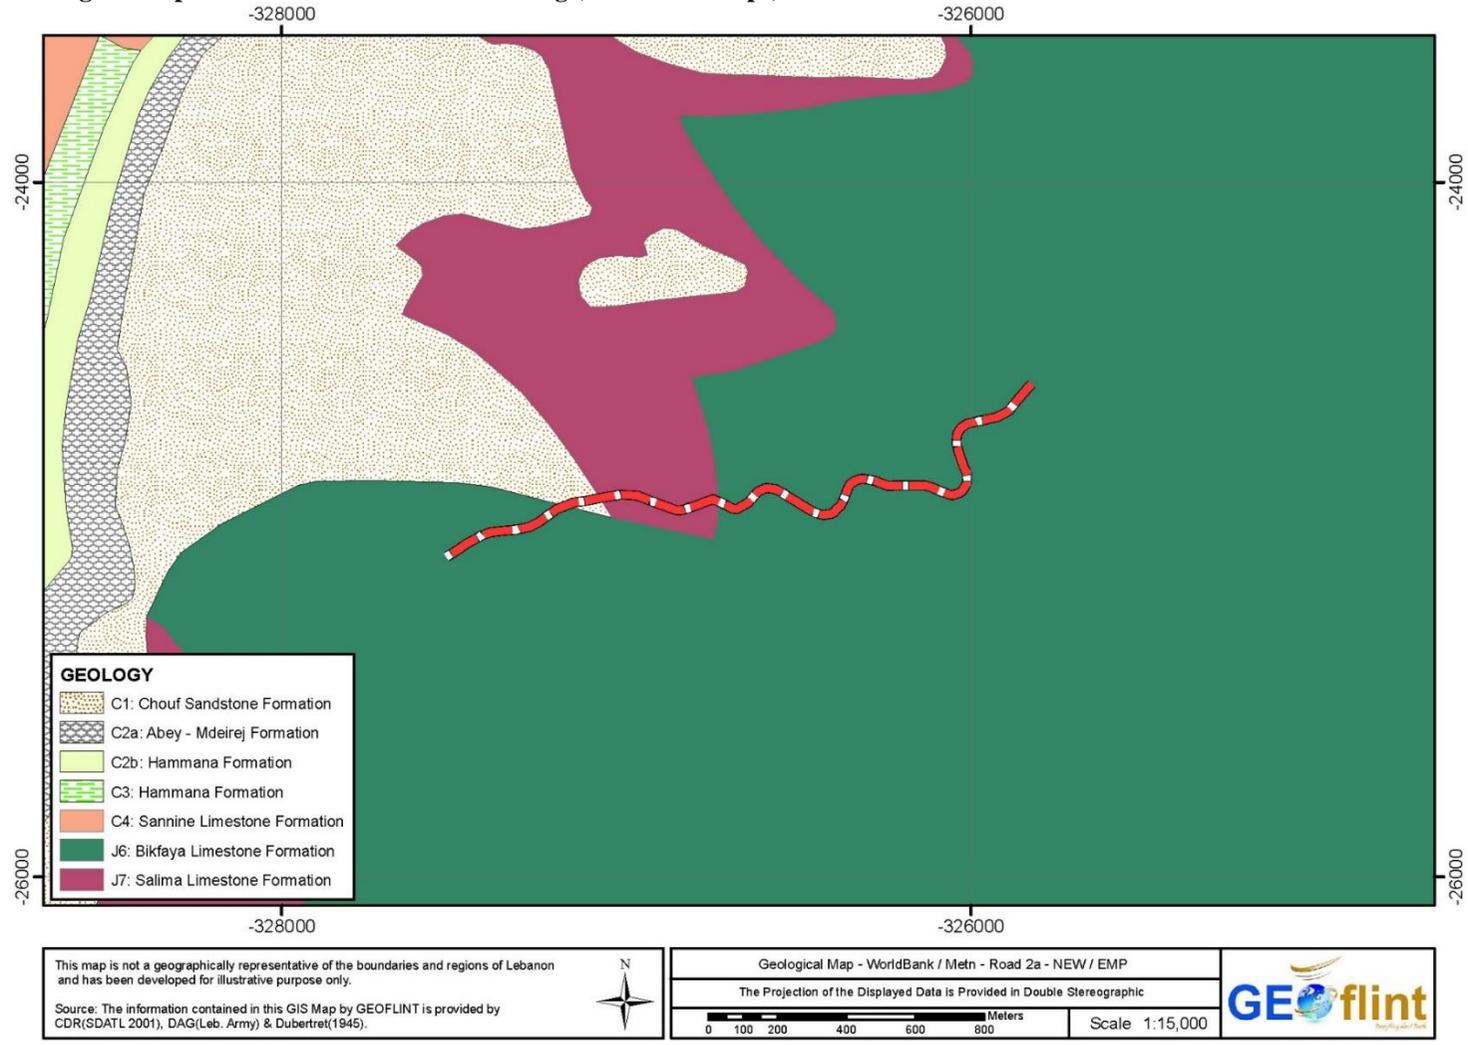
**Figure I General Geological map of Metn R2a and its surrounding (surface outcrops)**

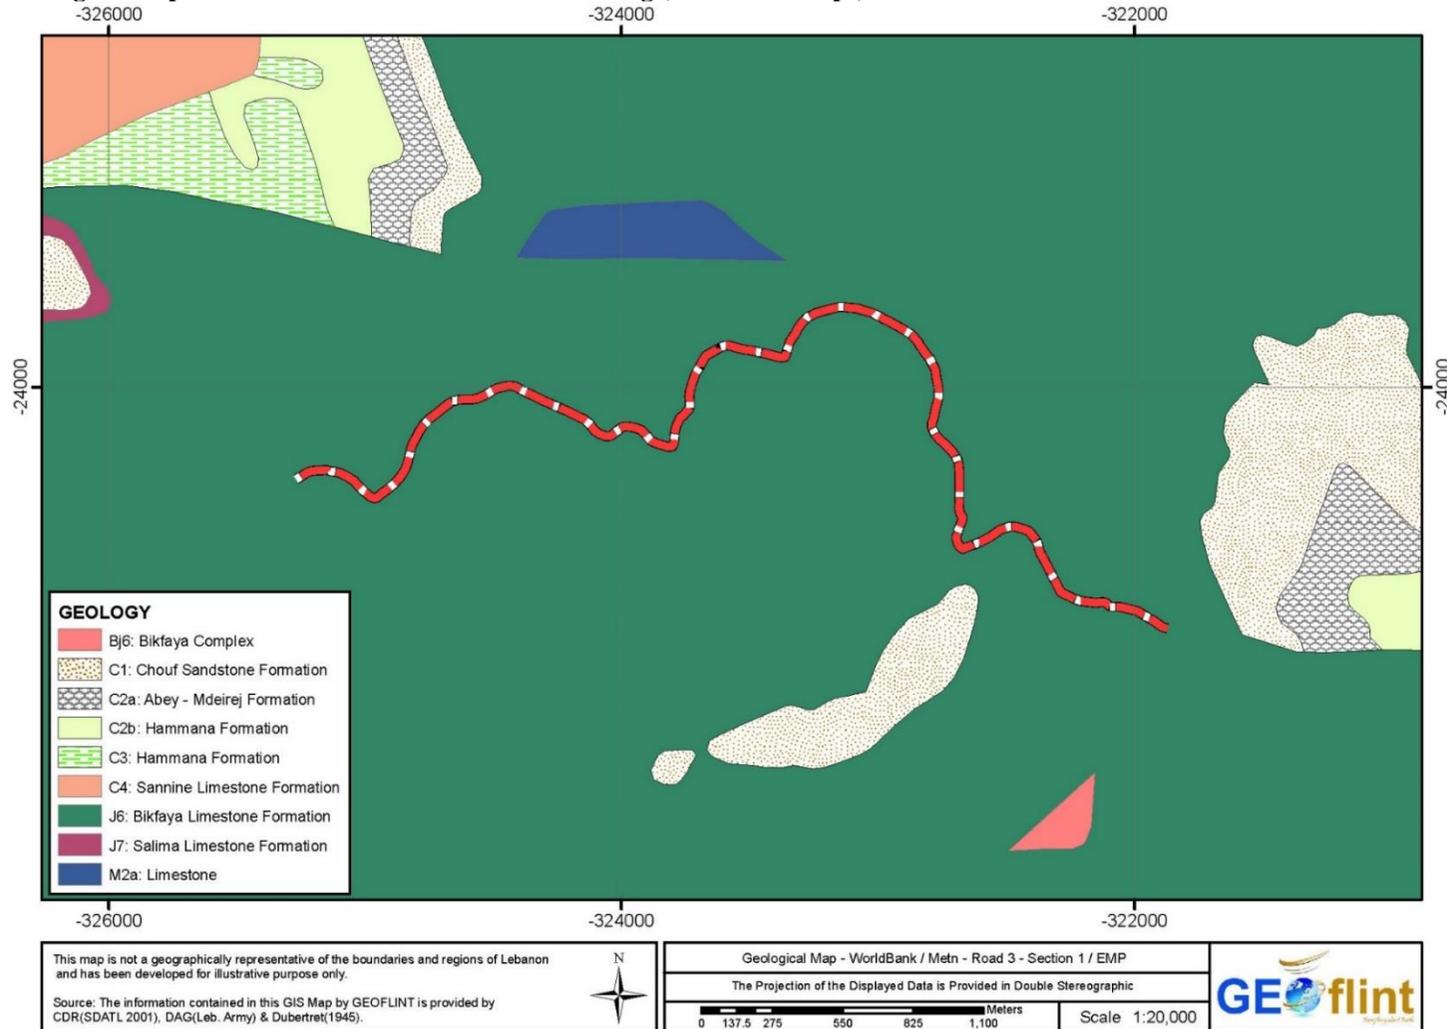
**Figure J General Geological map of Metn R3 section 1 and its surrounding (surface outcrops)**

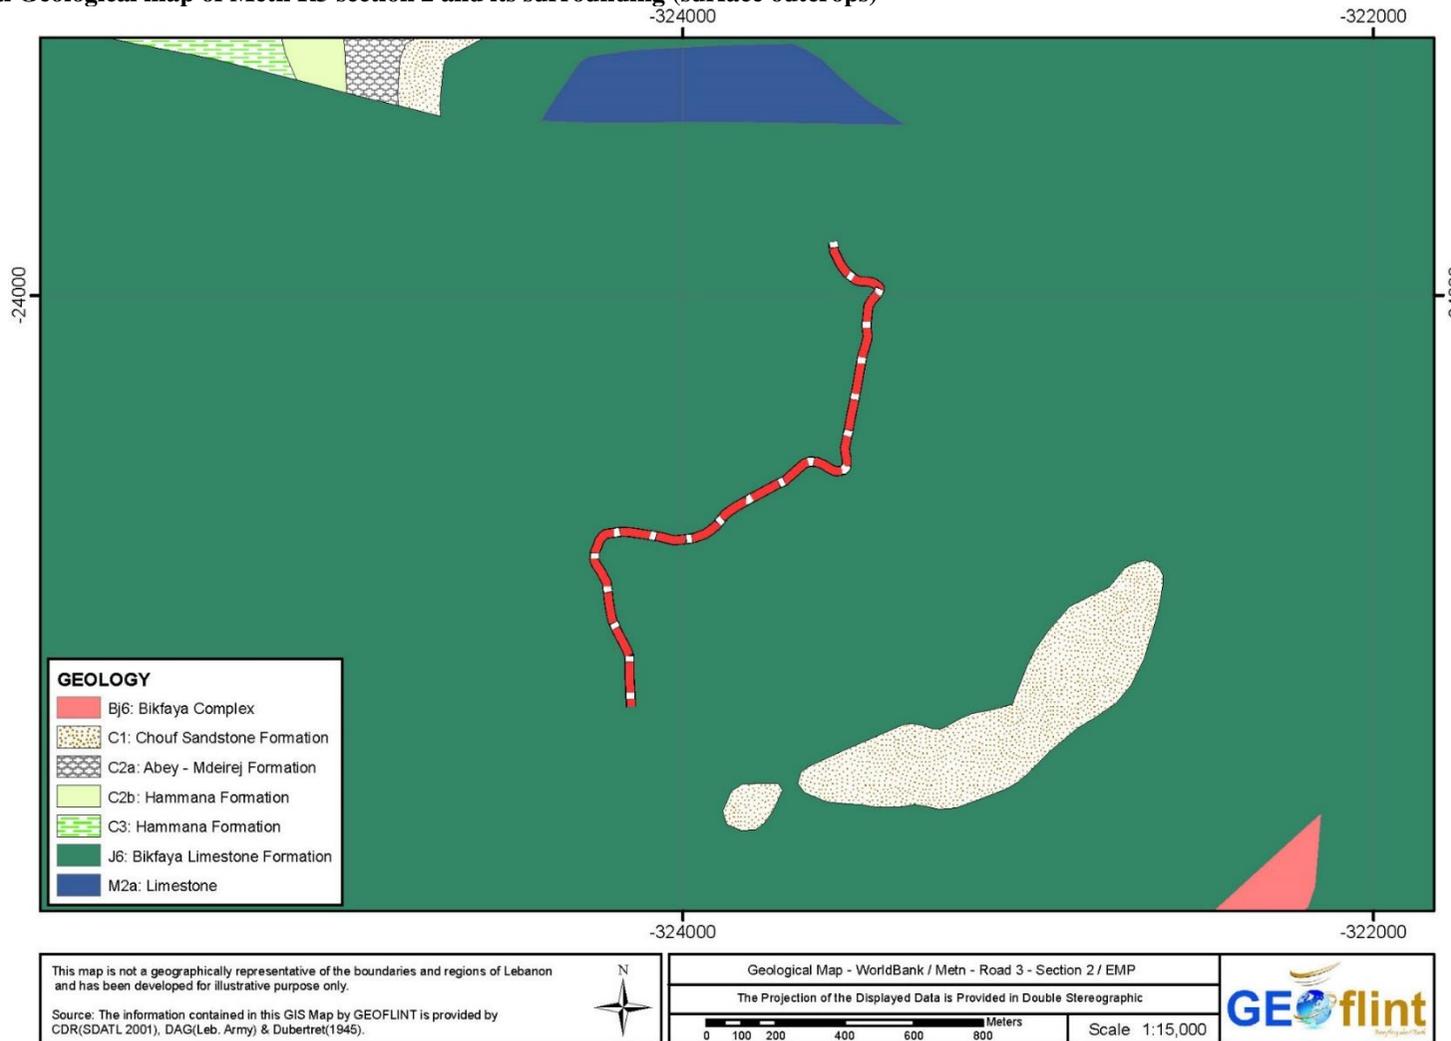
**Figure K General Geological map of Metn R3 section 2 and its surrounding (surface outcrops)**

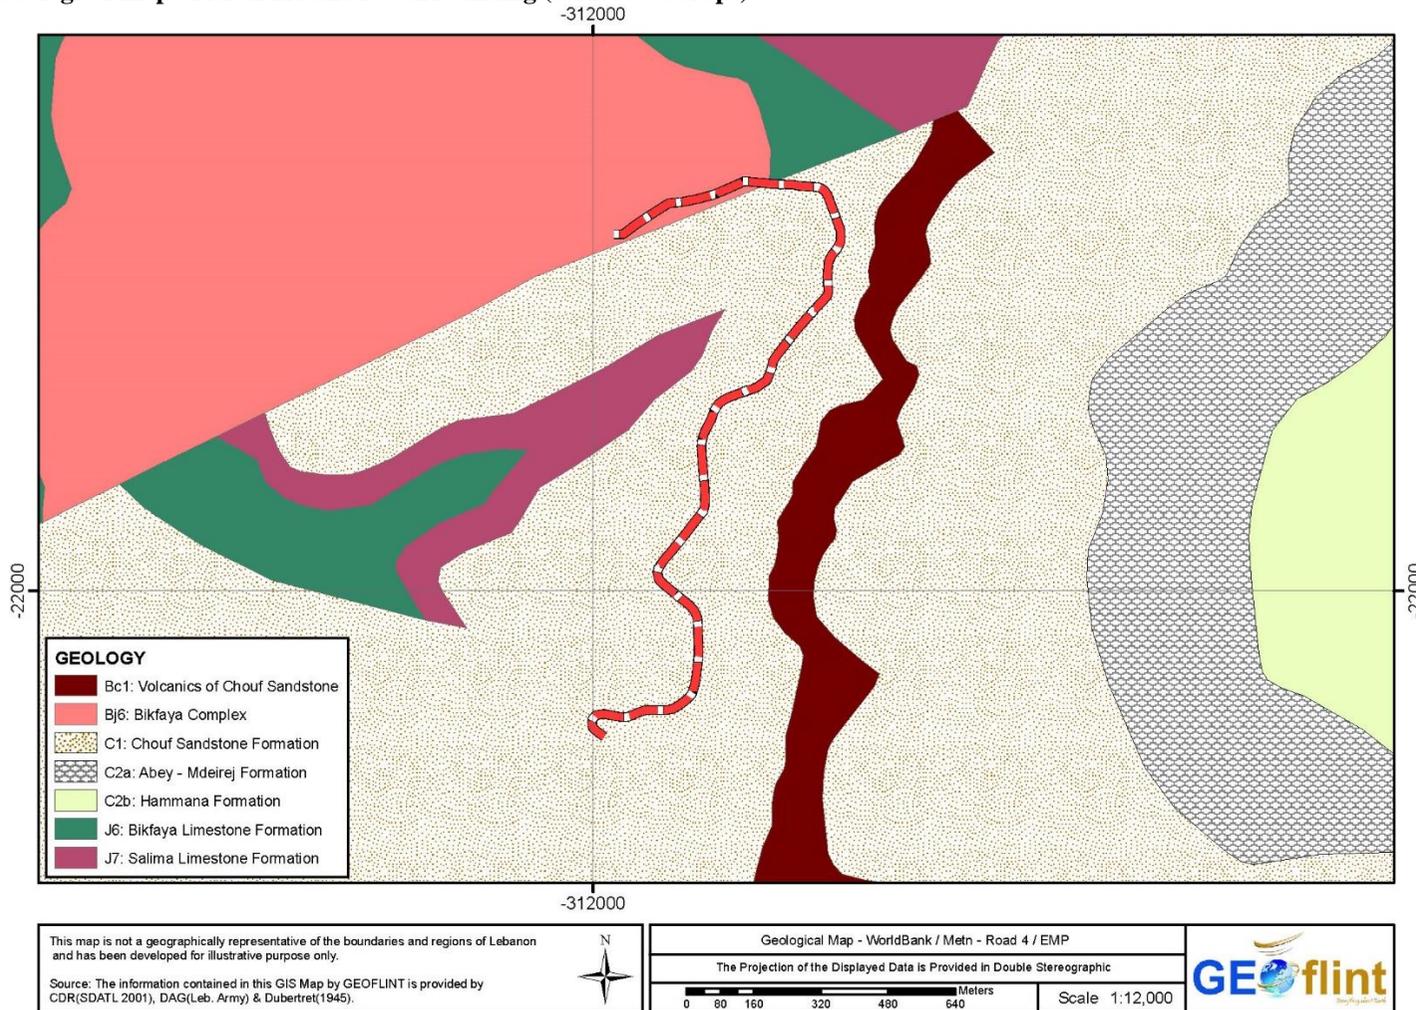
**Figure L General Geological map of Metn R4 and its surrounding (surface outcrops)**

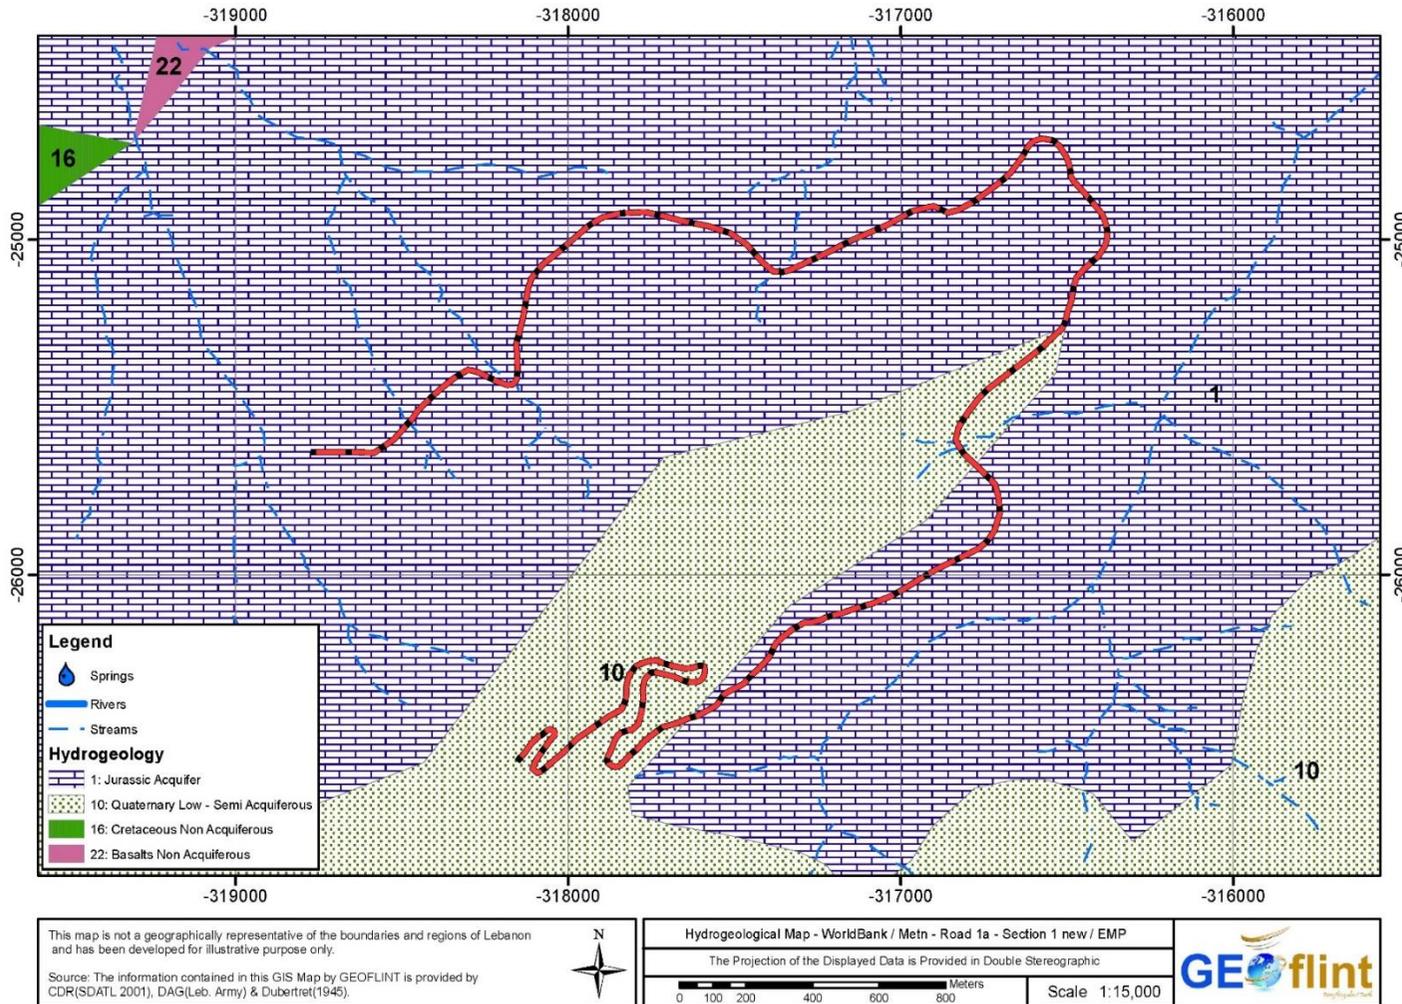
**Figure M Hydrogeological map of Metn R1a section 1 and its surrounding (map showing water potential of the subsurface). Refer to Table 4 8 for description of hydrogeology classes.**

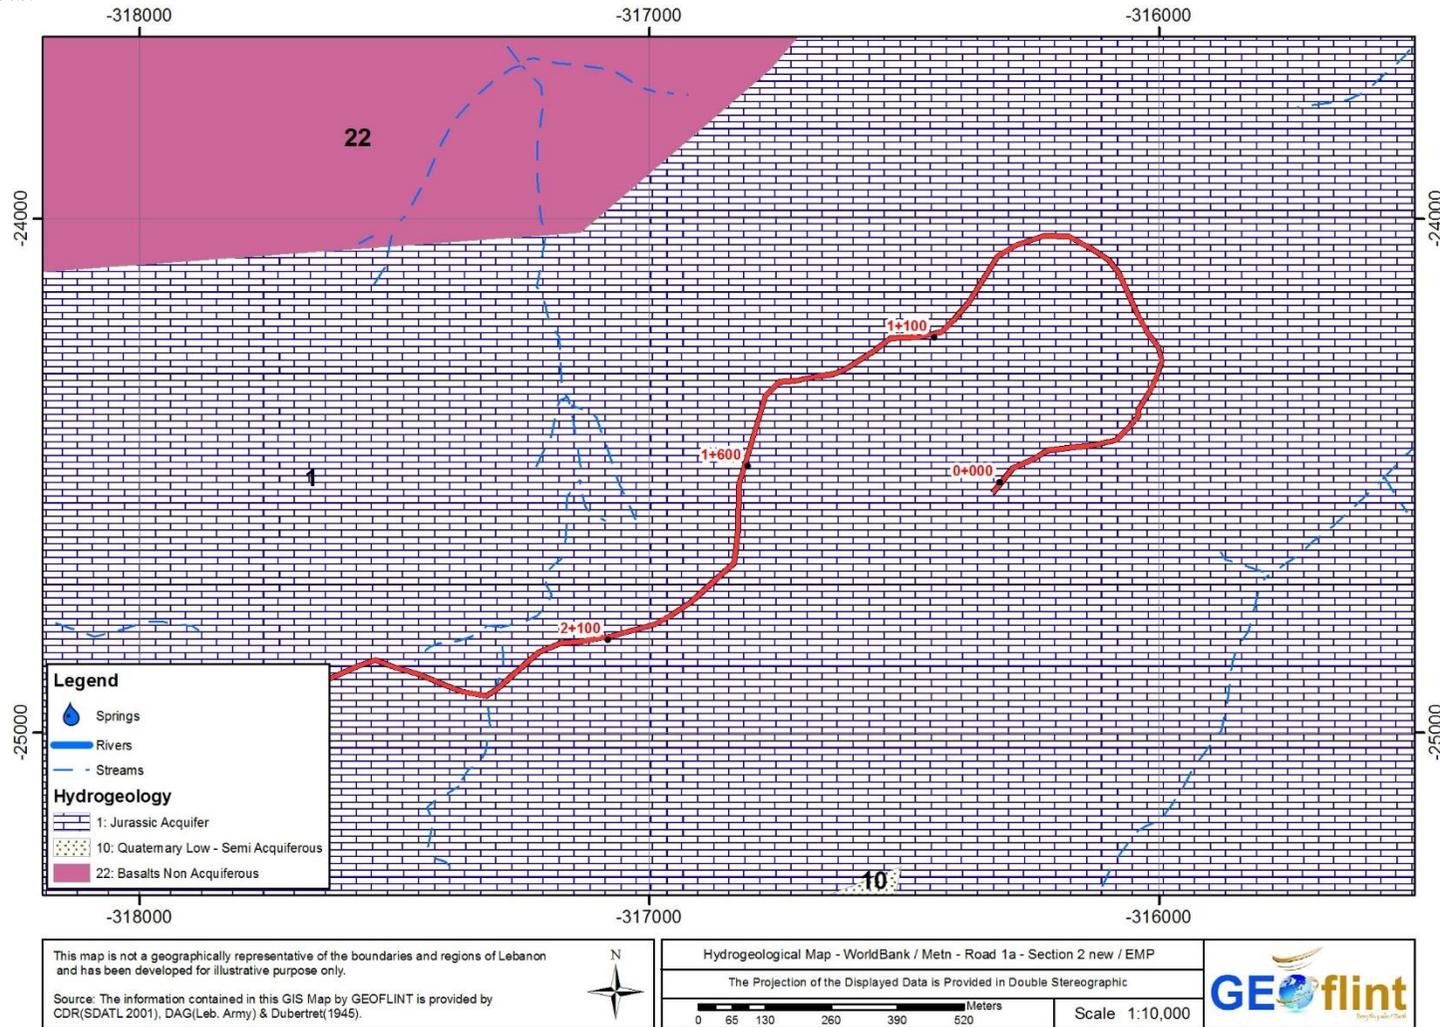
**Figure N Hydrogeological map of Metn R1a section 2 and its surrounding (map showing water potential of the subsurface). Refer to Table 4 8 for description of hydrogeology classes.**

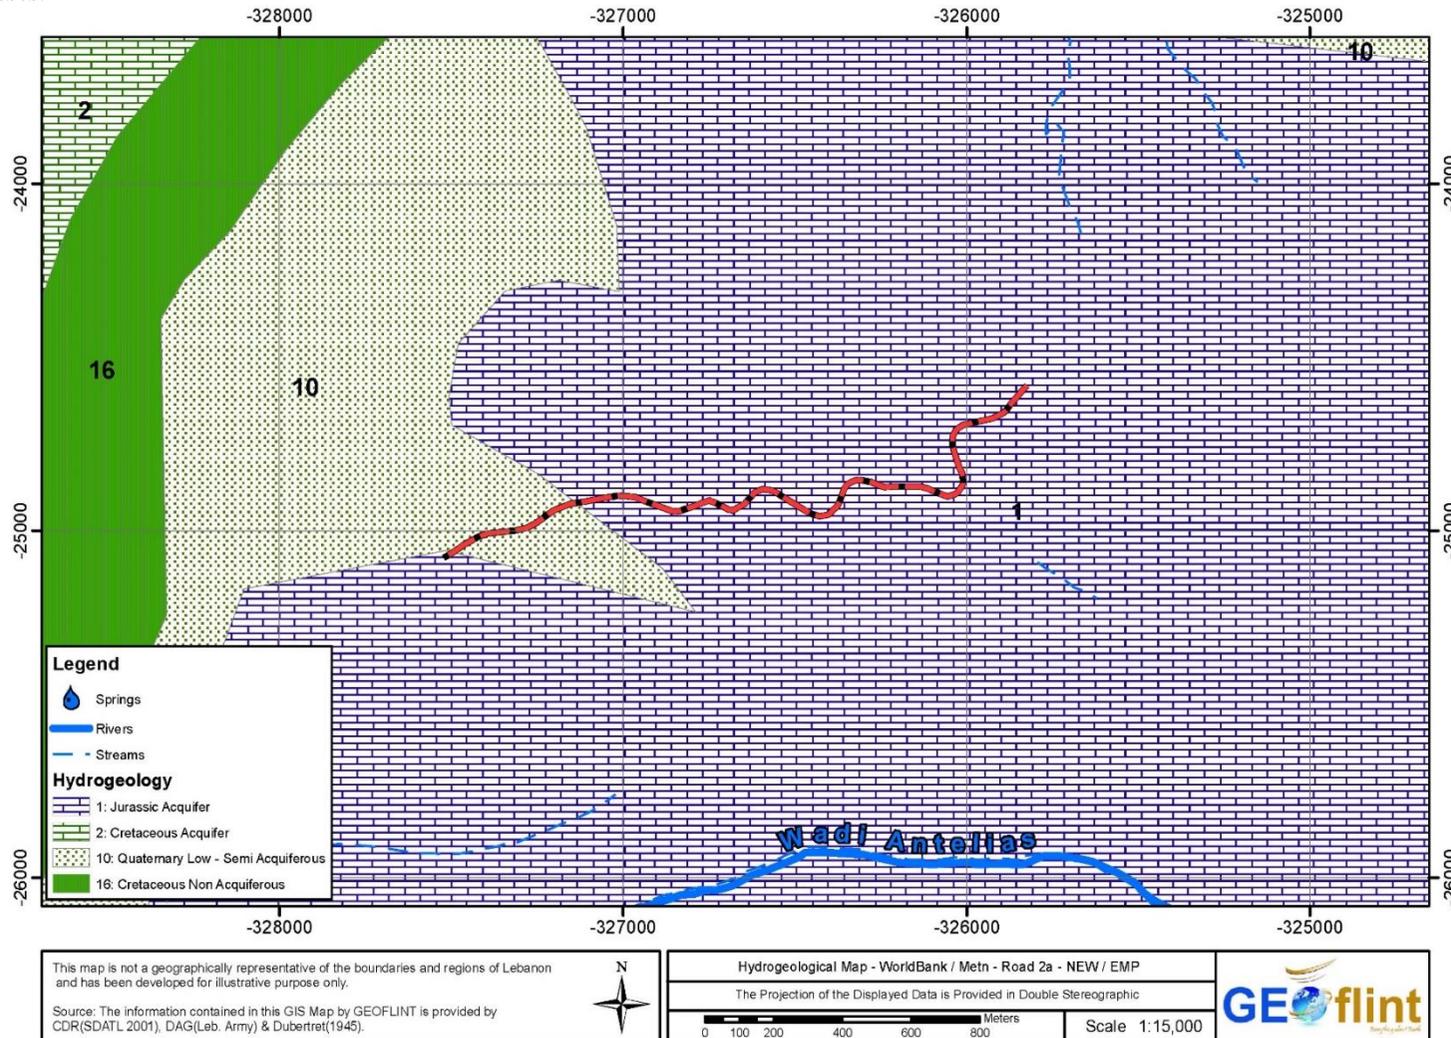
**Figure O Hydrogeological map of Metn R2 a and its surrounding (map showing water potential of the subsurface). Refer to Table 4 8 for description of hydrogeology classes.**
