Republic of Lebanon - Council for Development and Reconstruction

Road and Employment Project (REP)

Environmental and Social Management Plan (ESMP)  
Final Report

LOT 1: Caza of Metn

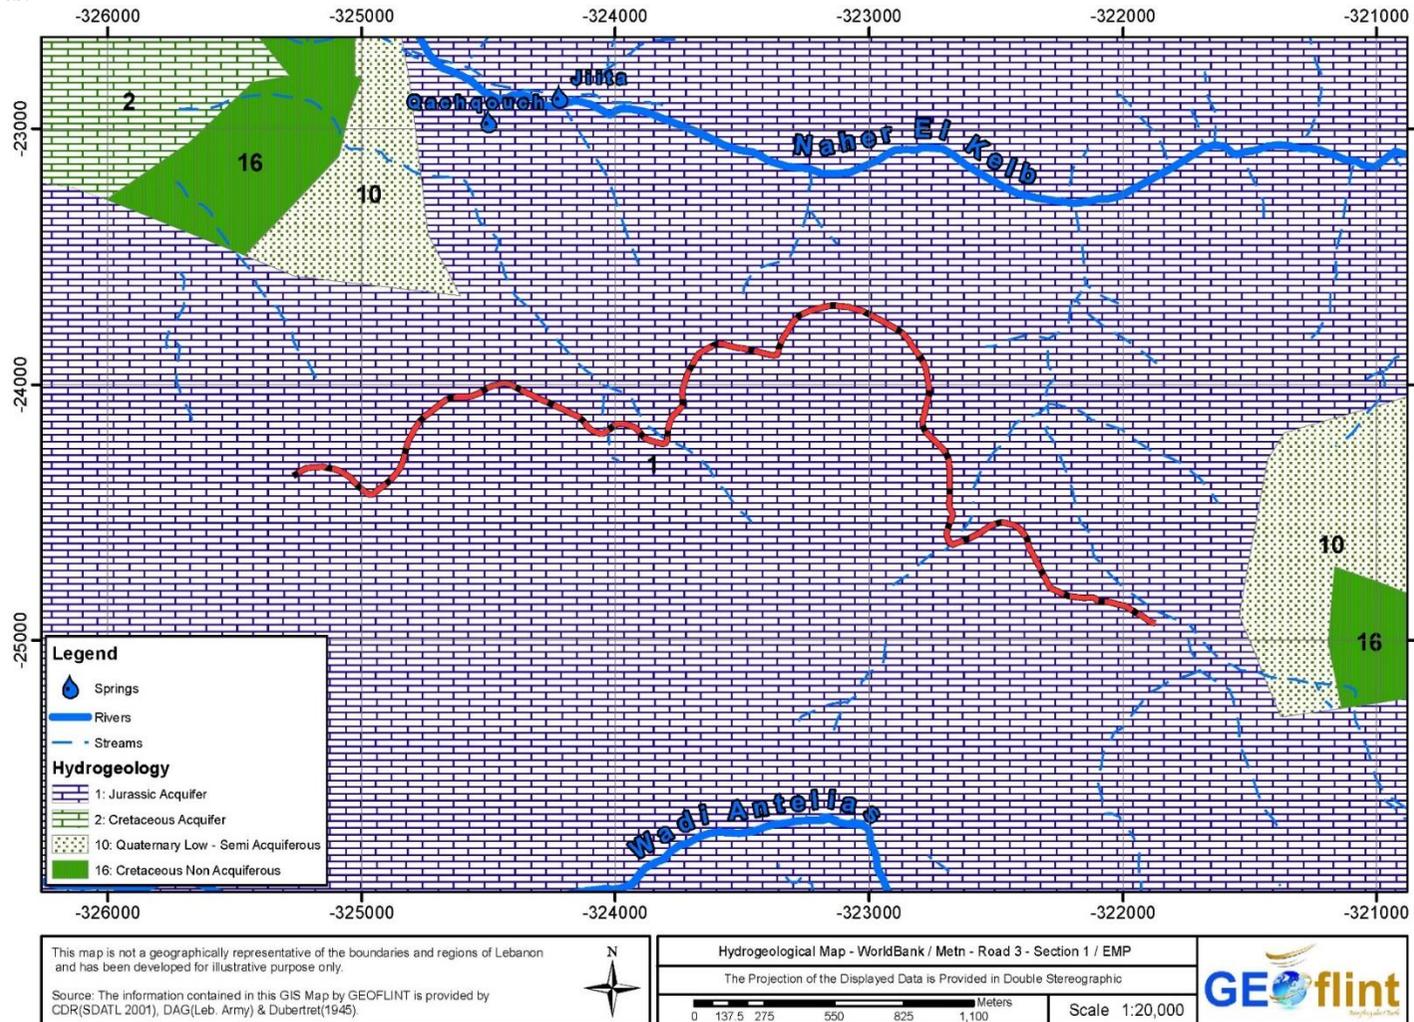
**Figure P Hydrogeological map of Metn R3 section 1 and its surrounding (map showing water potential of the subsurface). Refer to Table 4 8 for description of hydrogeology classes.**

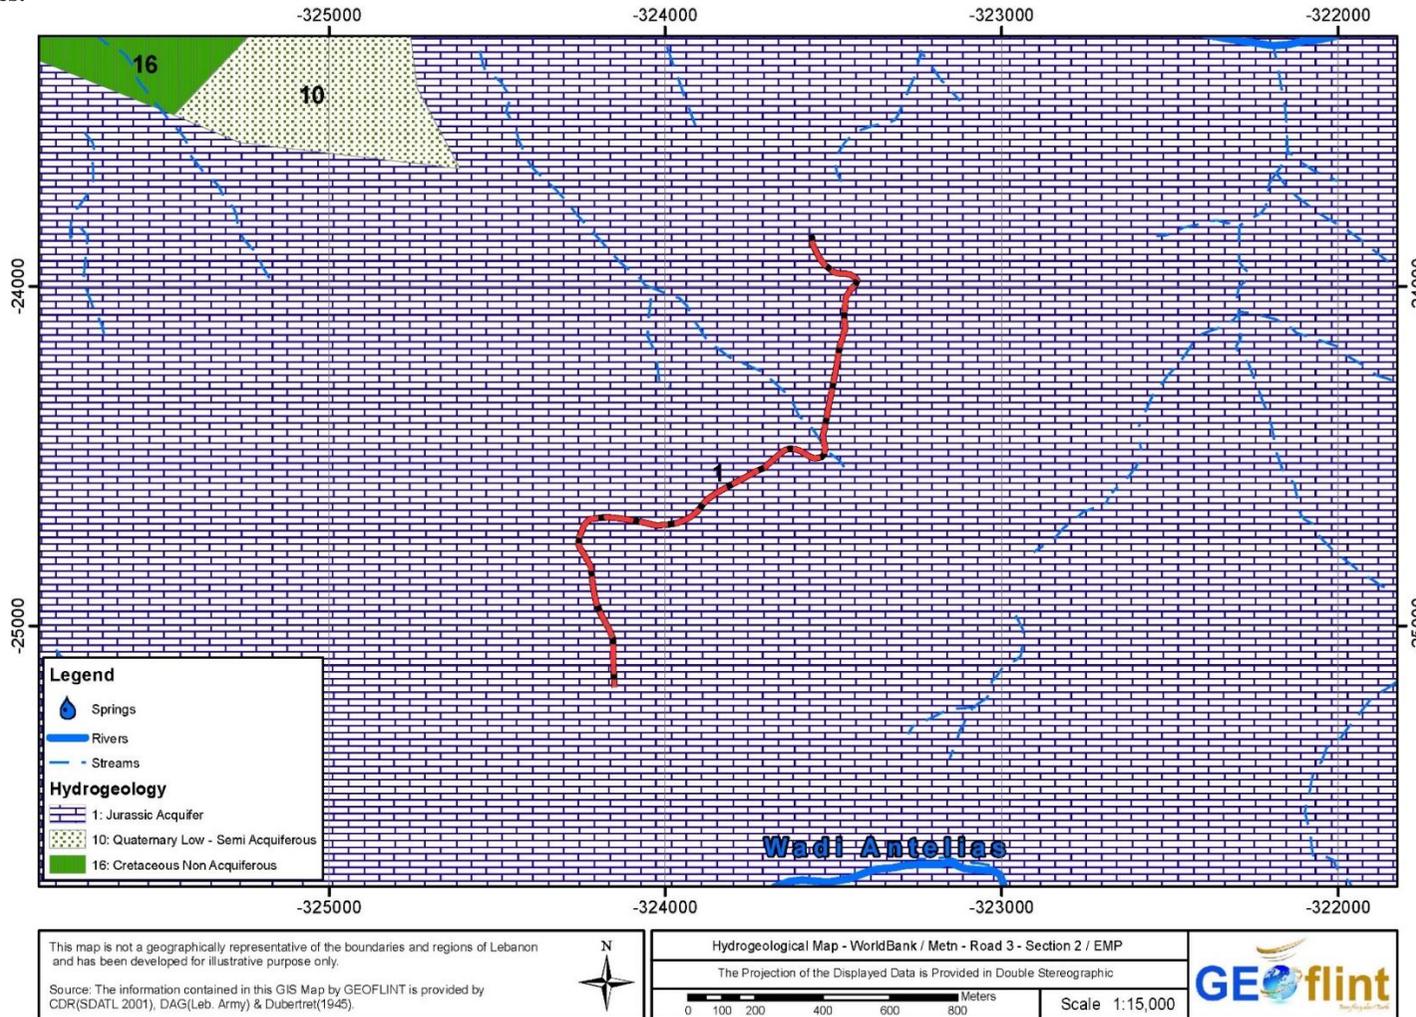
**Figure Q Hydrogeological map of Metn R3 section 2 and its surrounding (map showing water potential of the subsurface). Refer to Table 4 8 for description of hydrogeology classes.**

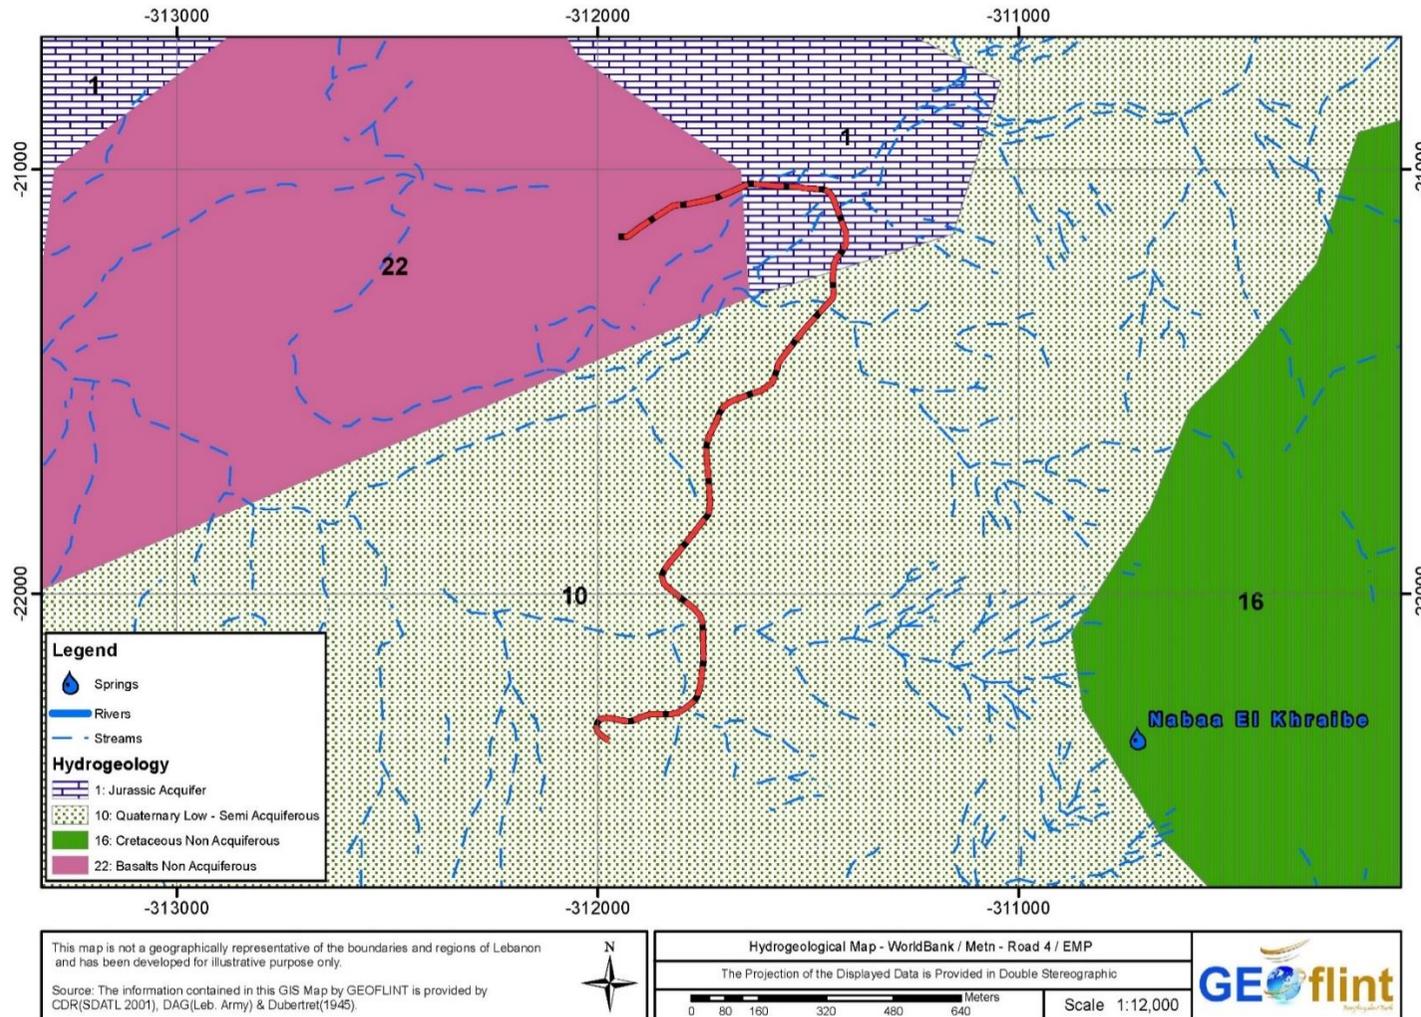
**Figure R Hydrogeological map of Metn R4 and its surrounding (map showing water potential of the subsurface). Refer to Table 4 8 for description of hydrogeology classes.**

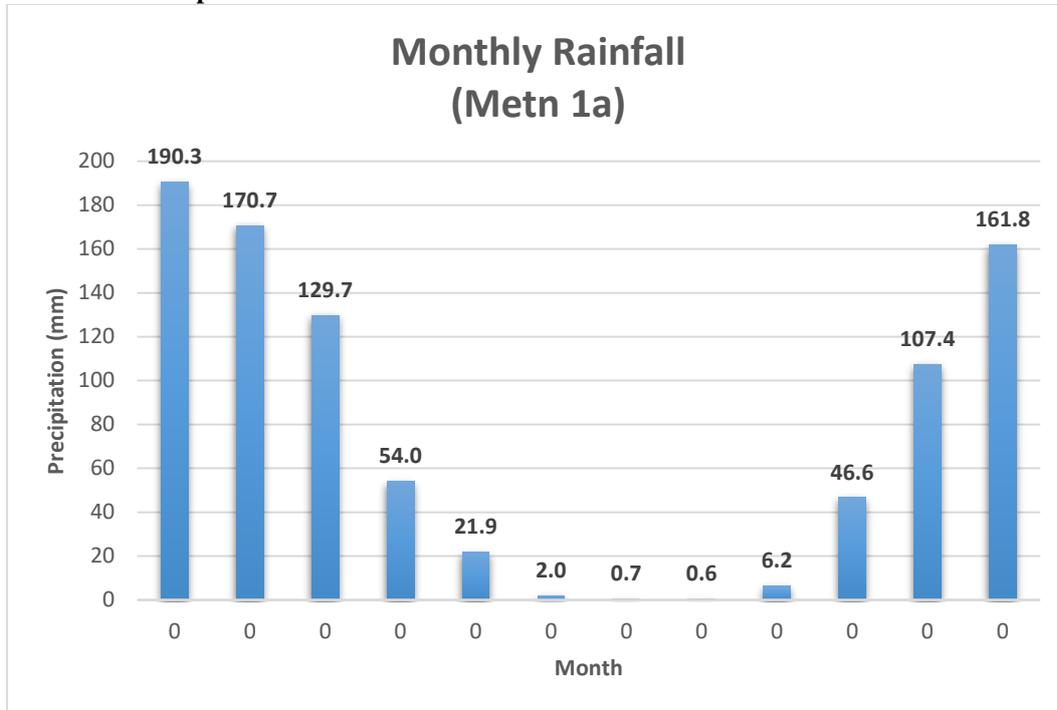
**Figure S Precipitations values along Metn R1a alignment (period extending between 1996-2018) CHIRPS satellite 4.5 km spatial resolution**

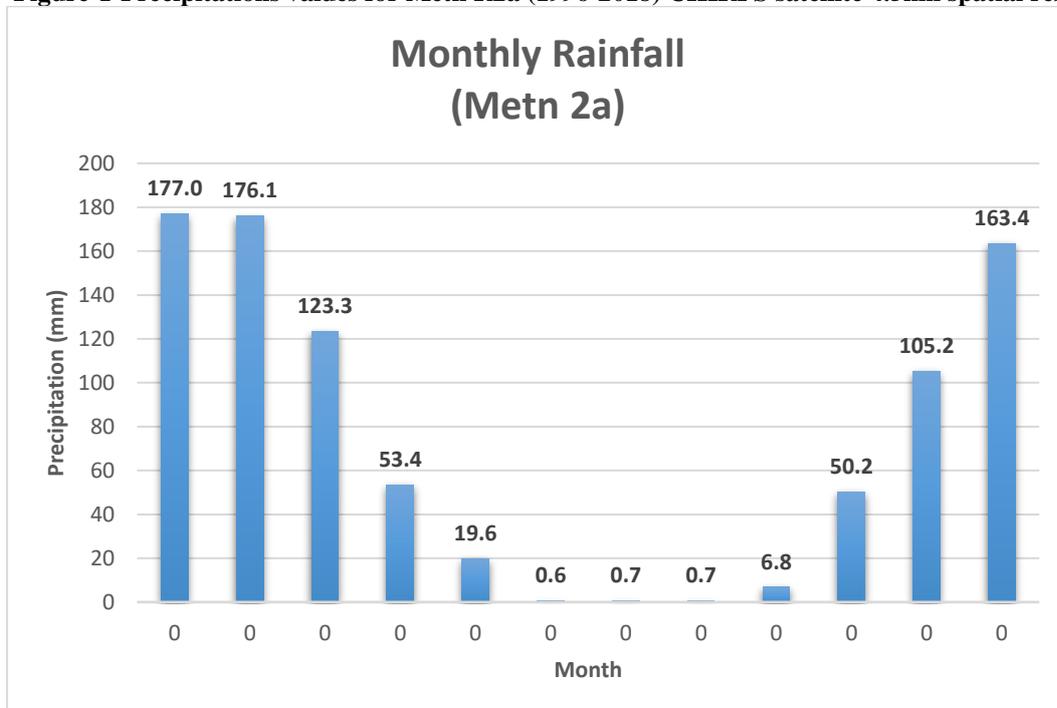
**Figure T Precipitations values for Metn R2a (1996-2018) CHIRPS satellite 4.5km spatial resolution**

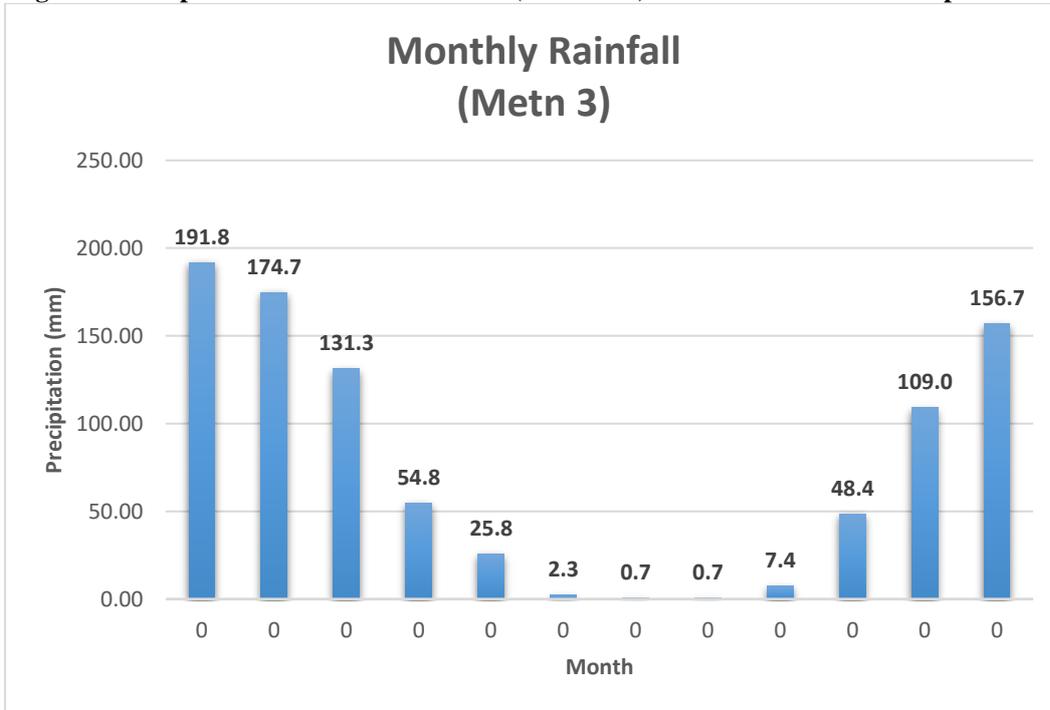
**Figure U Precipitations values for Metn R3 (1996-2018) CHIRPS satellite 4.5km spatial resolution**

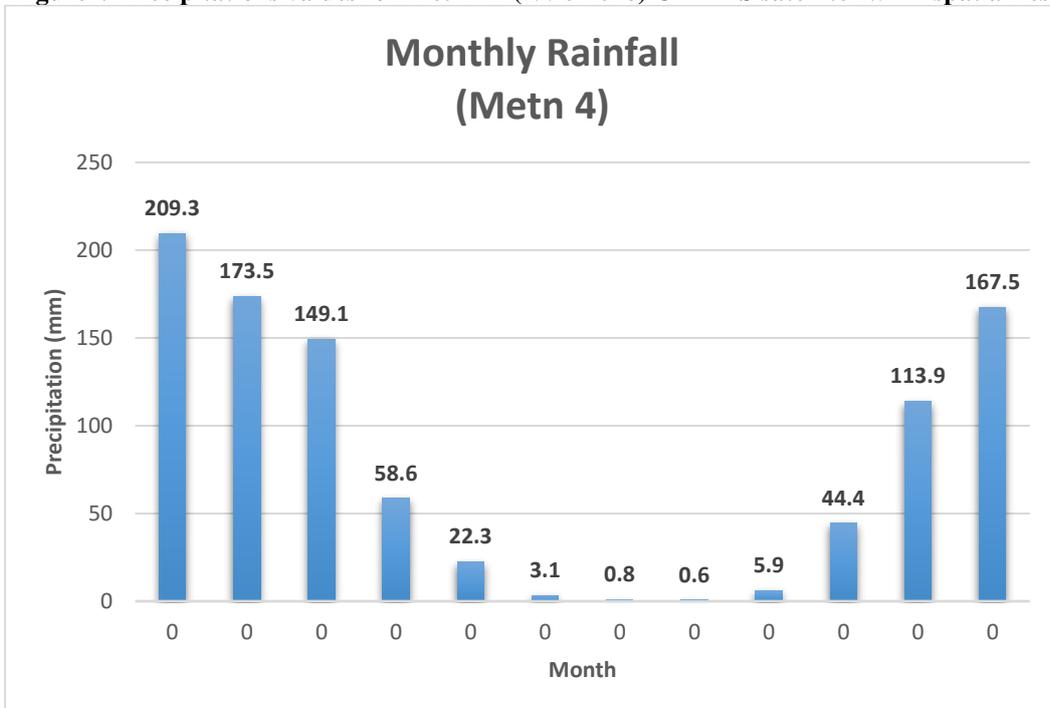
**Figure V Precipitations values for Metn R4 (1996-2018) CHIRPS satellite 4.5km spatial resolution**

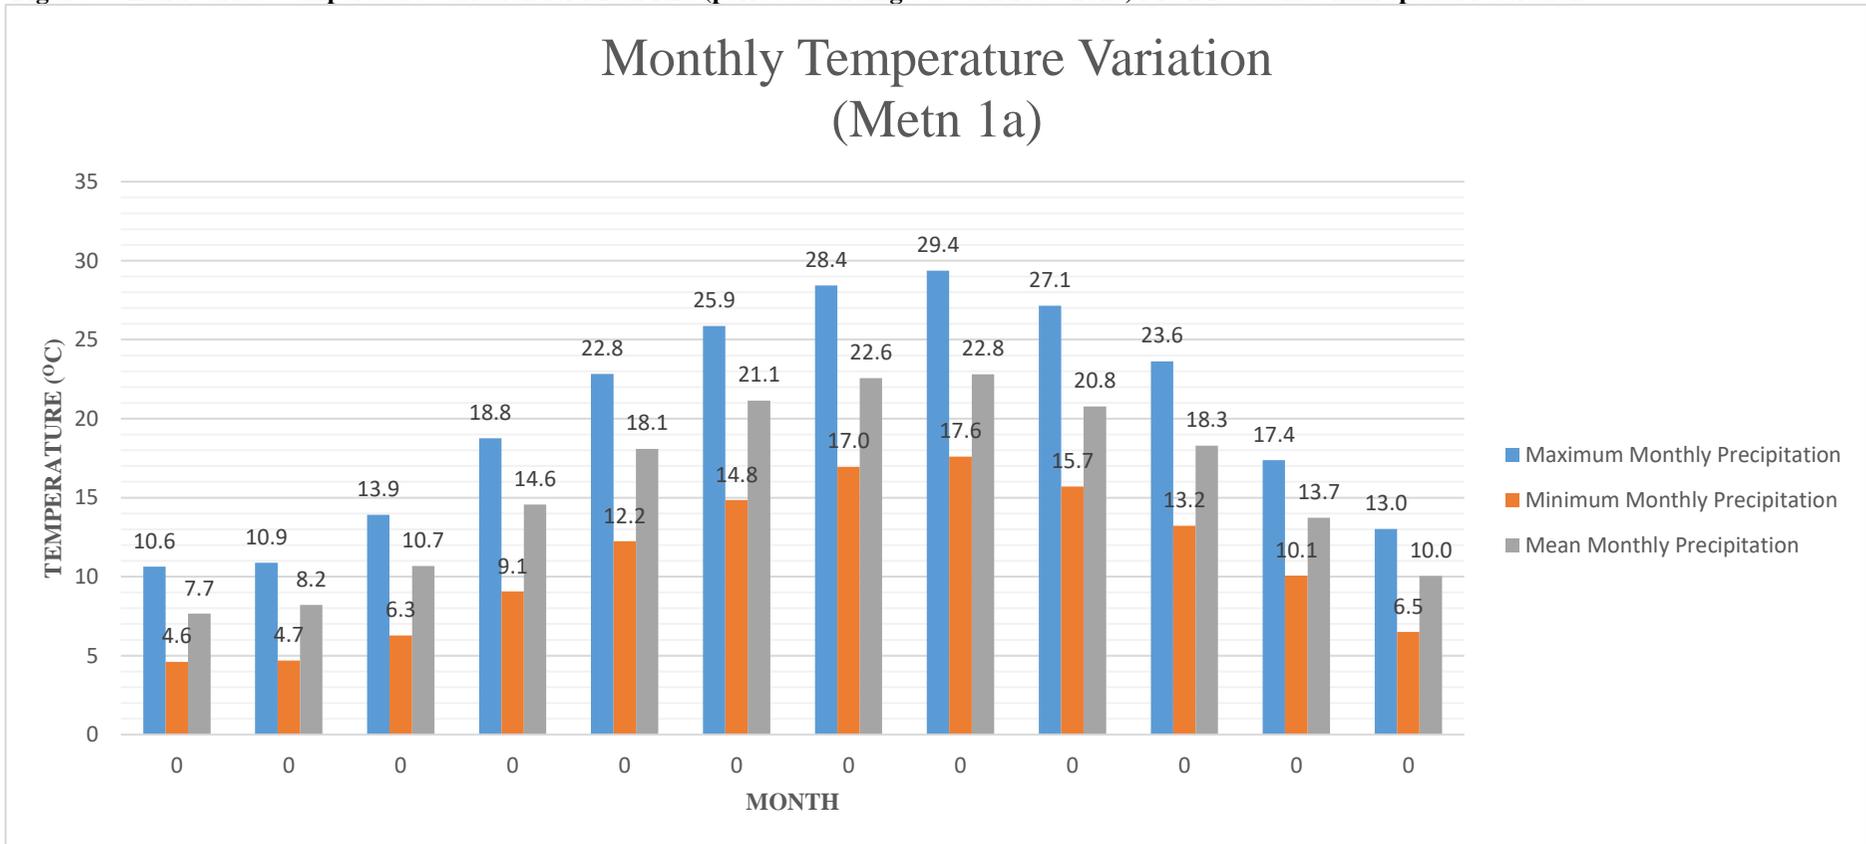
**Figure W Land surface temperature variation for Metn R1a (period extending between 2000-2018) MODIS satellite 1km spatial resolution**

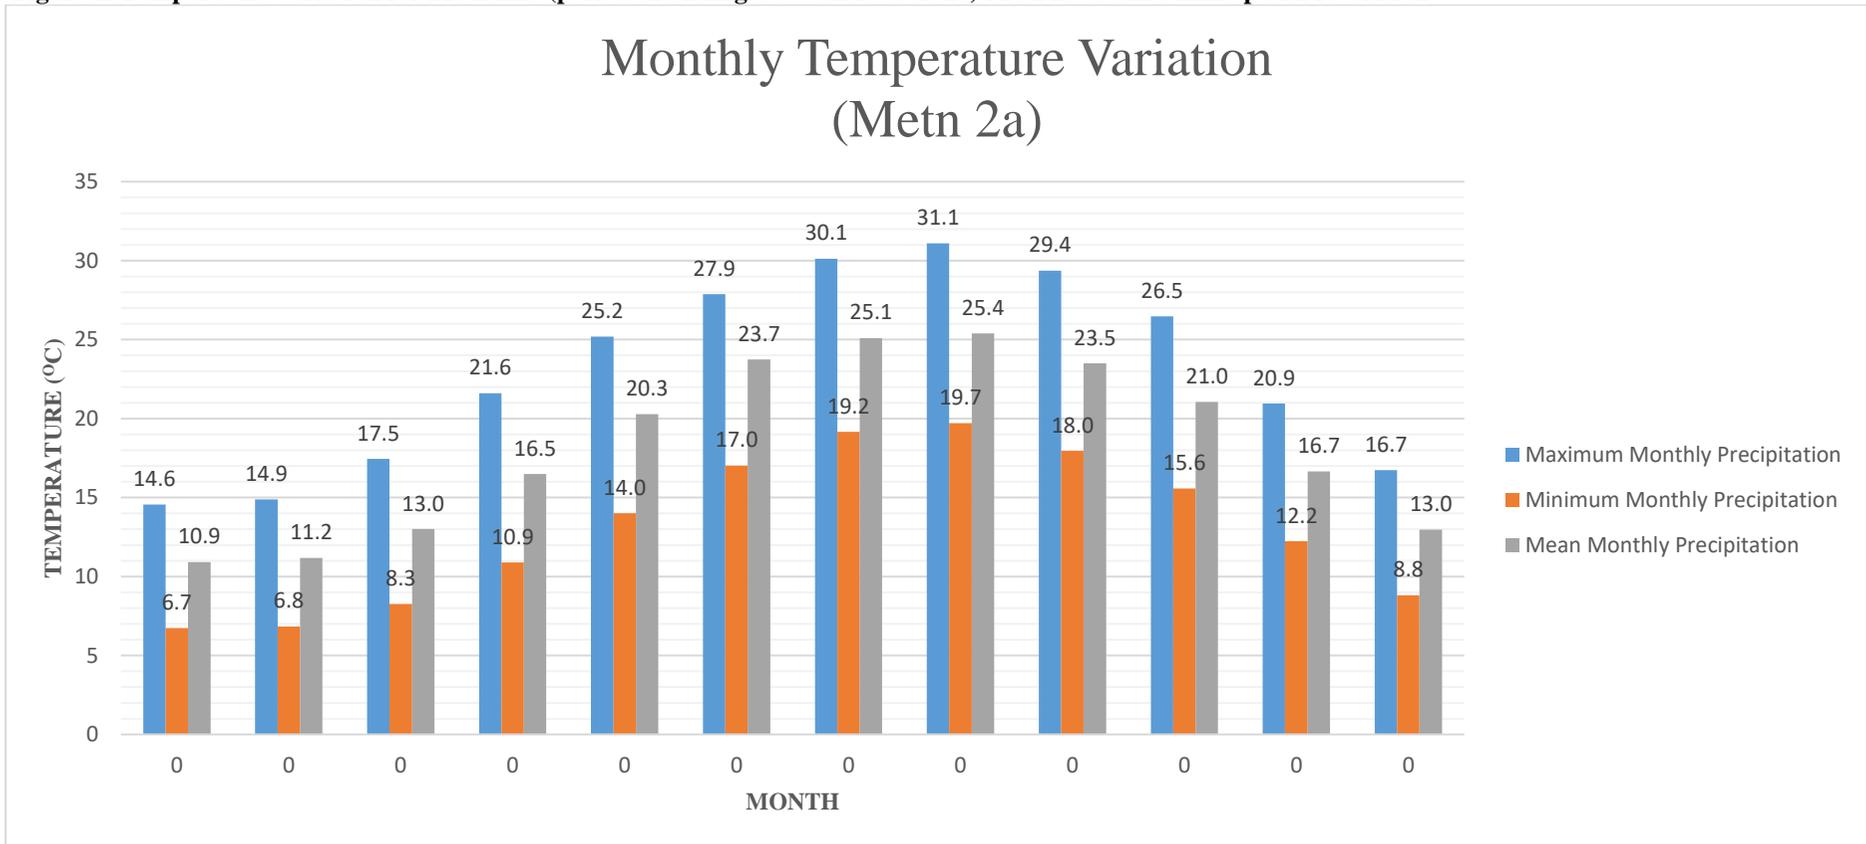
**Figure X Temperature variation for Metn R2a (period extending between 2000-2018) MODIS satellite 1km spatial resolution**

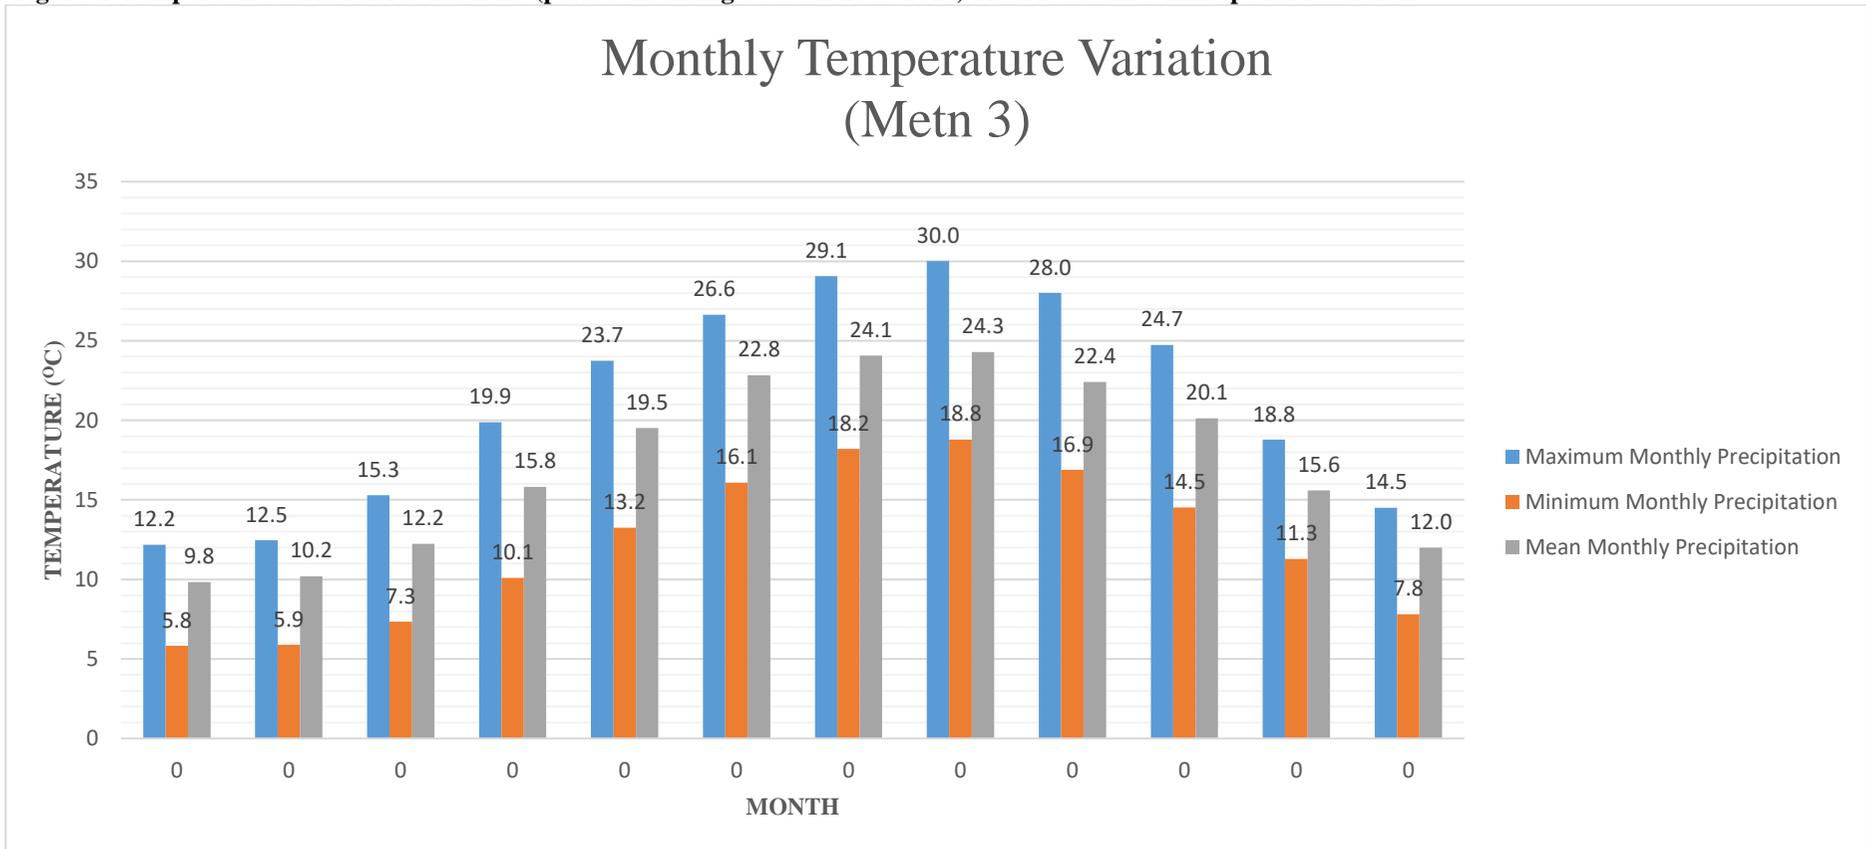
**Figure Y Temperature variation for Metn R3 (period extending between 2000-2018) MODIS satellite 1km spatial resolution**

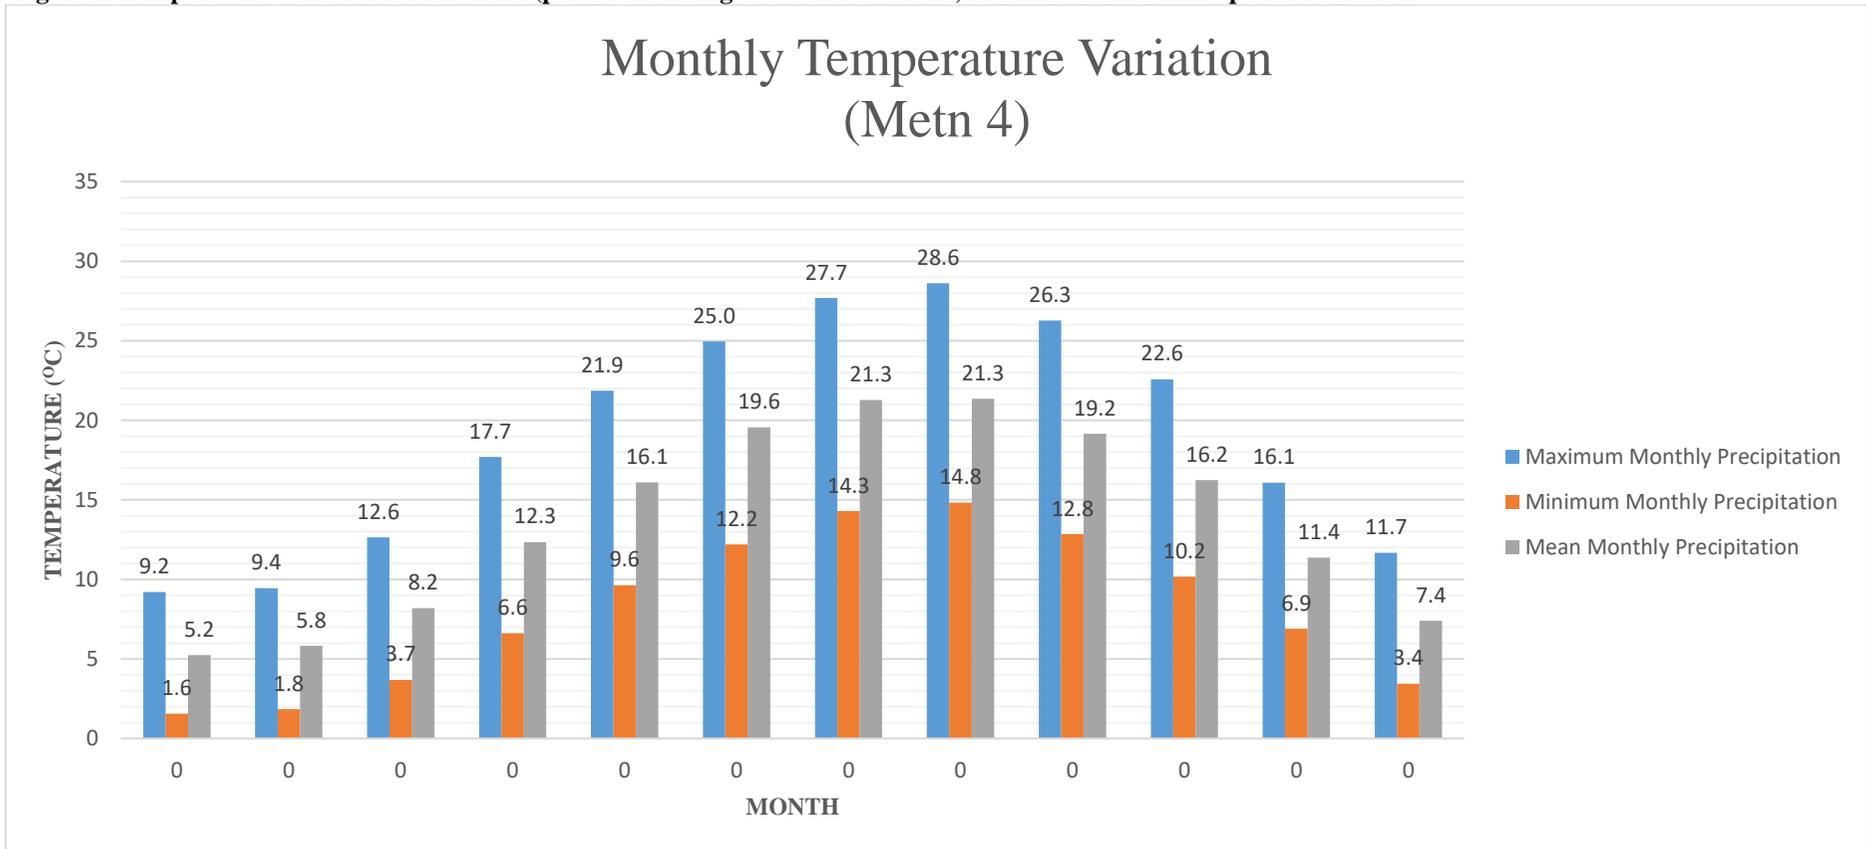
**Figure Z Temperature variation for Metn R4 (period extending between 2000-2018) MODIS satellite 1km spatial resolution**

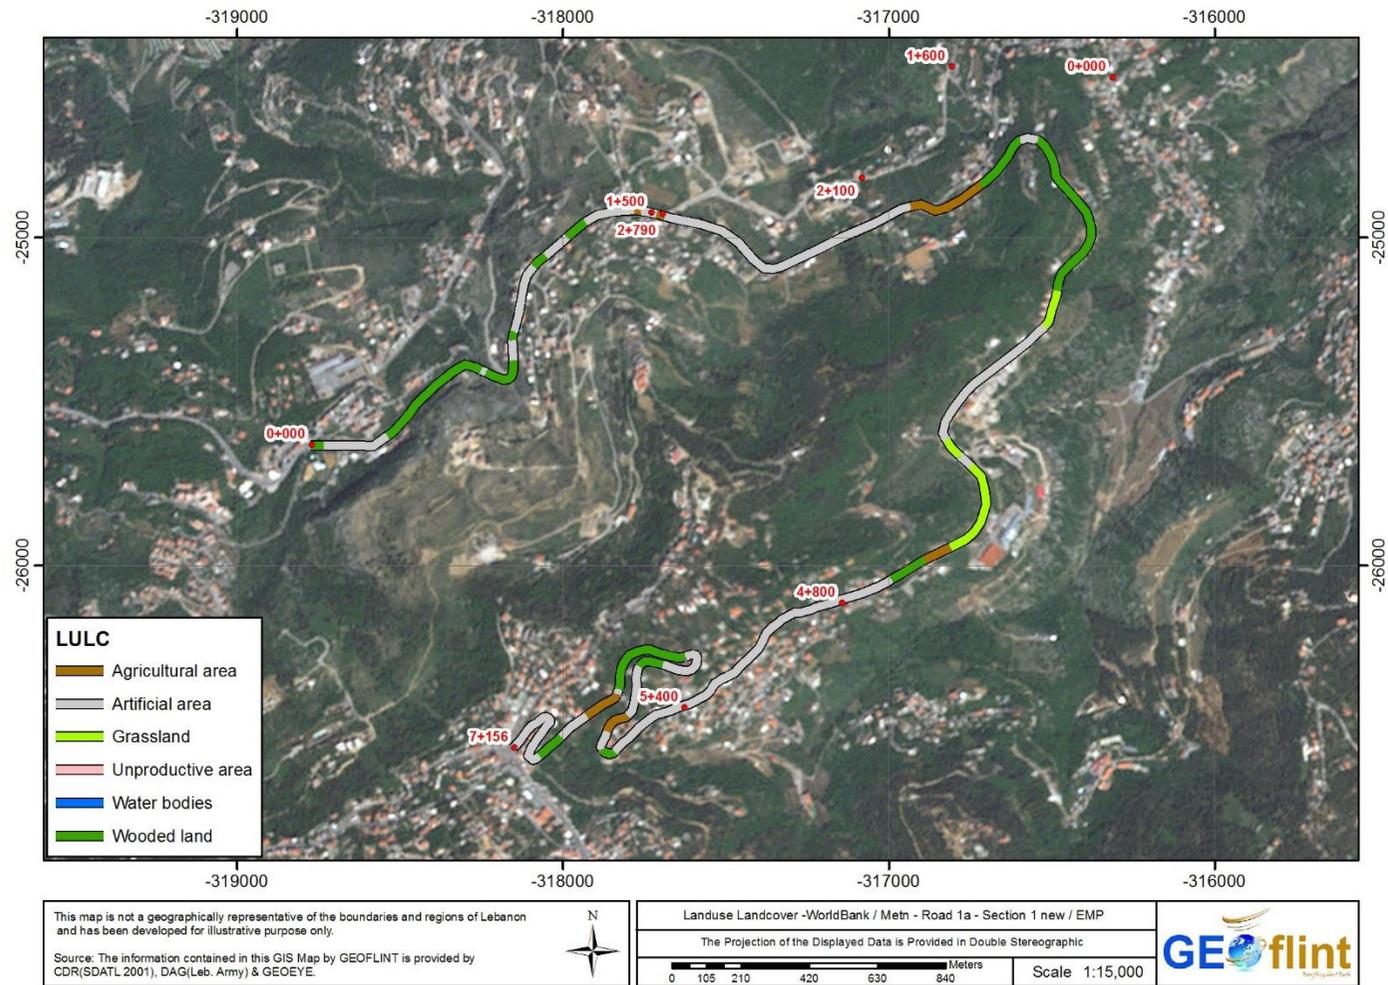
Figure AA LULC map with work stations shown in red along Metn R1a alignment (section 1)

**Table A Metn R1a existing acoustic conditions (location of stations shown in Figure AA and Figure BB in Annex 1)**

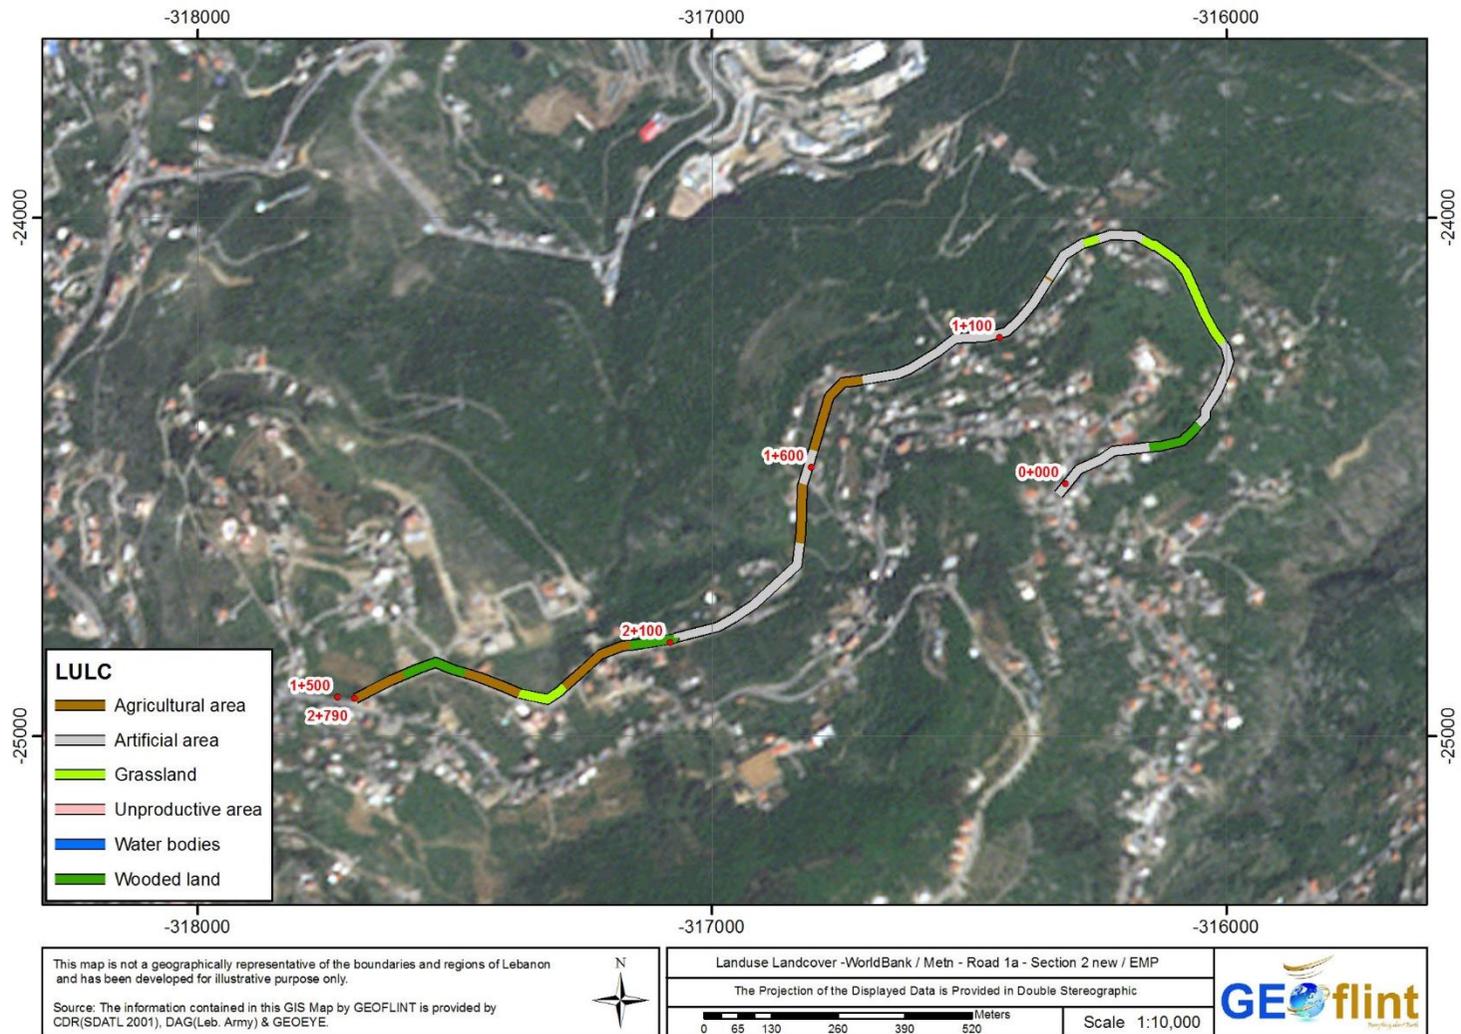
**Figure BB LULC map with work stations shown in red along Metn R1a alignment (section 2)**
