Republic of Lebanon - Council for Development and Reconstruction

Road and Employment Project (REP)

Environmental and Social Management Plan (ESMP)
Final Report

LOT 1: Caza of Kesrouane

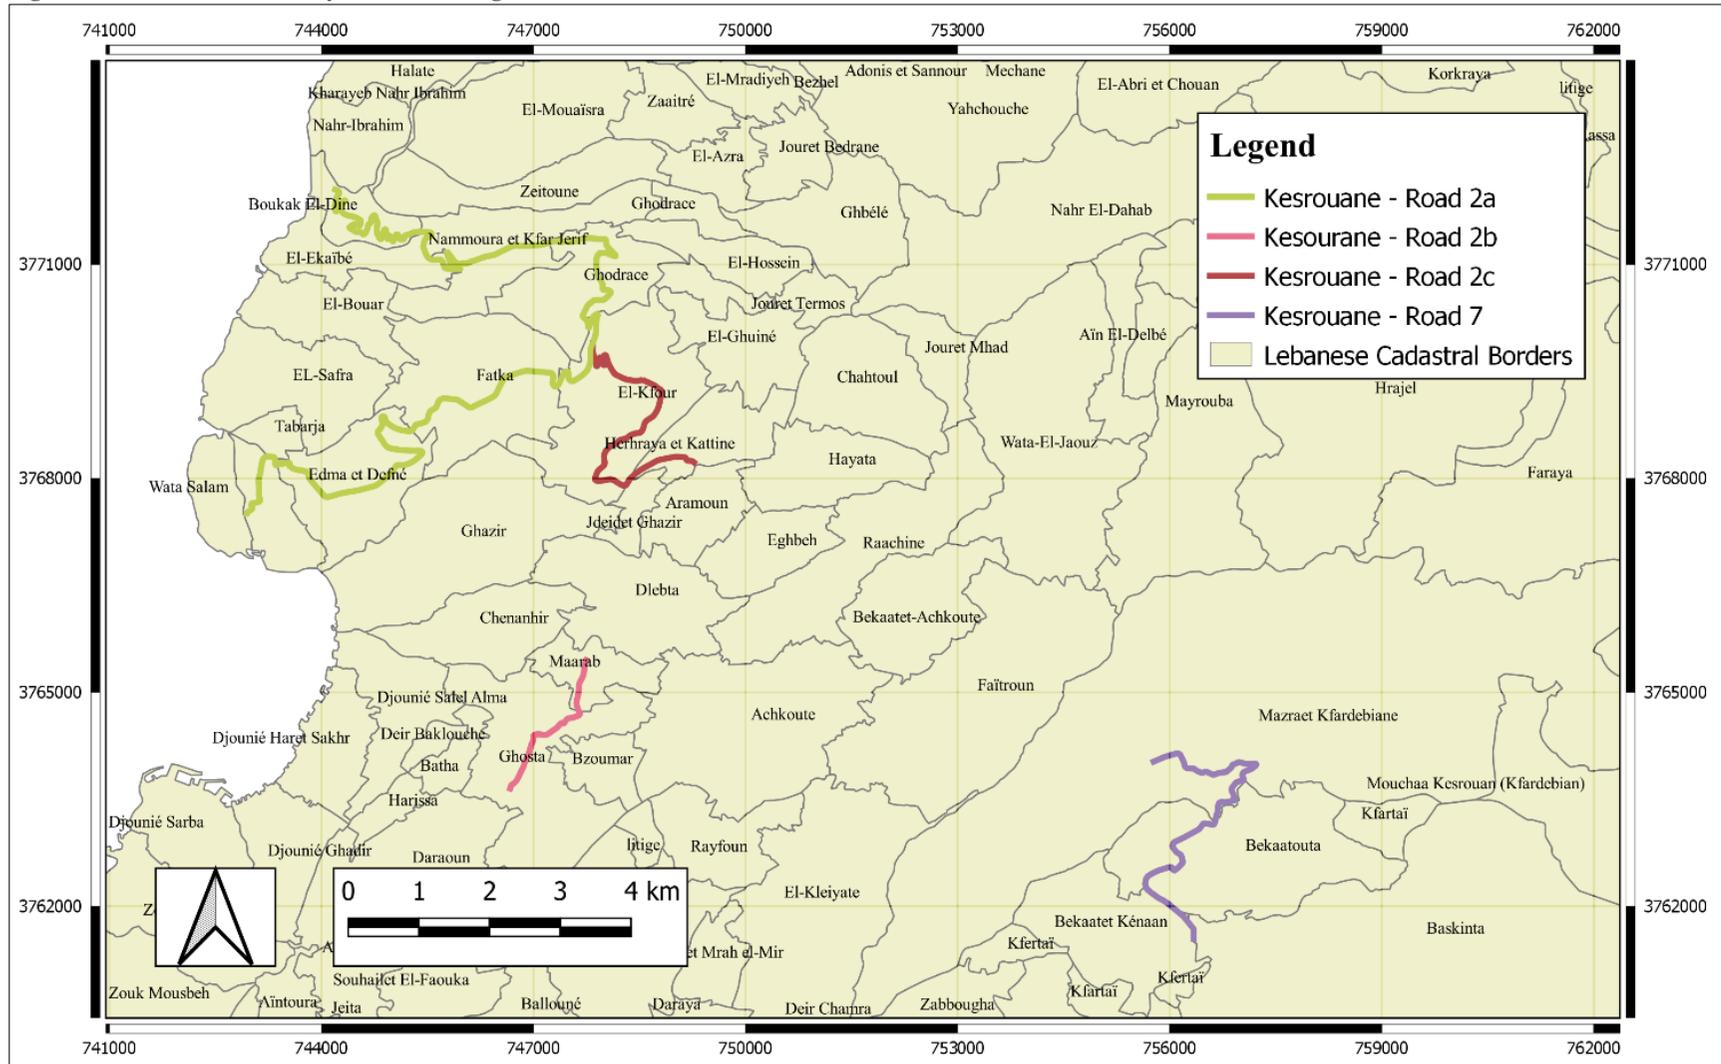
Figure 1-1 Lot 1 – Roads Key Plan Drawing (Kesrouane roads)

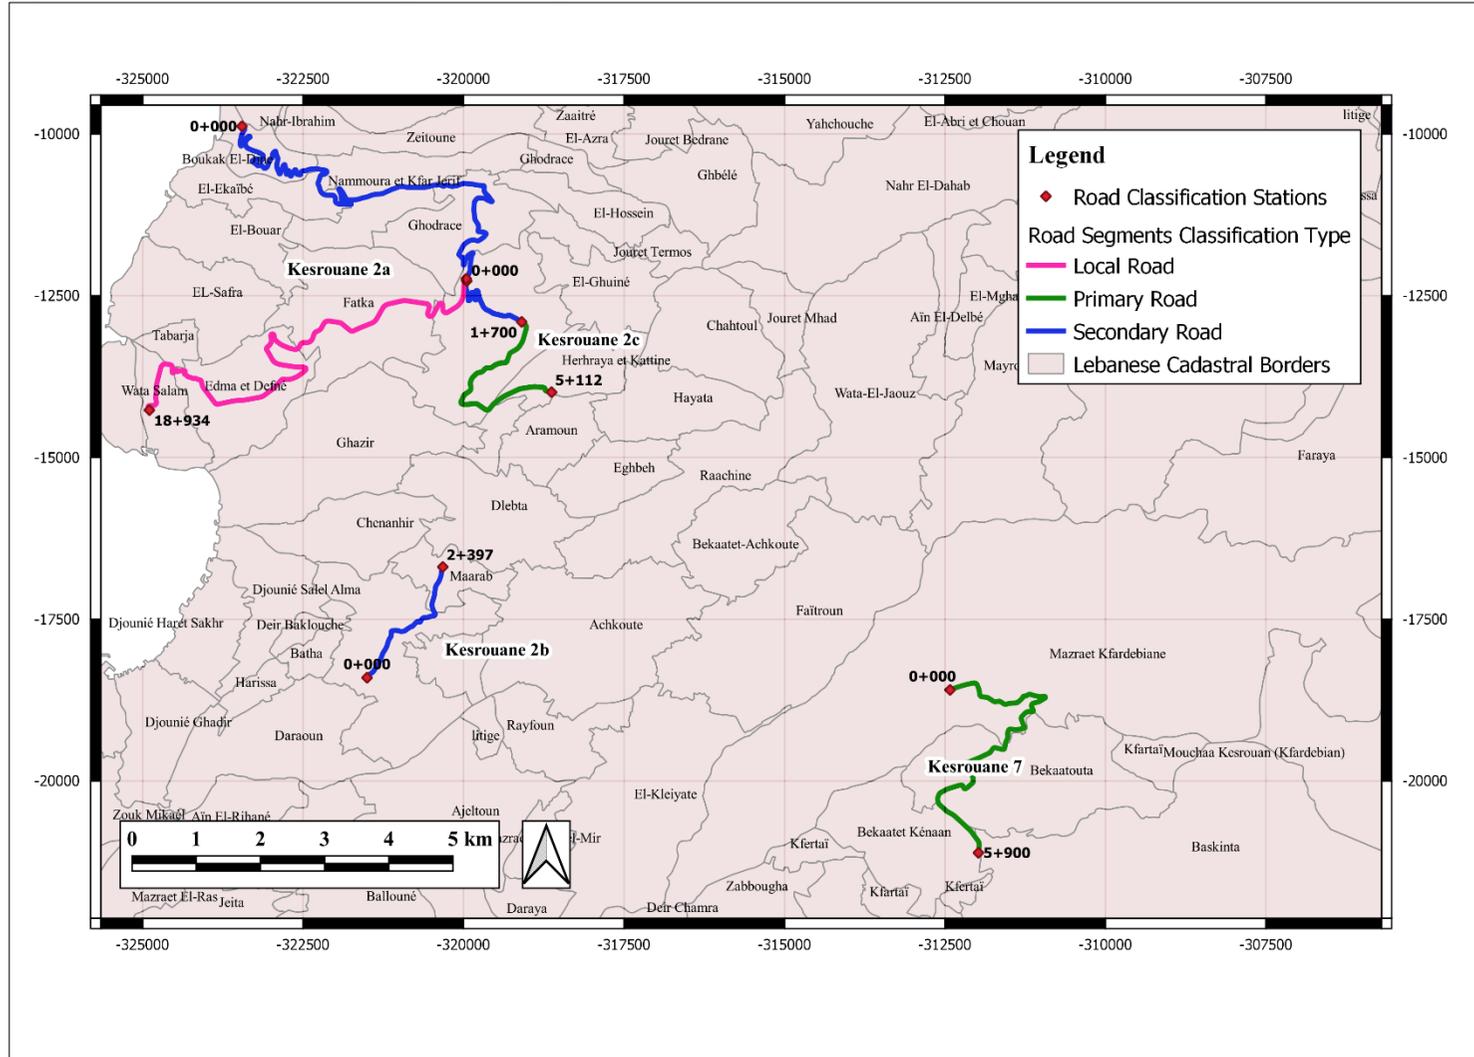
Figure 3-1 Classification of road segments among Kesrouane roads

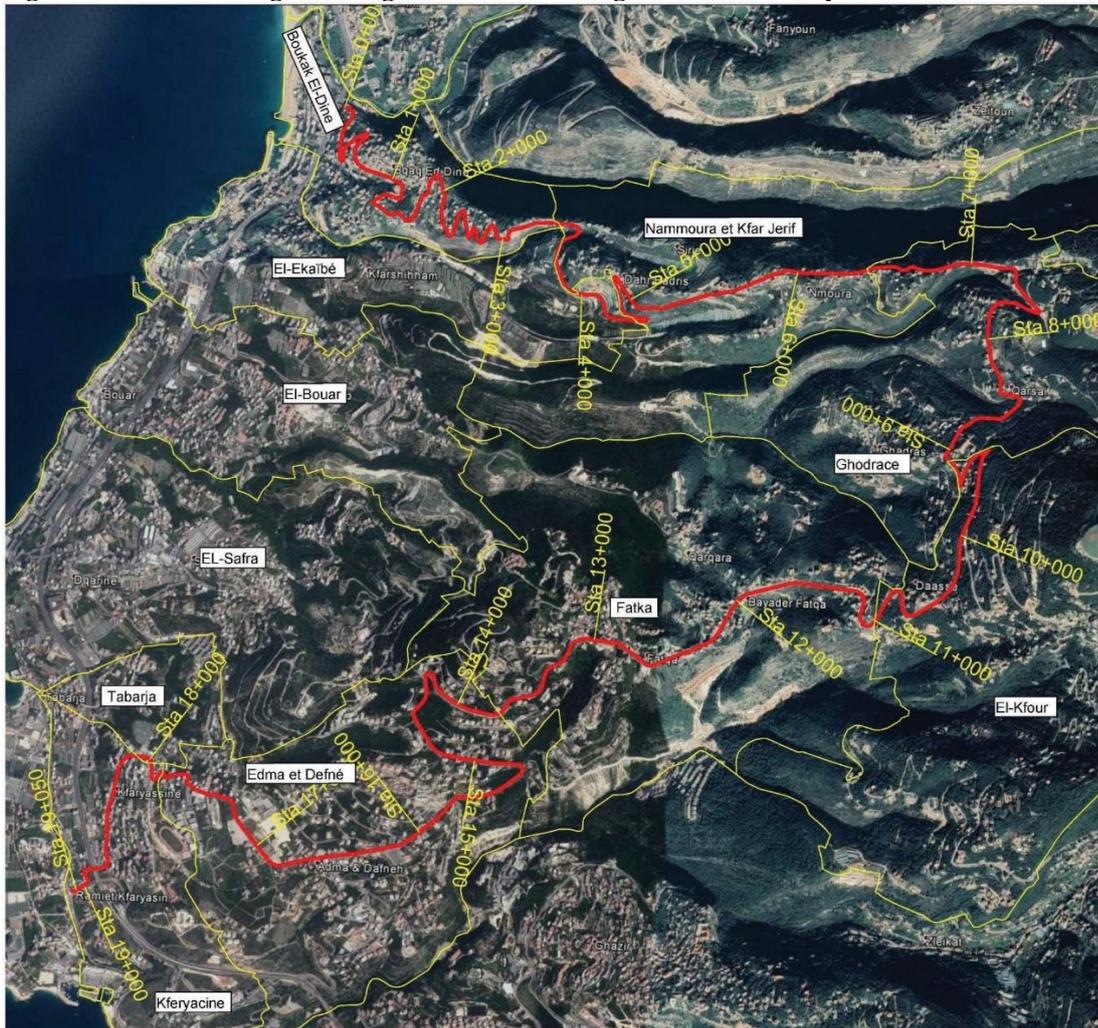
Figure 3-2 Satellite image showing Kesrouane R2a alignment with surveyed stations

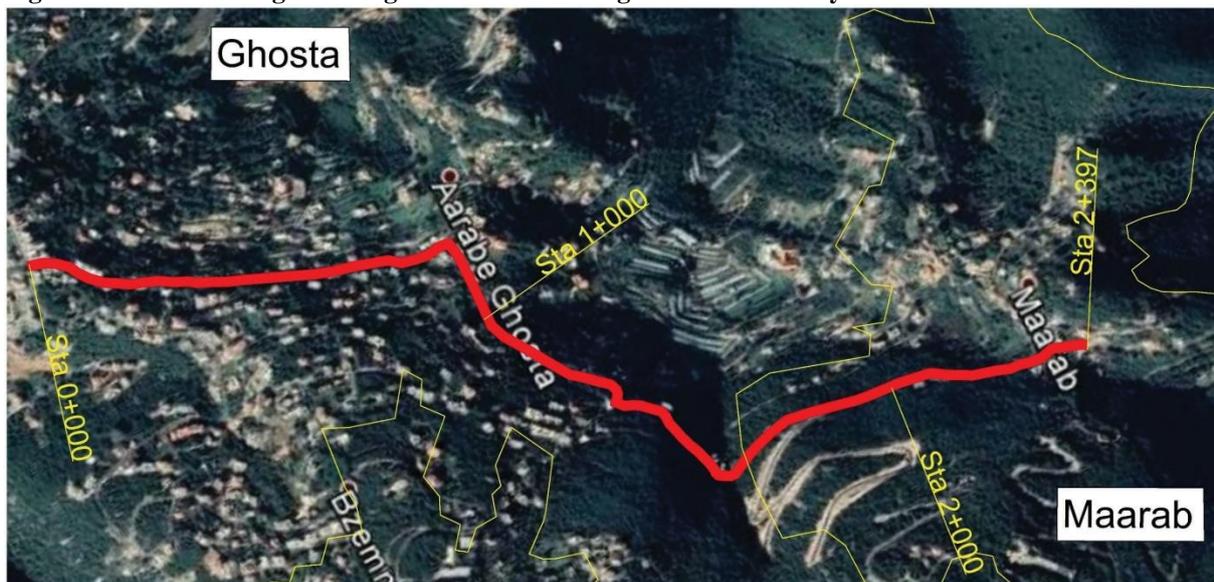
Figure 3-3 Satellite image showing Kesrouane R2b alignment with surveyed stations

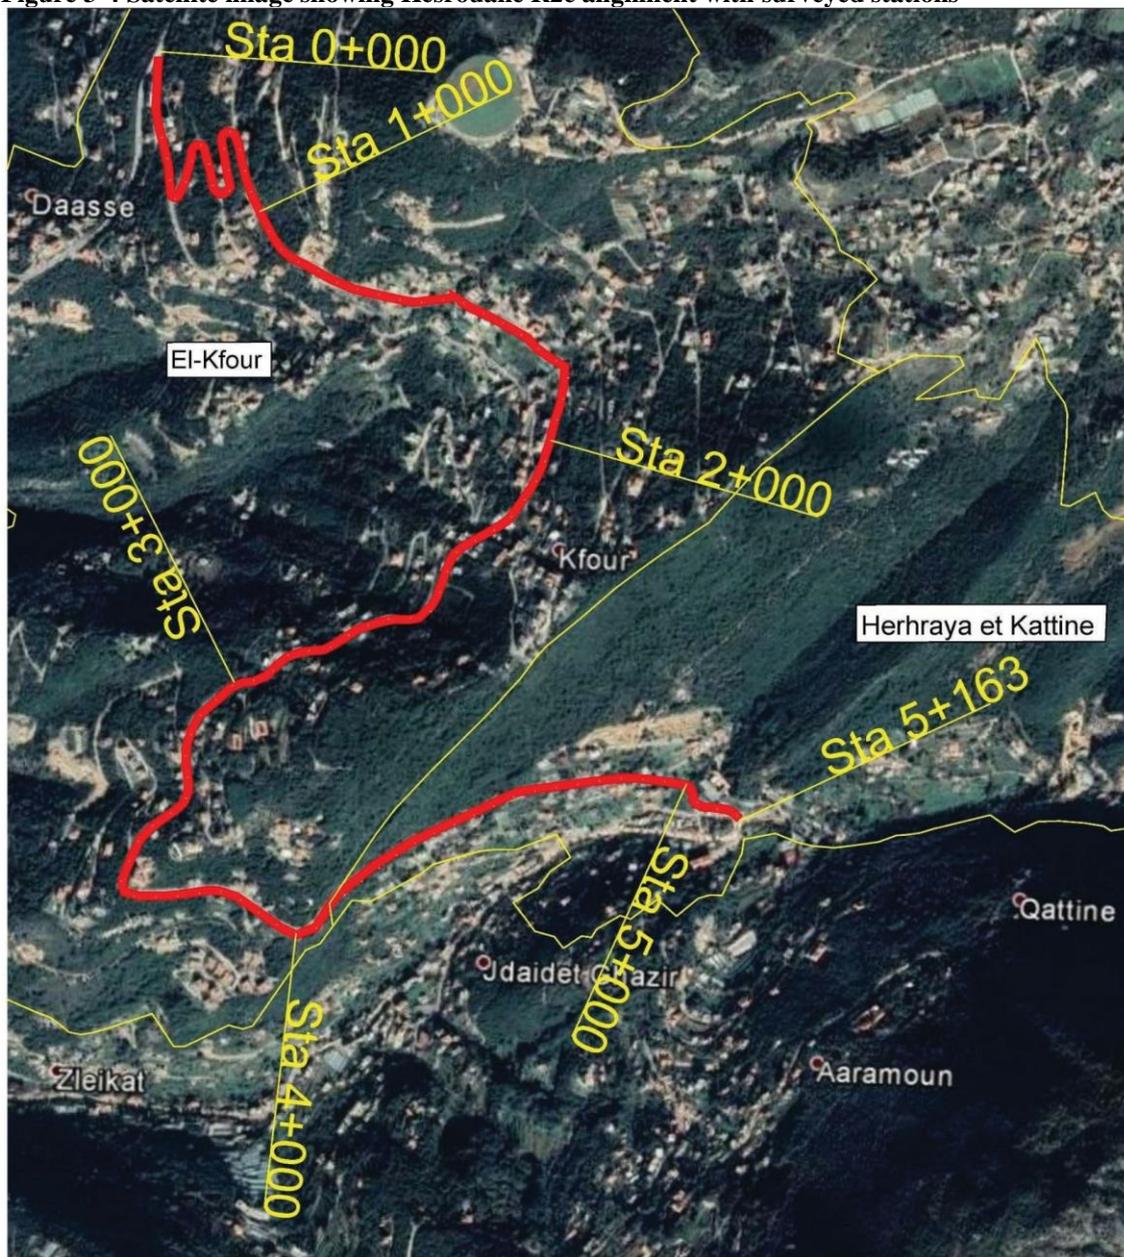
Figure 3-4 Satellite image showing Kesrouane R2c alignment with surveyed stations

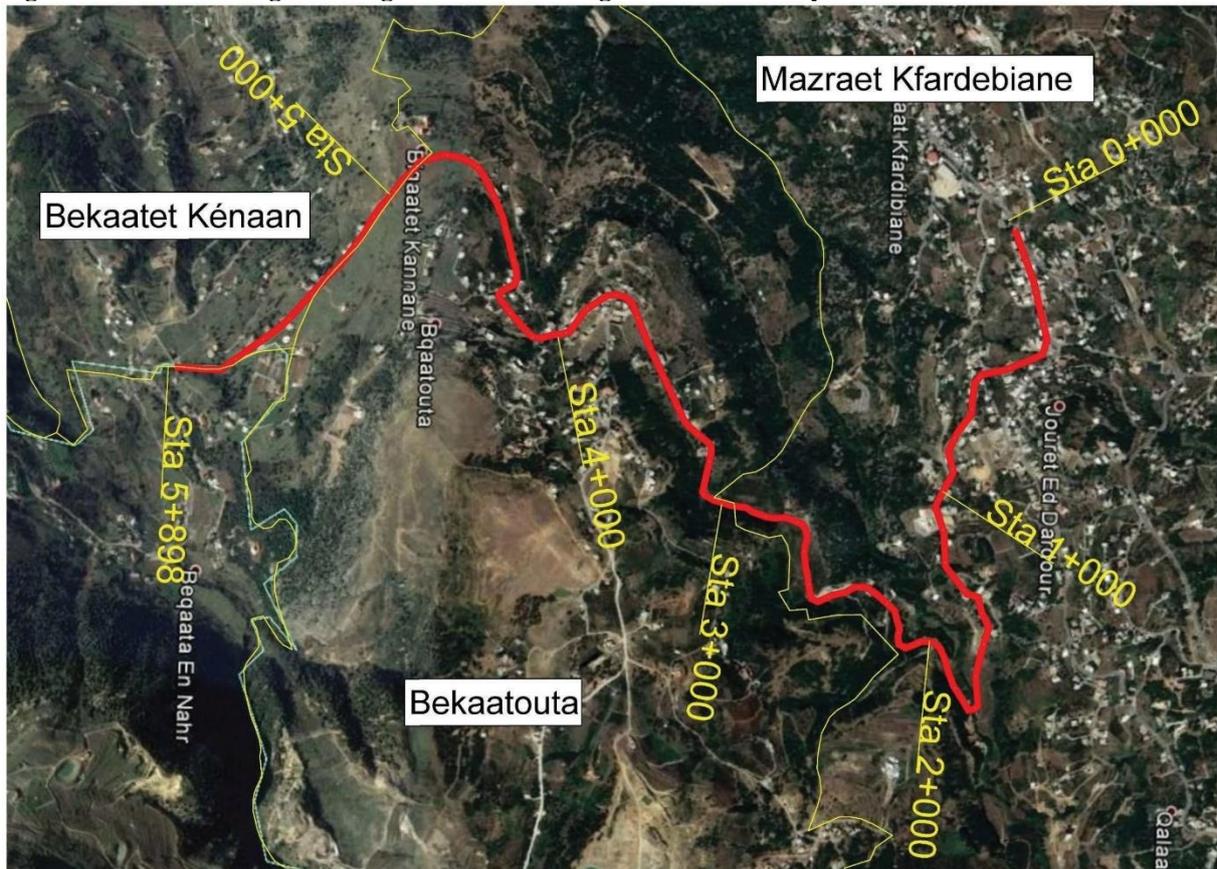
Figure 3-5 Satellite image showing Kesrouane R7 alignment with surveyed stations

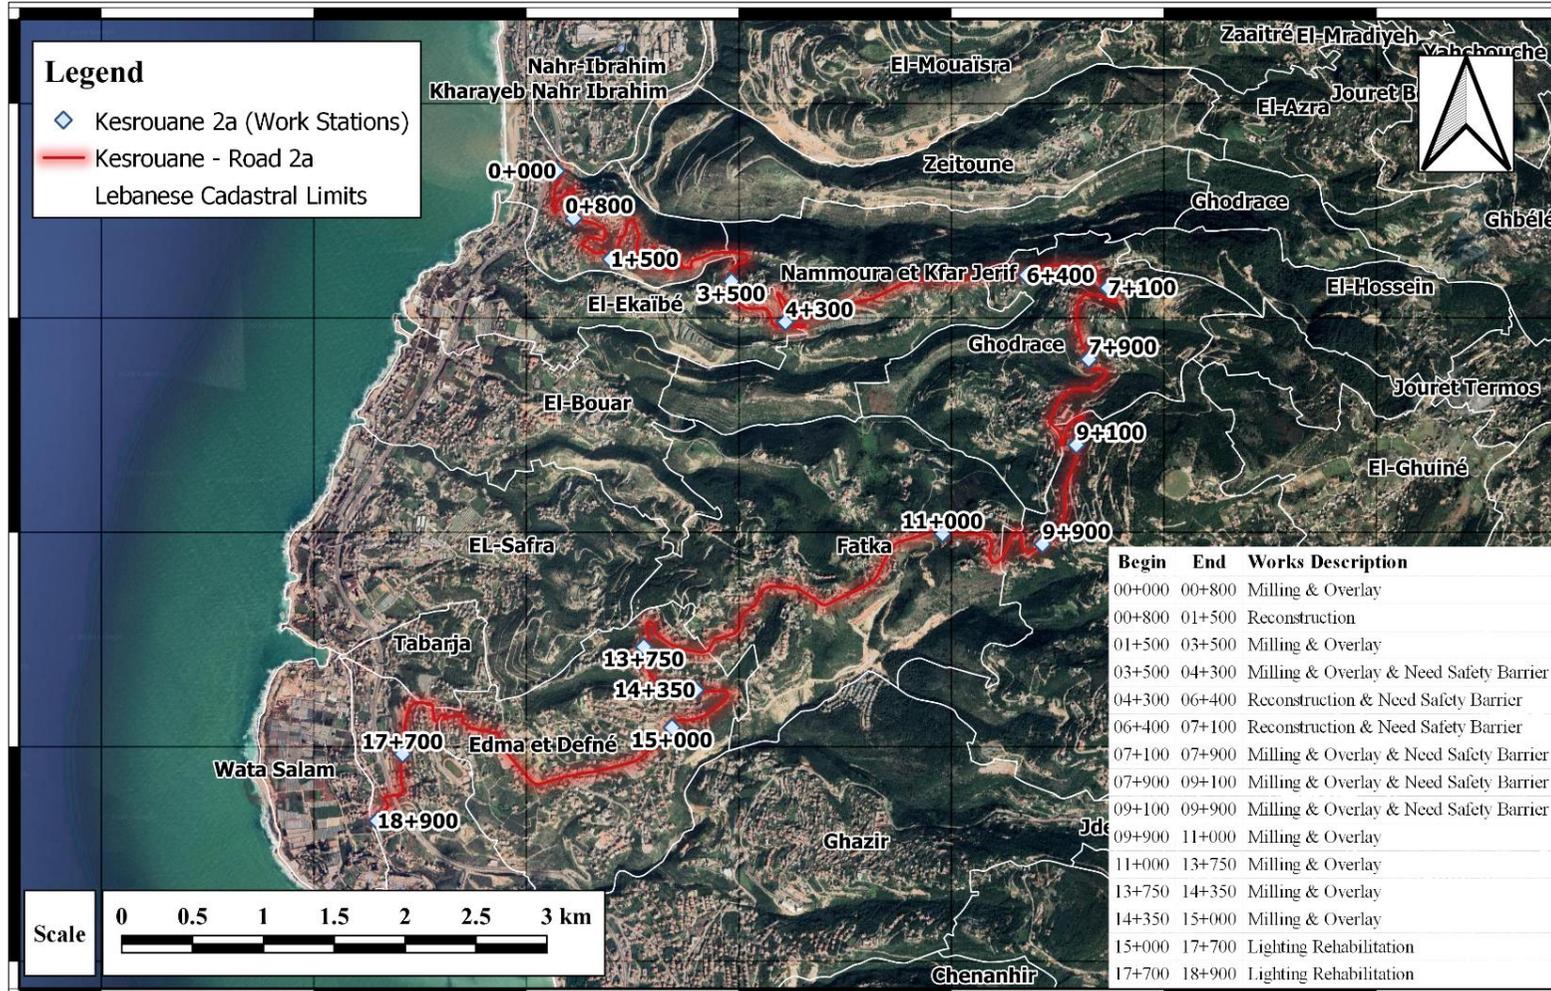
Figure 3-6 Work stations along with road rehabilitation activities along Kesrouane R2a alignment

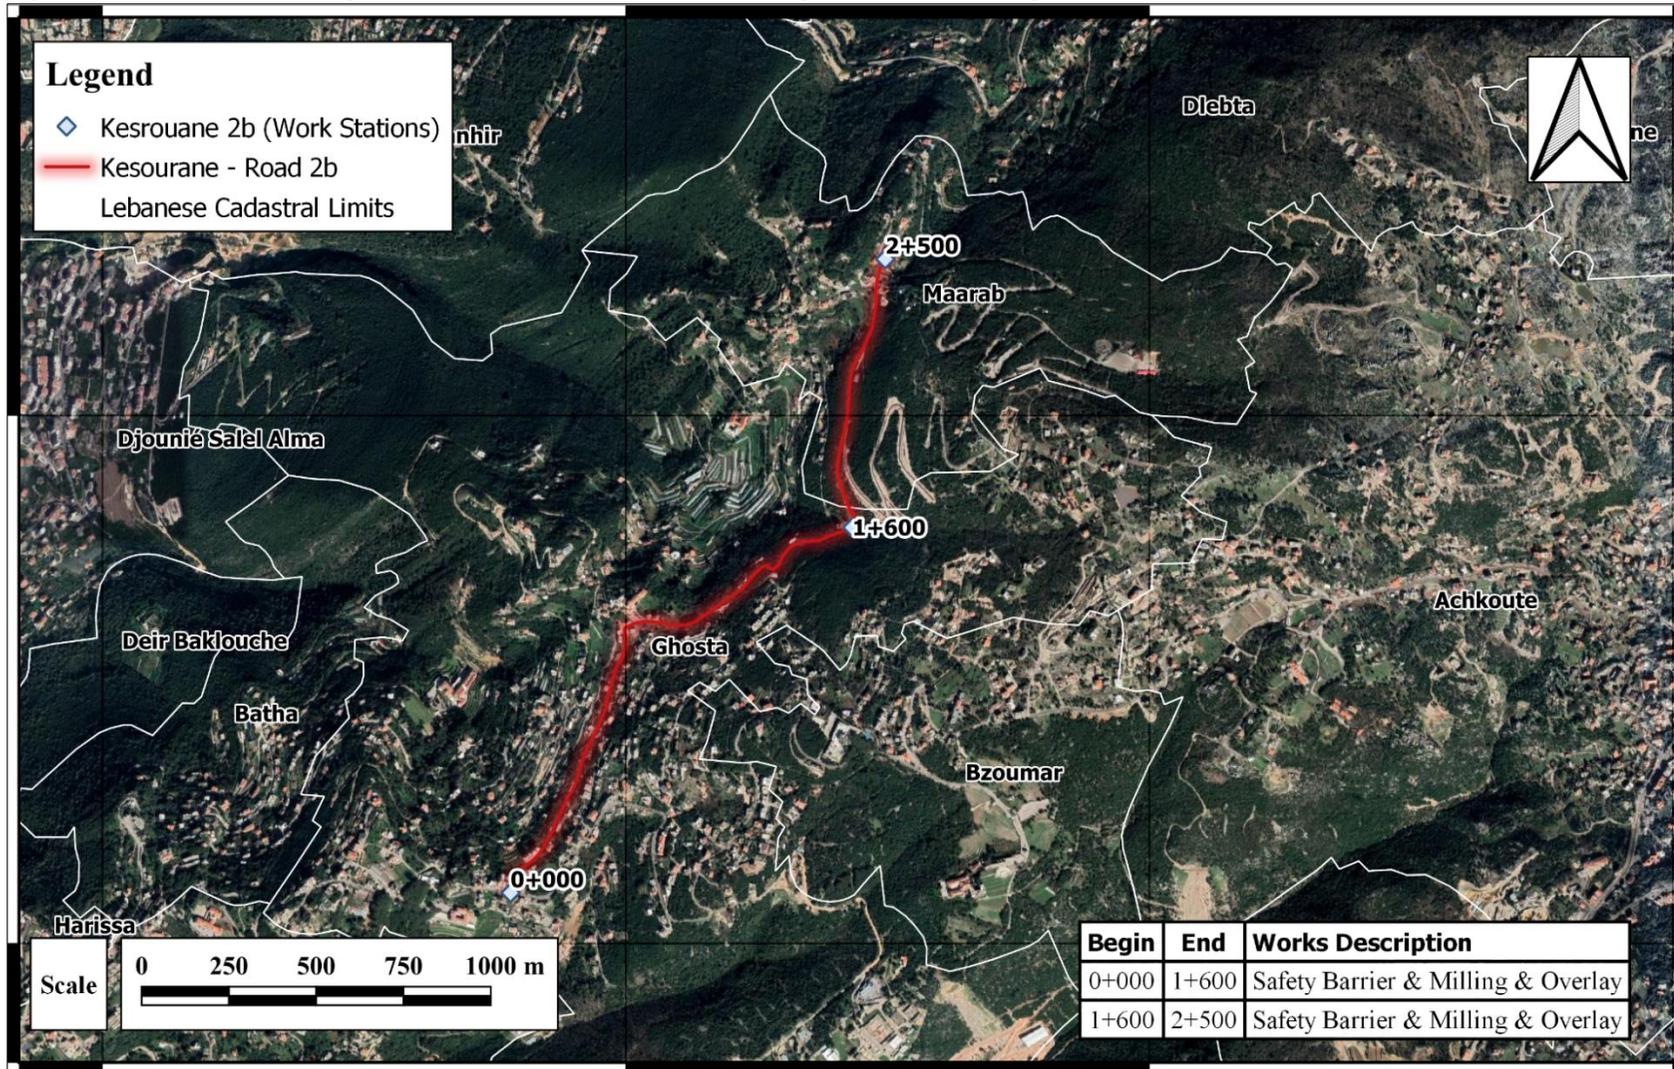
Figure 3-7 Work stations along with road rehabilitation activities along Kesrouane R2b alignment

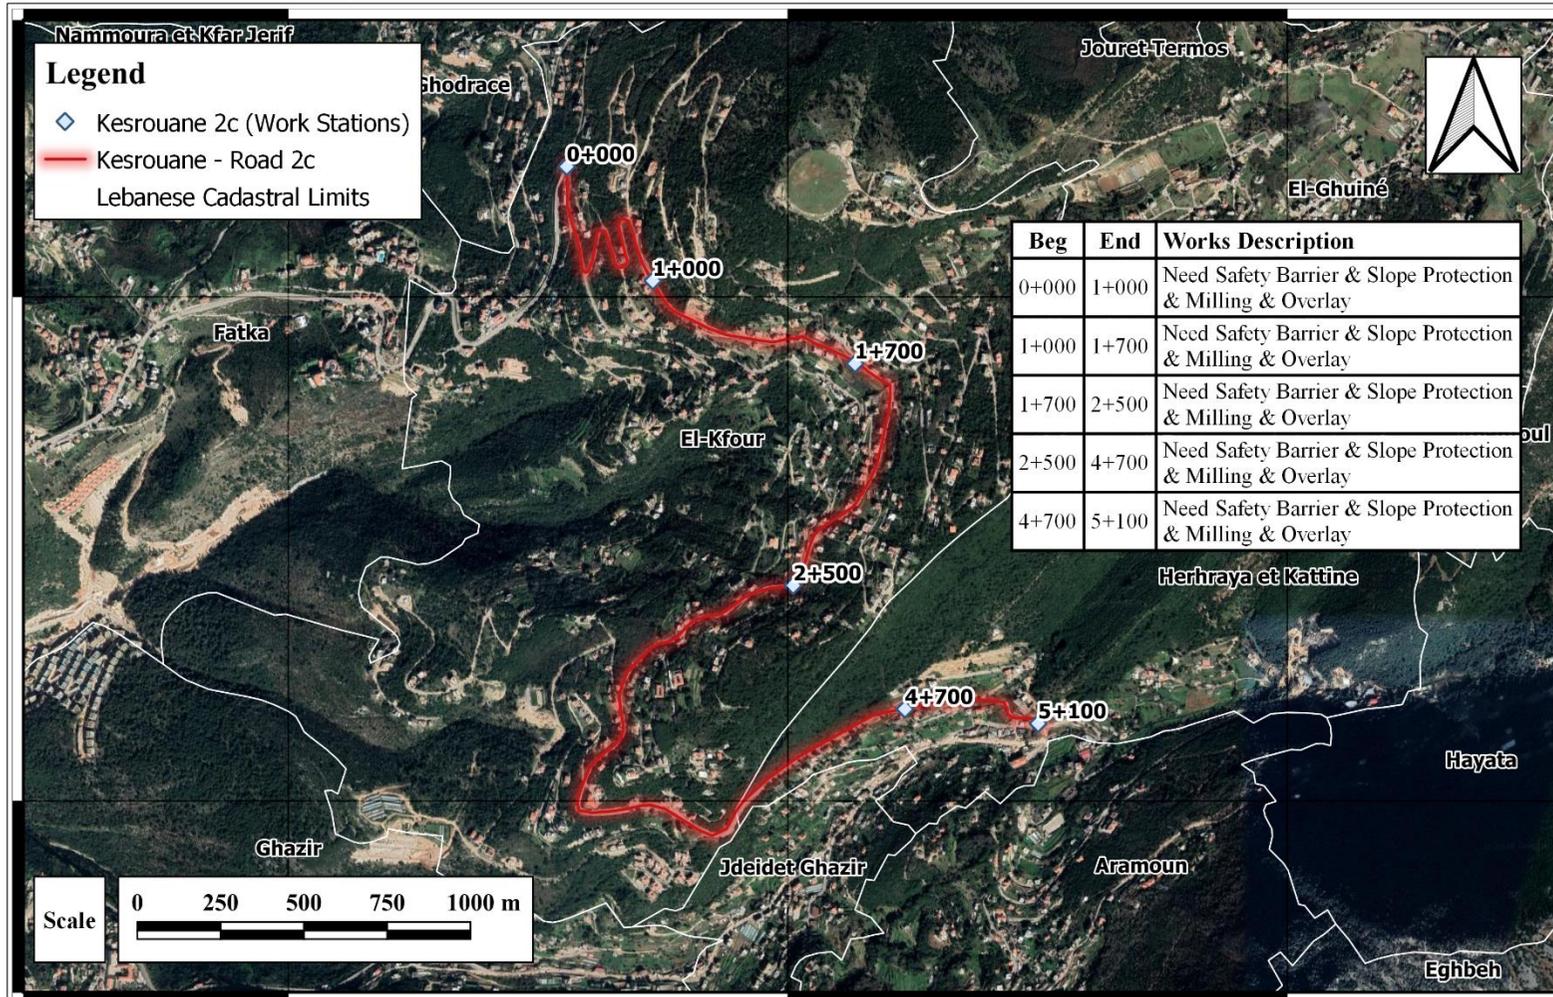
Figure 3-8 Work stations along with road rehabilitation activities along Kesrouane R2c alignment

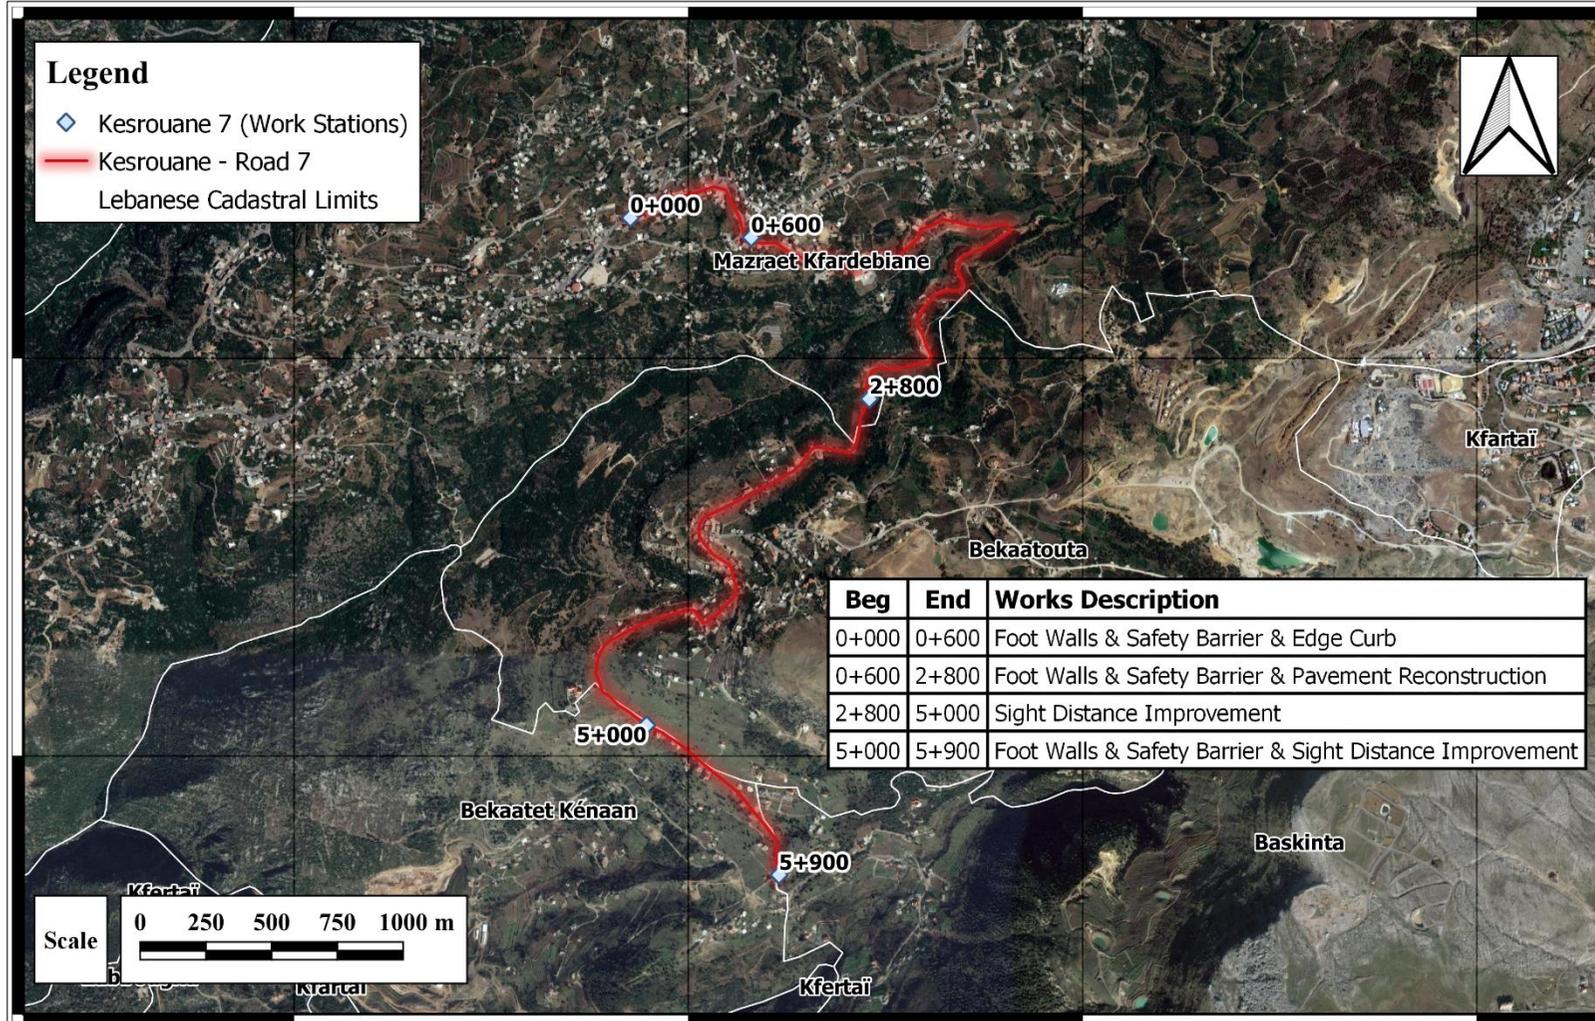
Figure 3-9 Work stations along with road rehabilitation activities along Kesrouane R7 alignment

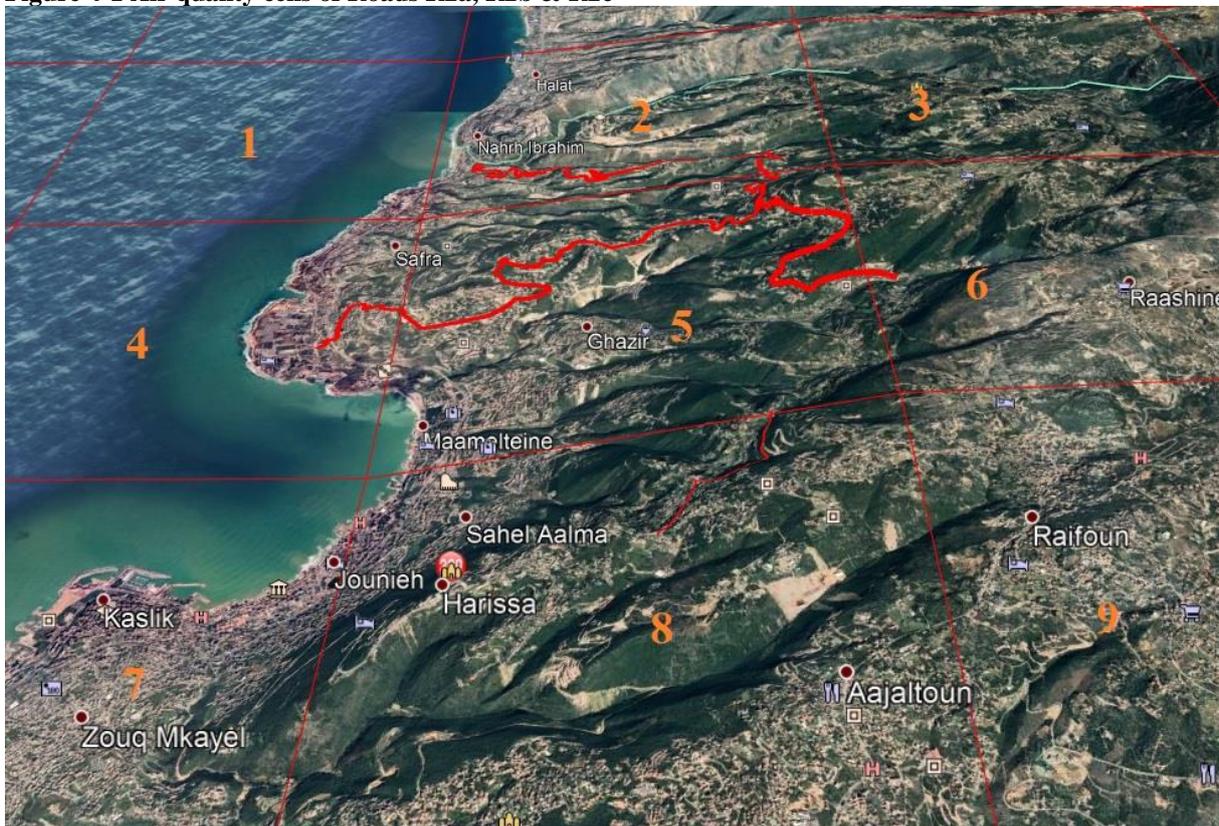
Figure 4-1 Air quality cells of Roads R2a, R2b & R2c

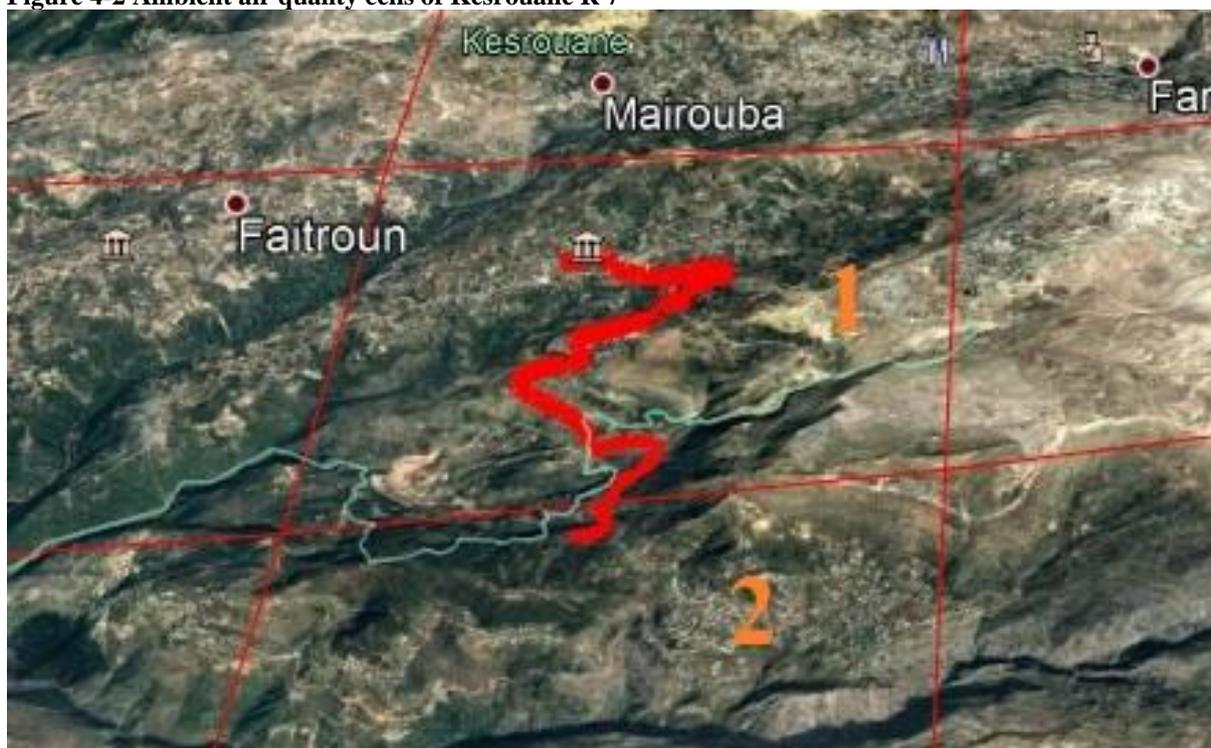
Figure 4-2 Ambient air quality cells of Kesrouane R 7

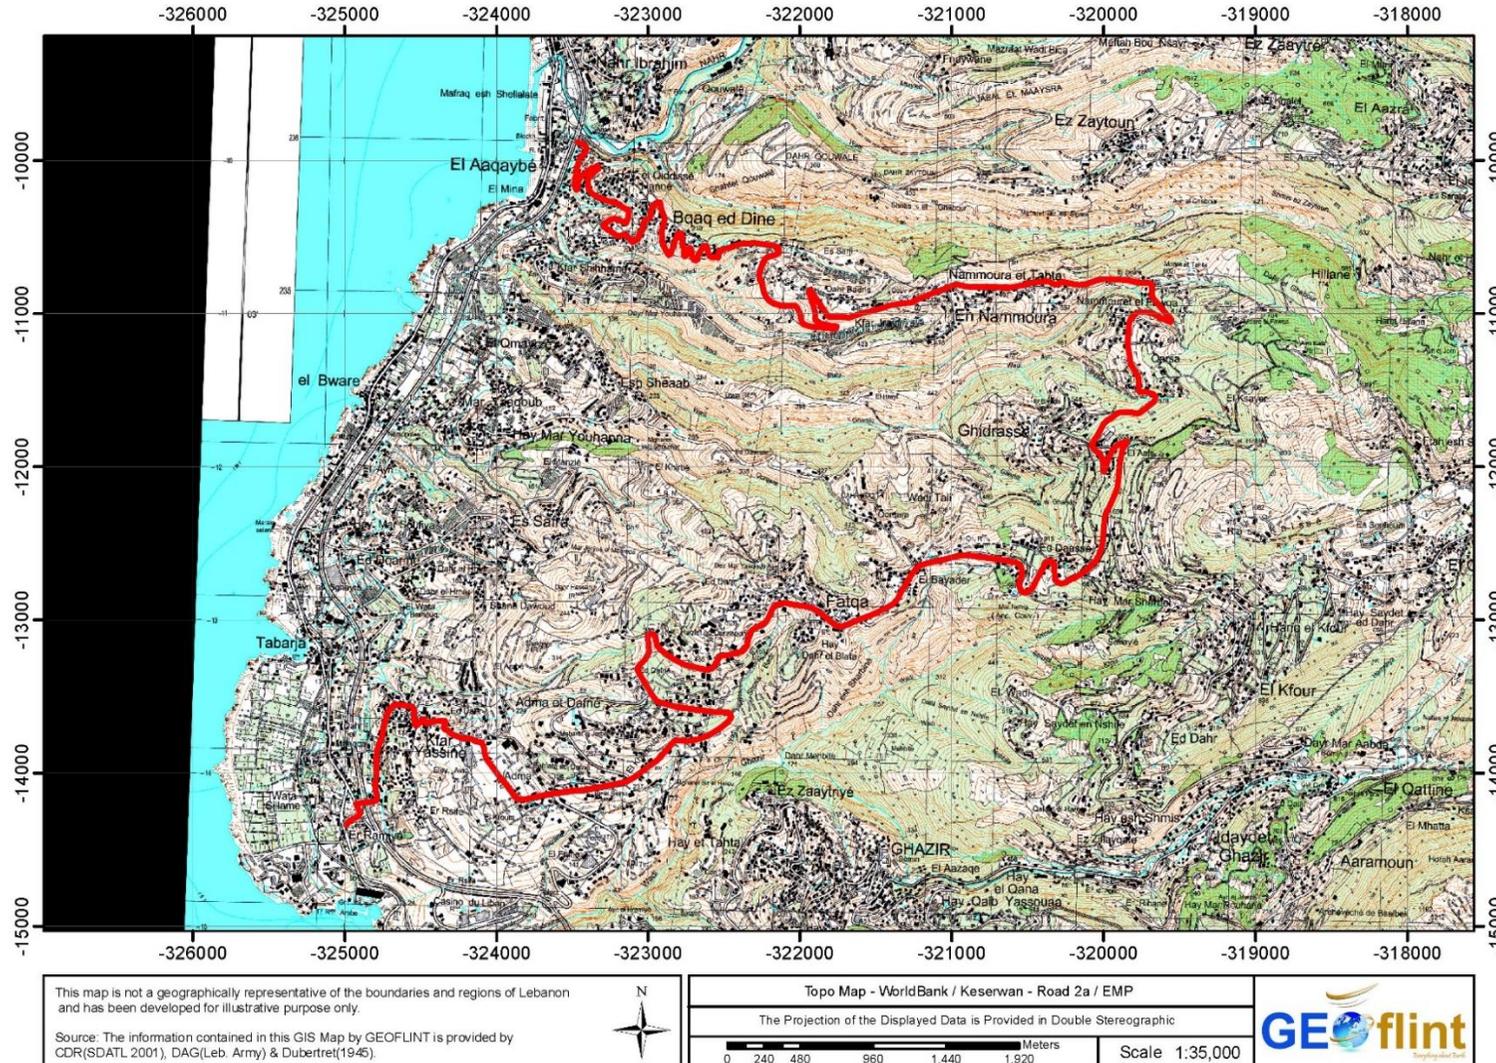
Figure A Elevation contour lines for Kesrouane R2a and its surrounding

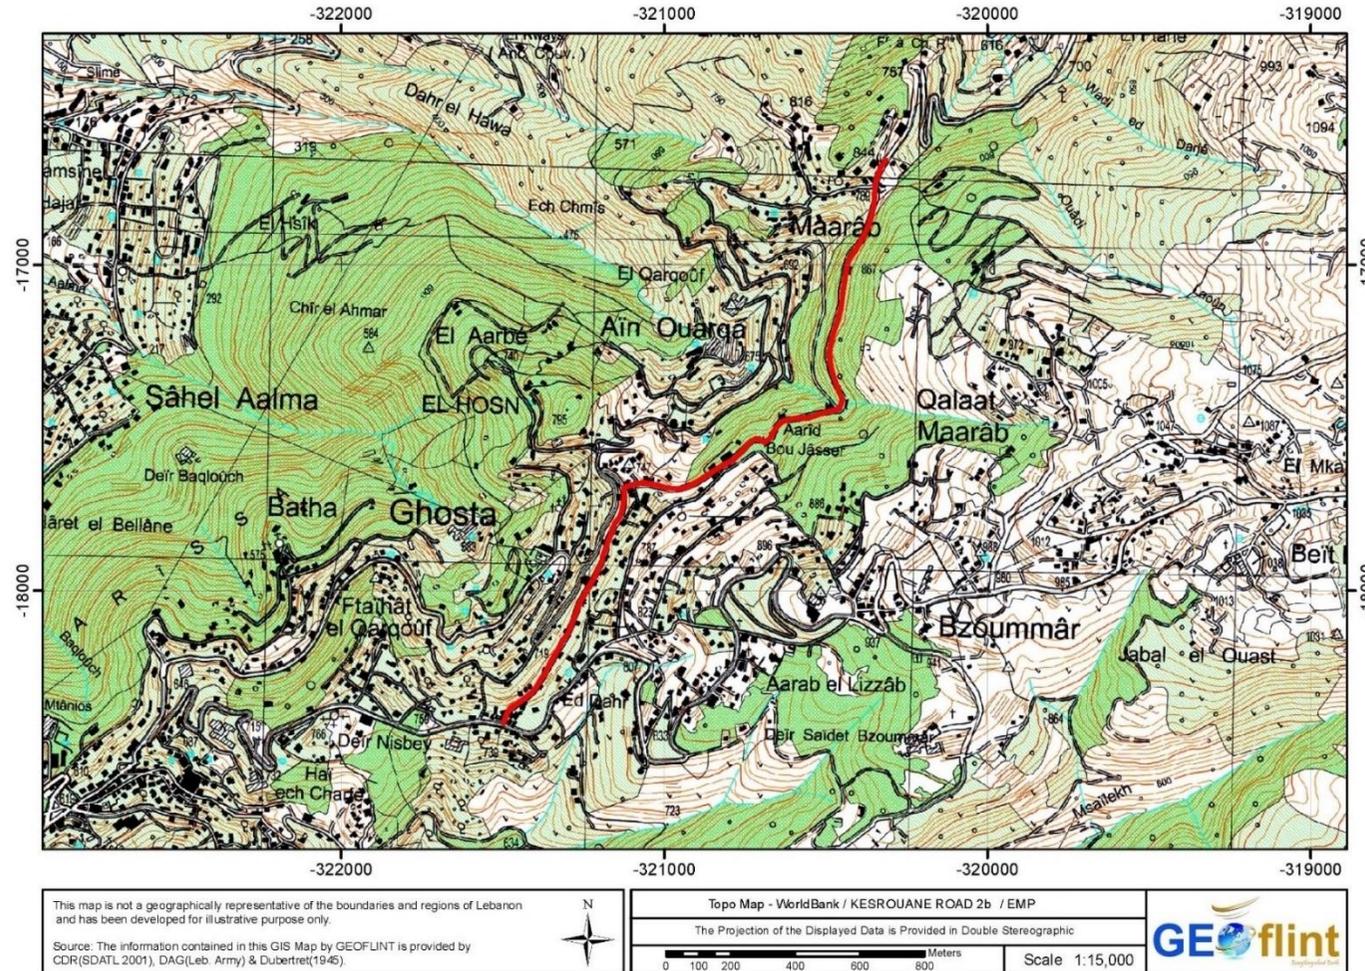
Figure B Elevation contour lines for Kesrouane R2b and its surrounding

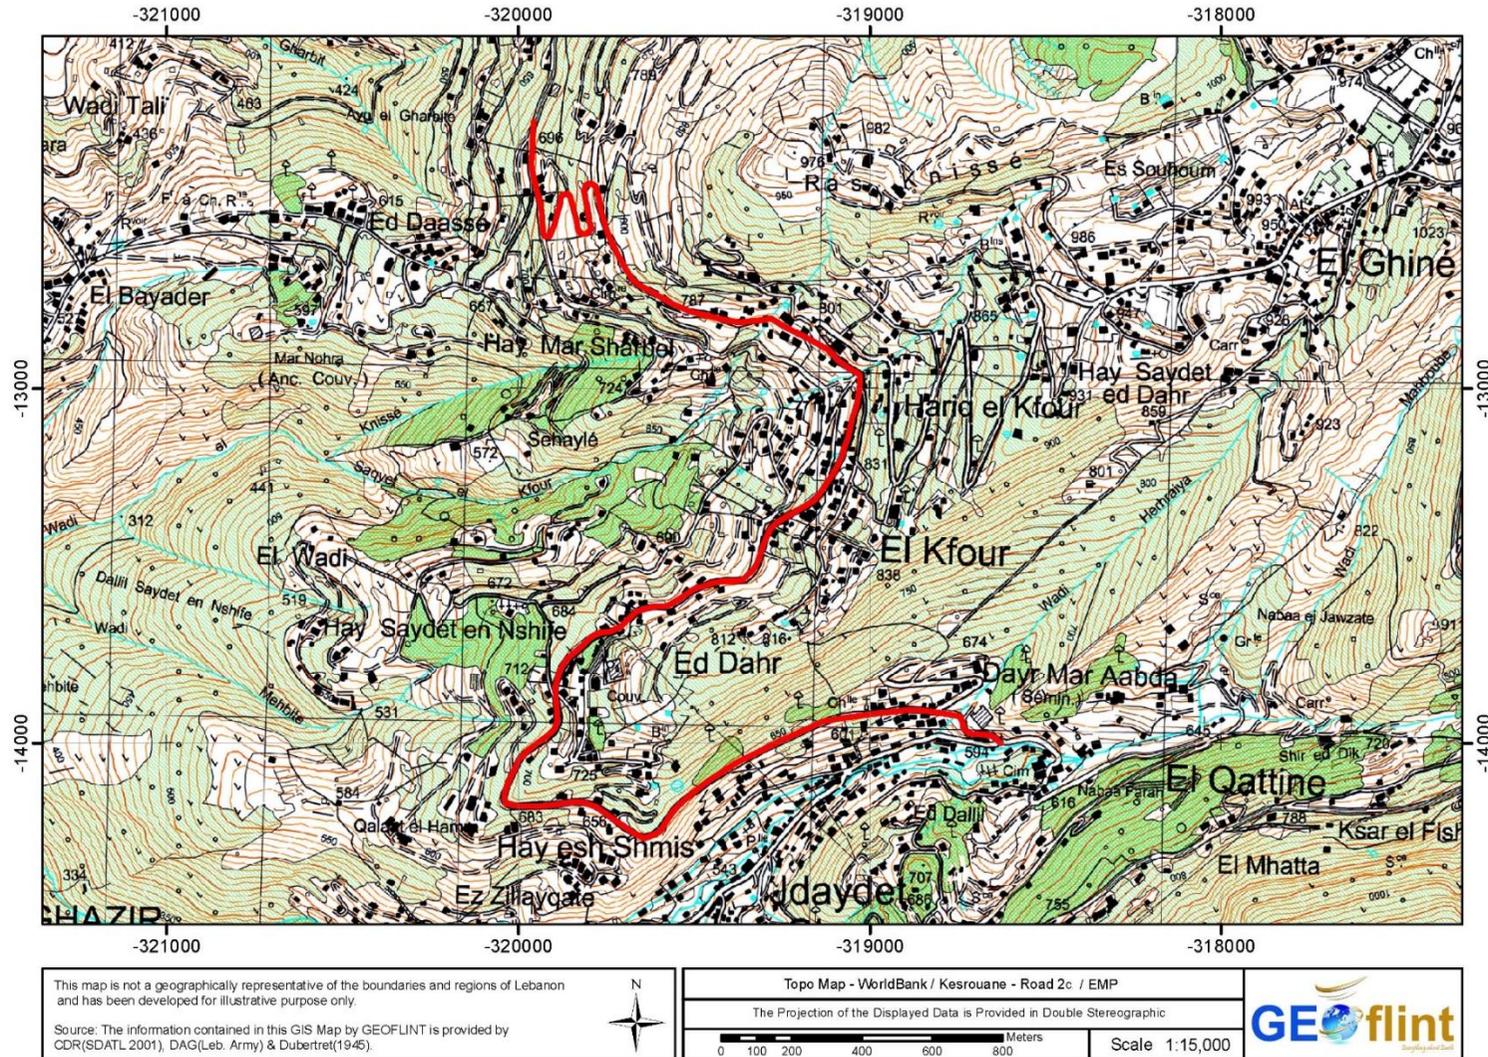
Figure C Elevation contour lines for Kesrouane R2c and its surrounding

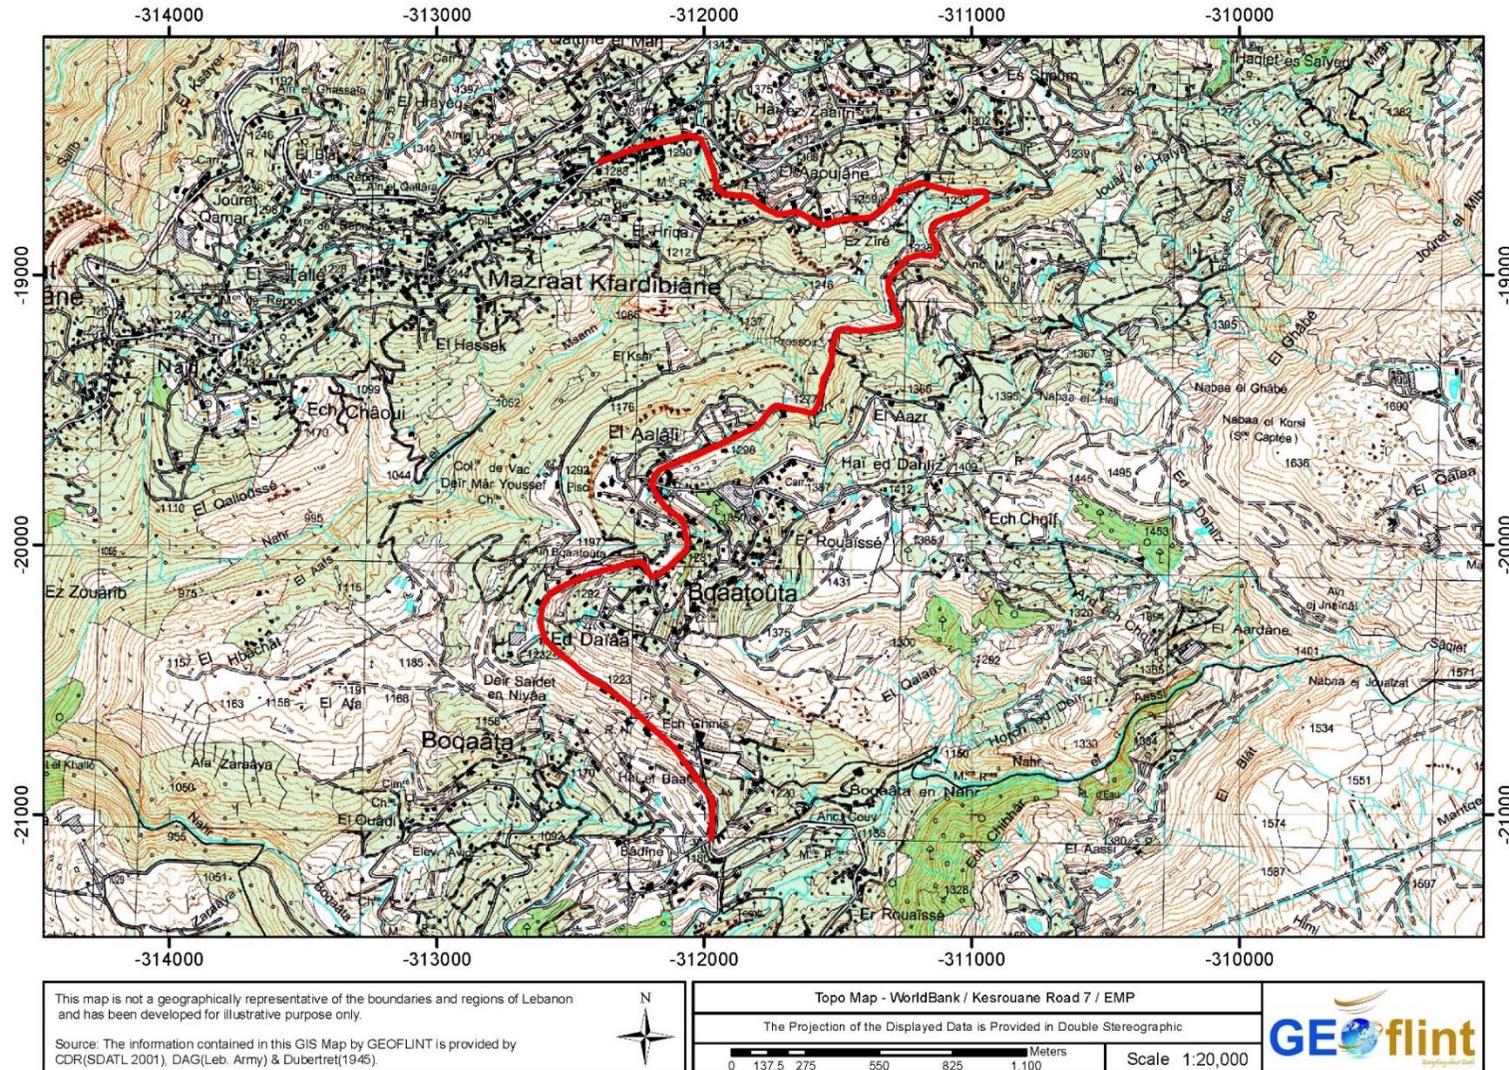
Figure D Elevation contour lines for Kesrouane R7 and its surrounding
