Republic of Lebanon - Council for Development and Reconstruction

Road and Employment Project (REP)

Environmental and Social Management Plan (ESMP)
Final Report

LOT 1: Caza of Kesrouane

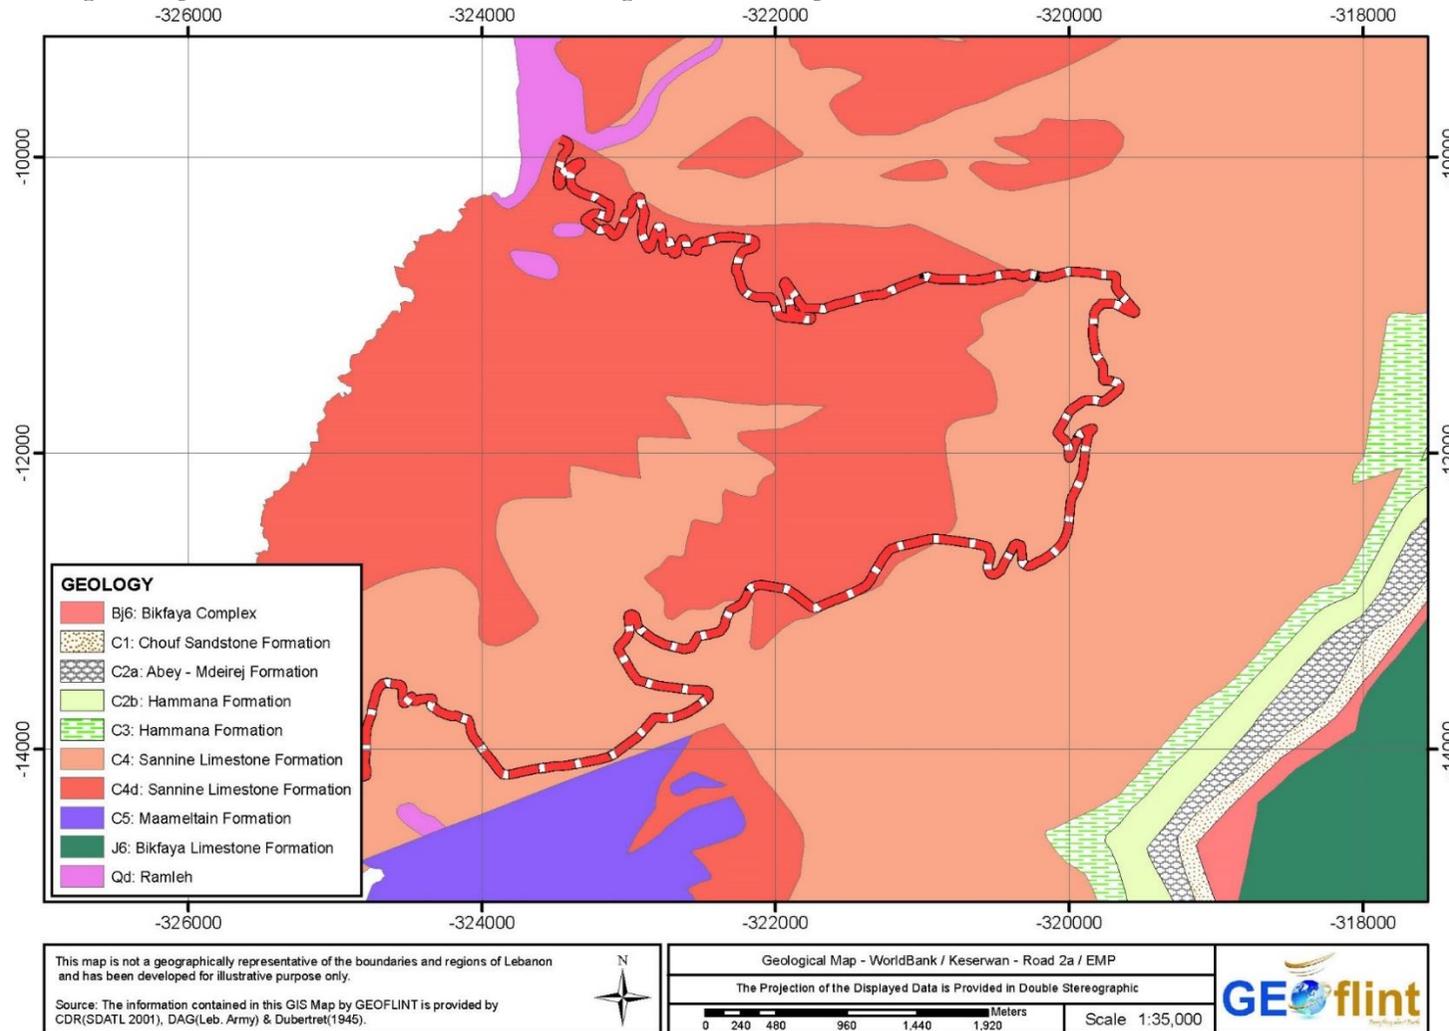
Figure E General Geological map of Kesrouane R2a and its surrounding (surface outcrops)

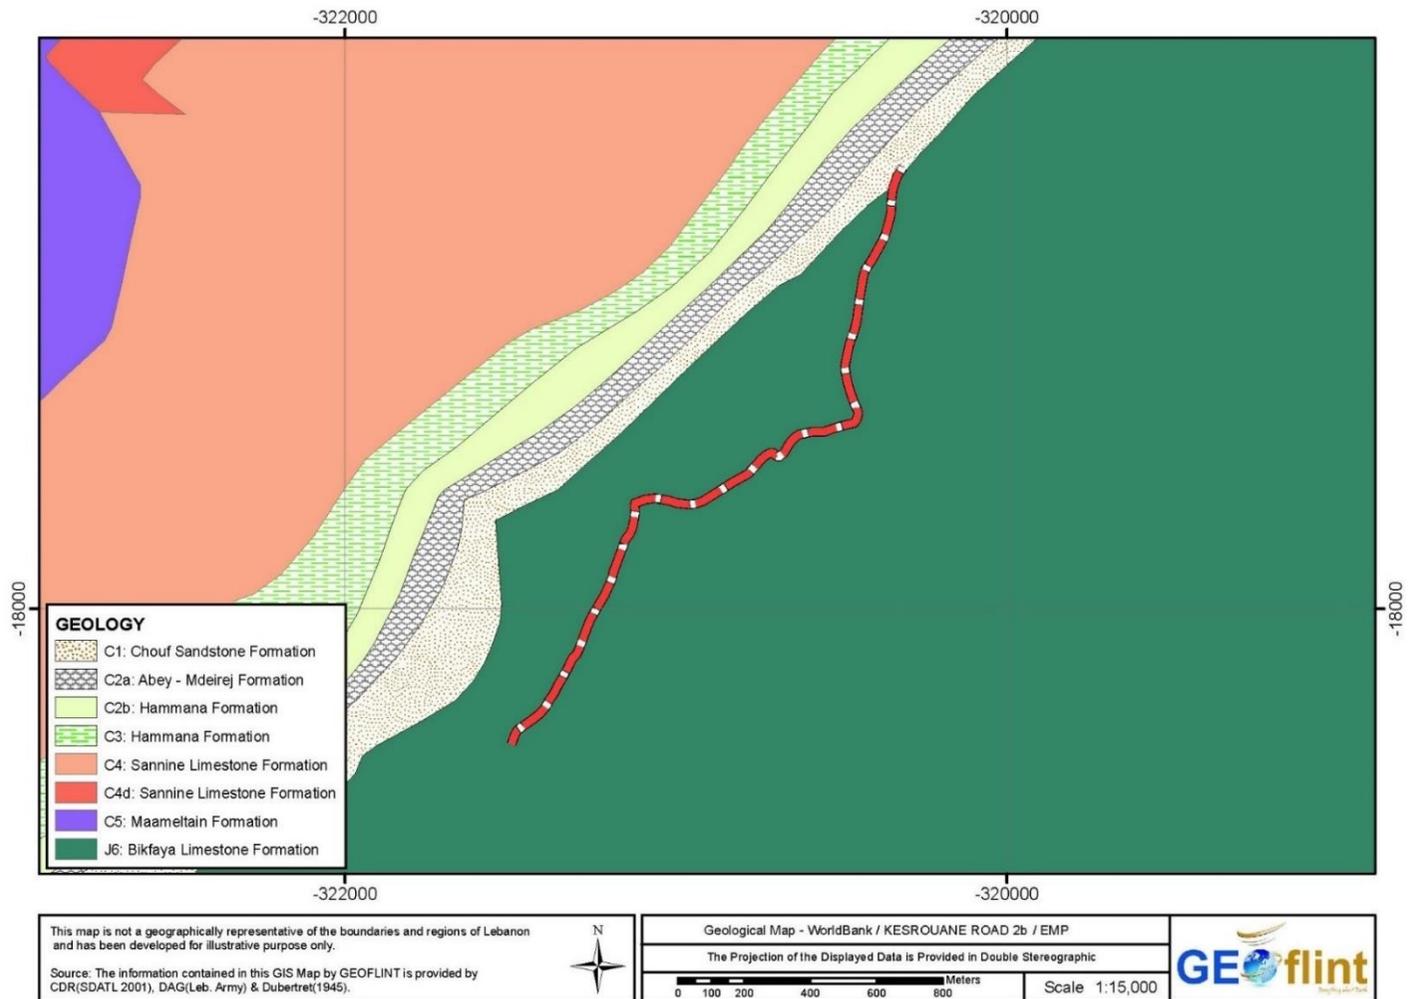
Figure F General Geological map of Kesrouane R2b and its surrounding (surface outcrops)

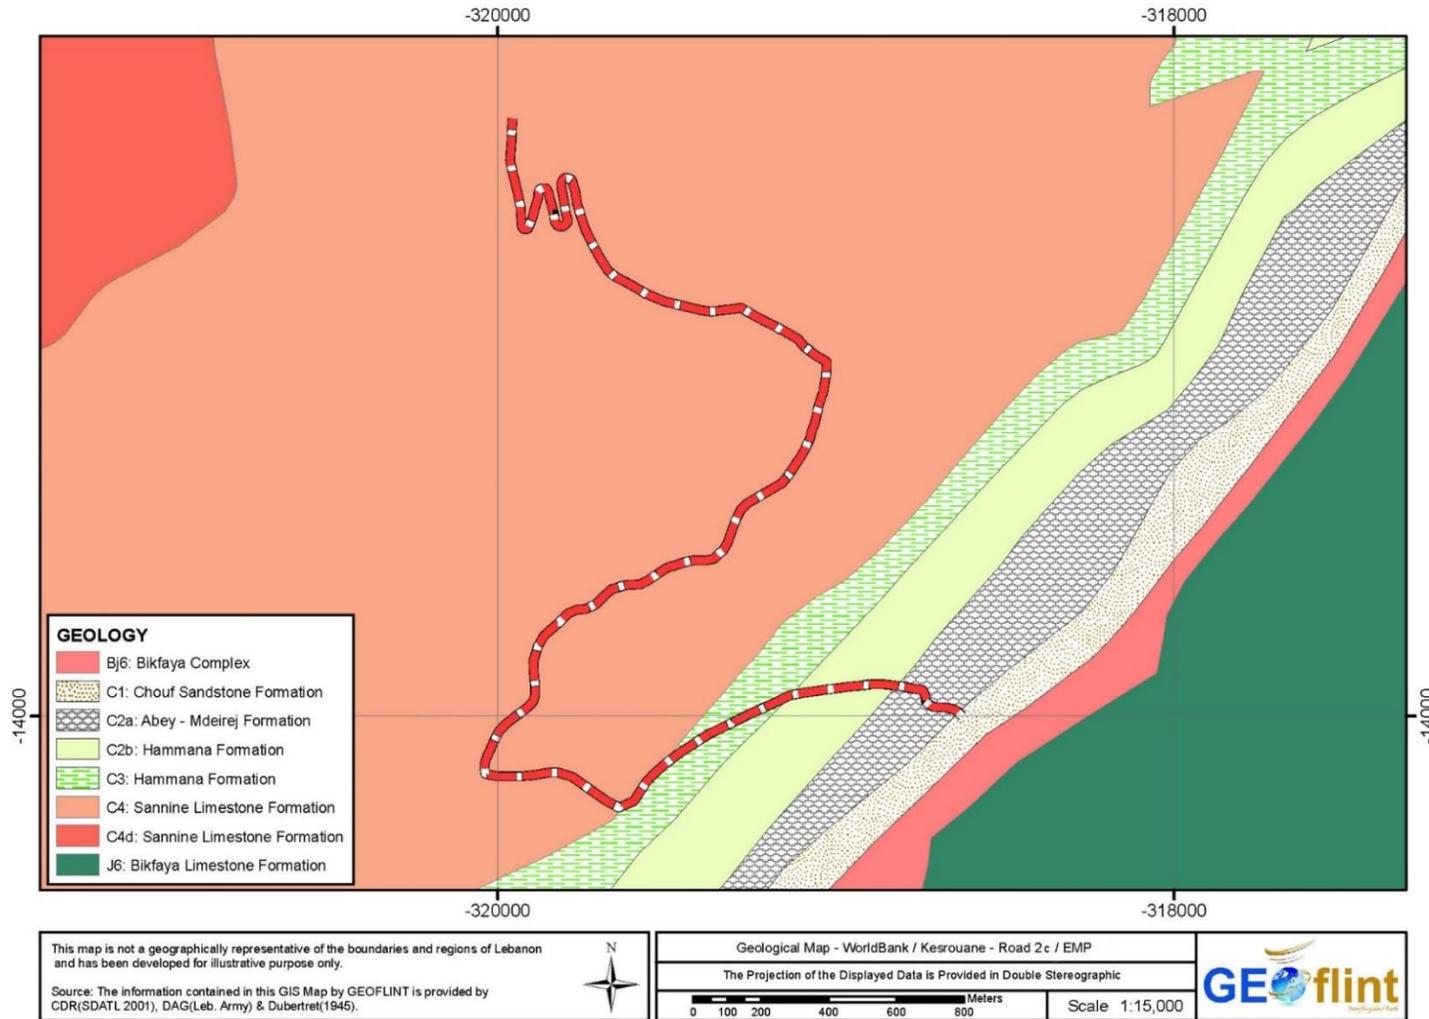
Figure G General Geological map of Kesrouane R2c and its surrounding (surface outcrops)

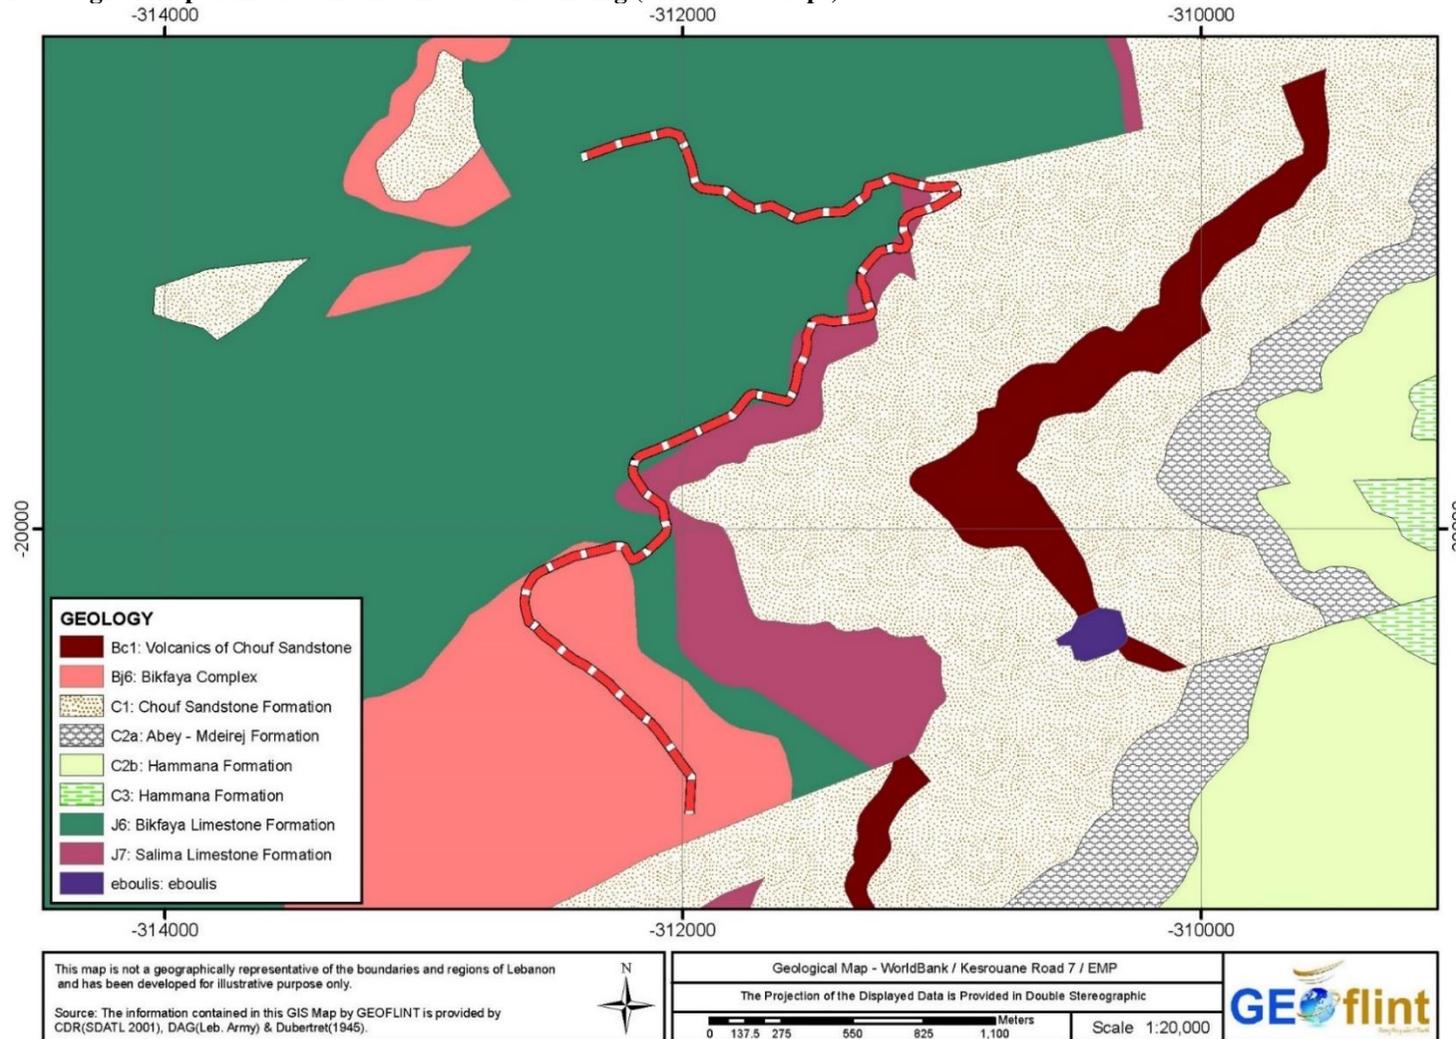
Figure H General Geological map of Kesrouane R7 and its surrounding (surface outcrops)

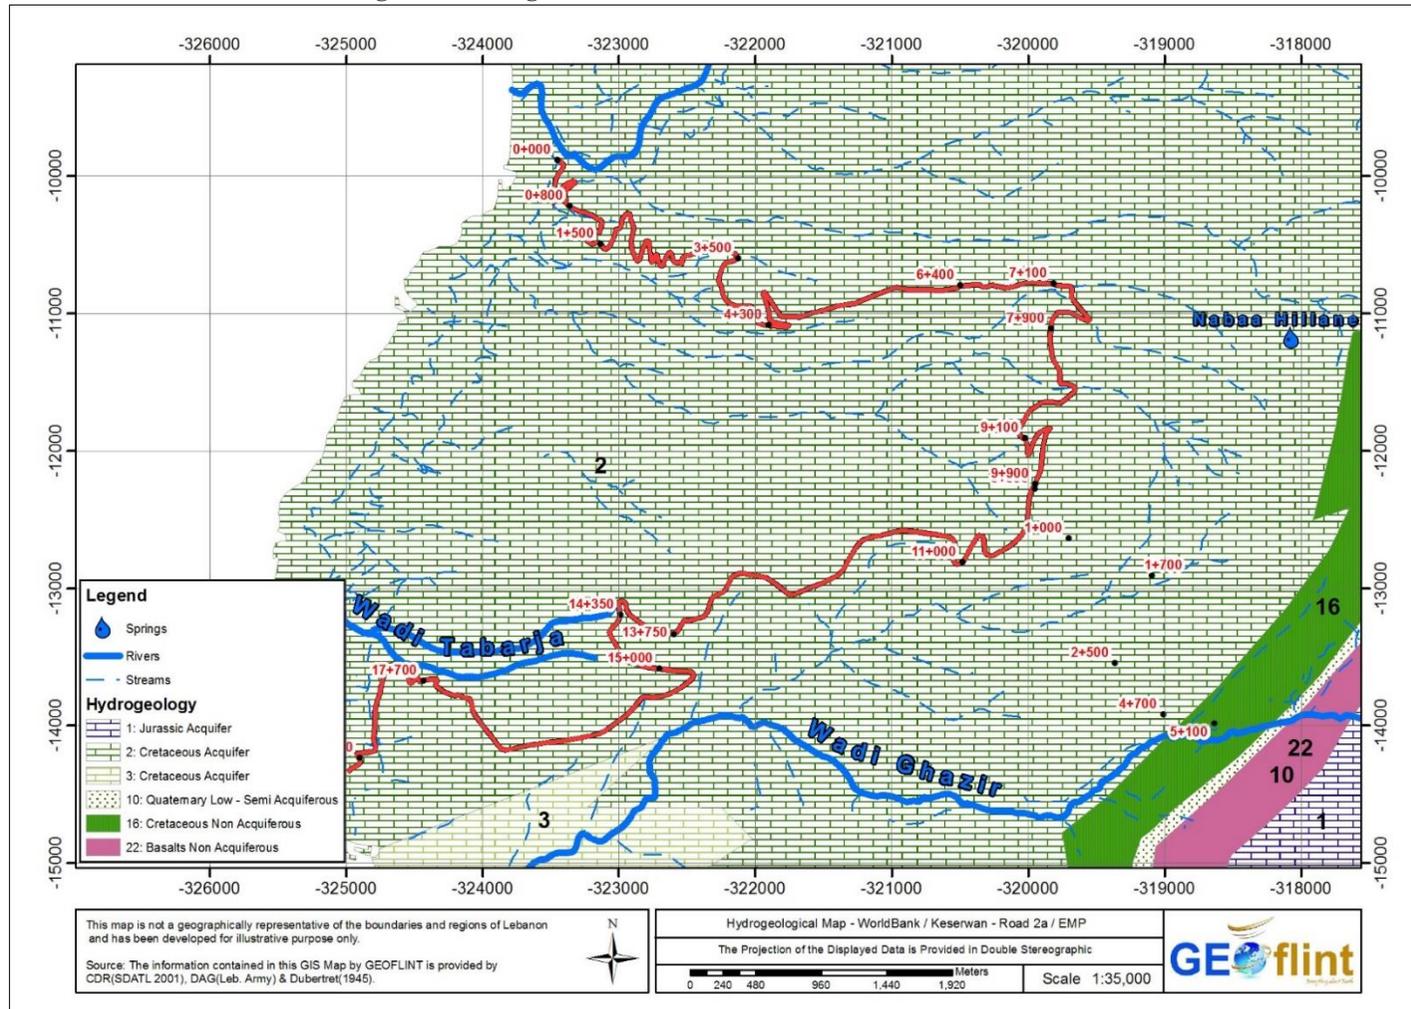
Figure I Hydrogeological map of Kesrouane R2a and its surrounding (map showing water potential of the subsurface). Refer to Table 4 6 for description of hydrogeology classes. Work stations are shown along the road alignment.

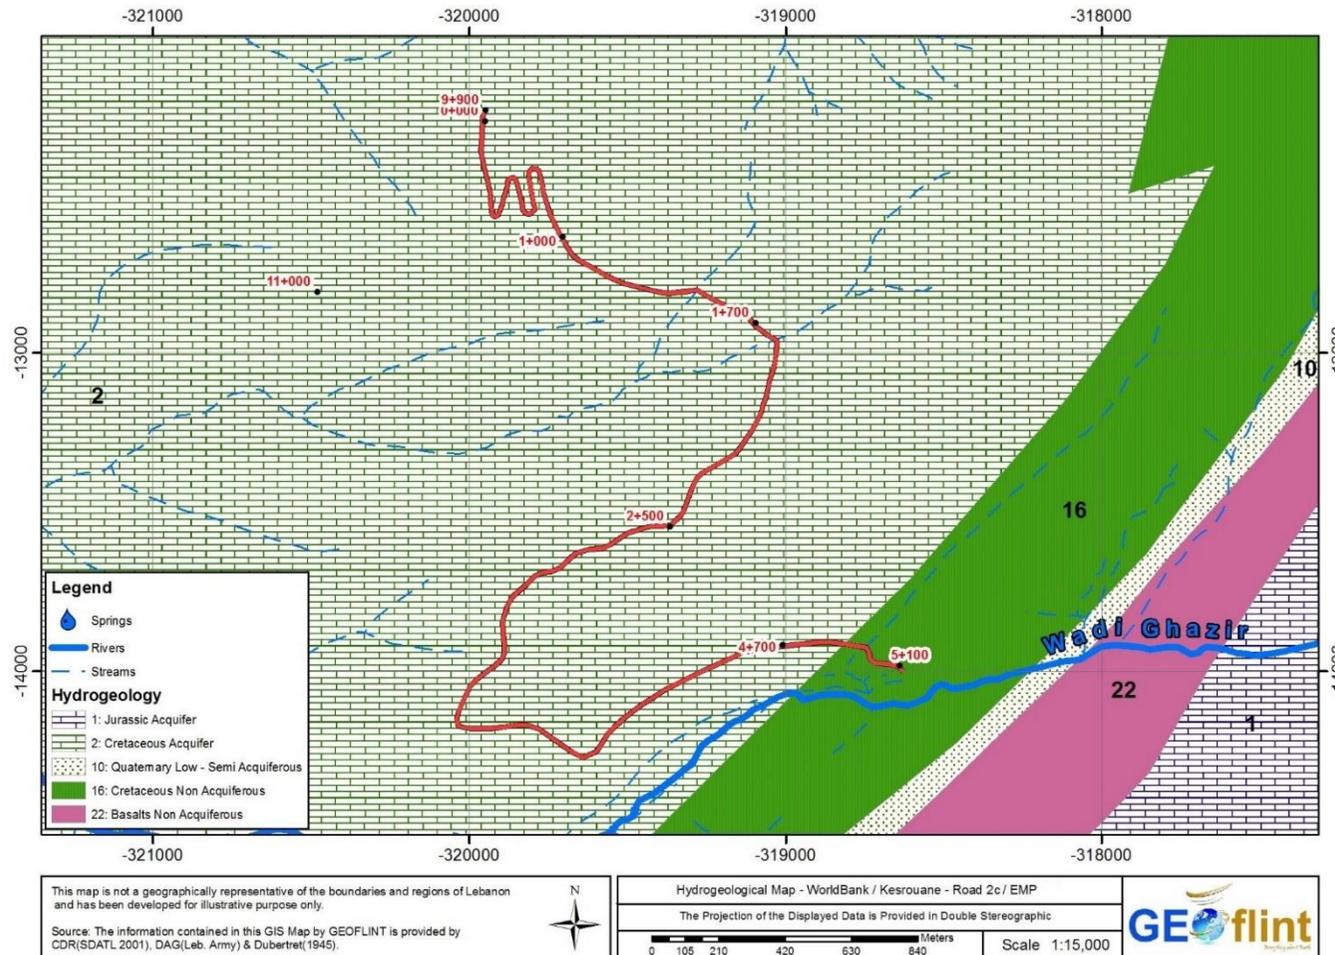
Figure J Hydrogeological map of Kesrouane R2c and its surrounding (map showing water potential of the subsurface). Refer to Table 4 6 for description of hydrogeology classes. Work stations are shown along the road alignment.

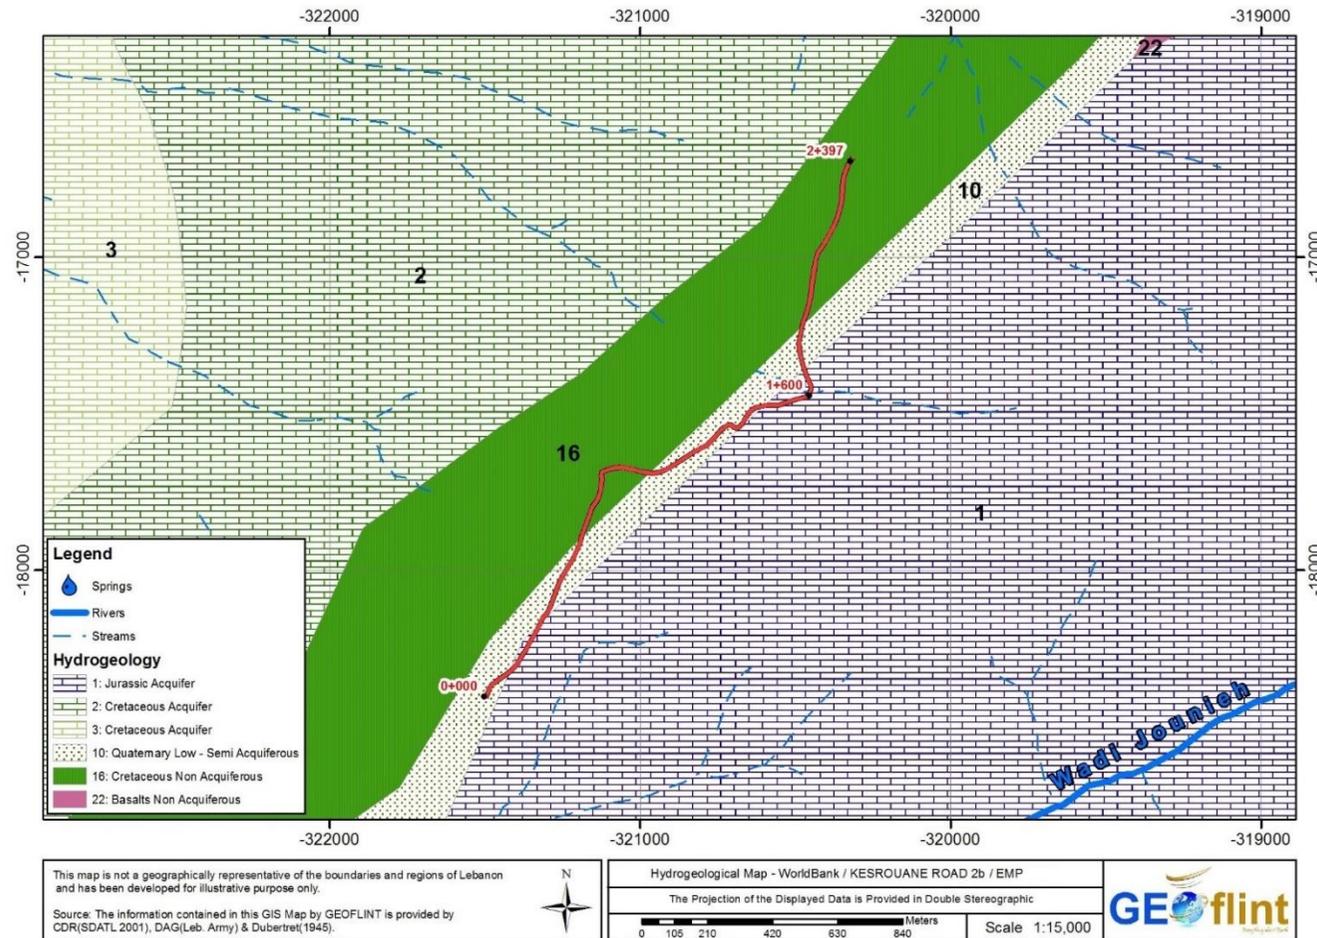
Figure K Hydrogeological map of Kesrouane R2b and its surrounding (map showing water potential of the subsurface). Refer to Table 4 6 for description of hydrogeology classes. Work stations are shown along the road alignment.

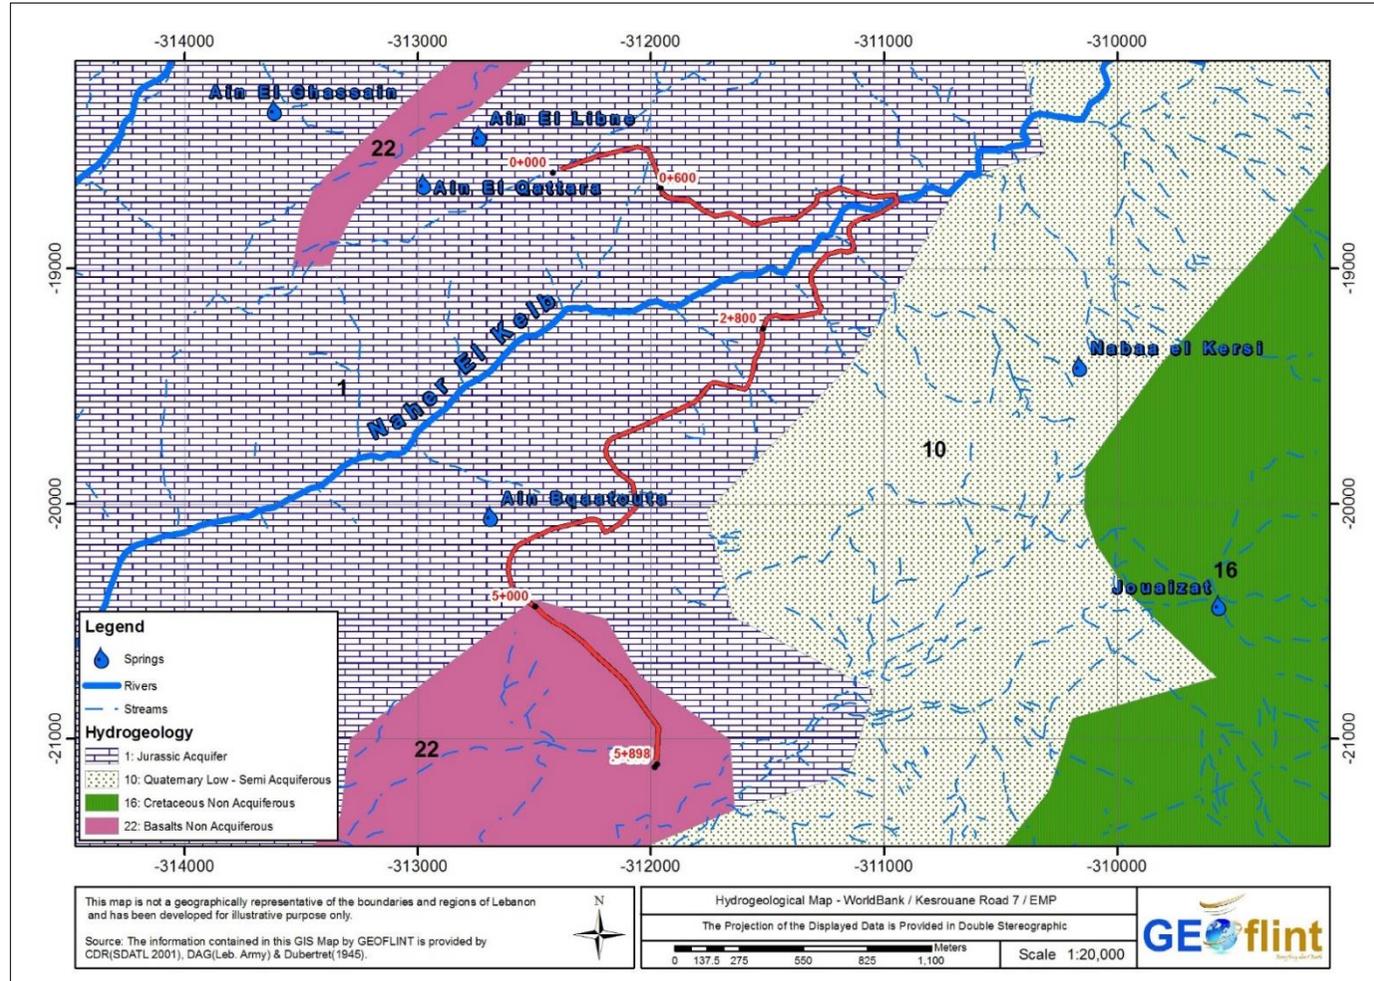
Figure L Hydrogeological map of Kesrouane R7 and its surrounding (map showing water potential of the subsurface). Refer to Table 4 6 for description of hydrogeology classes. Work stations are shown along the road alignment.

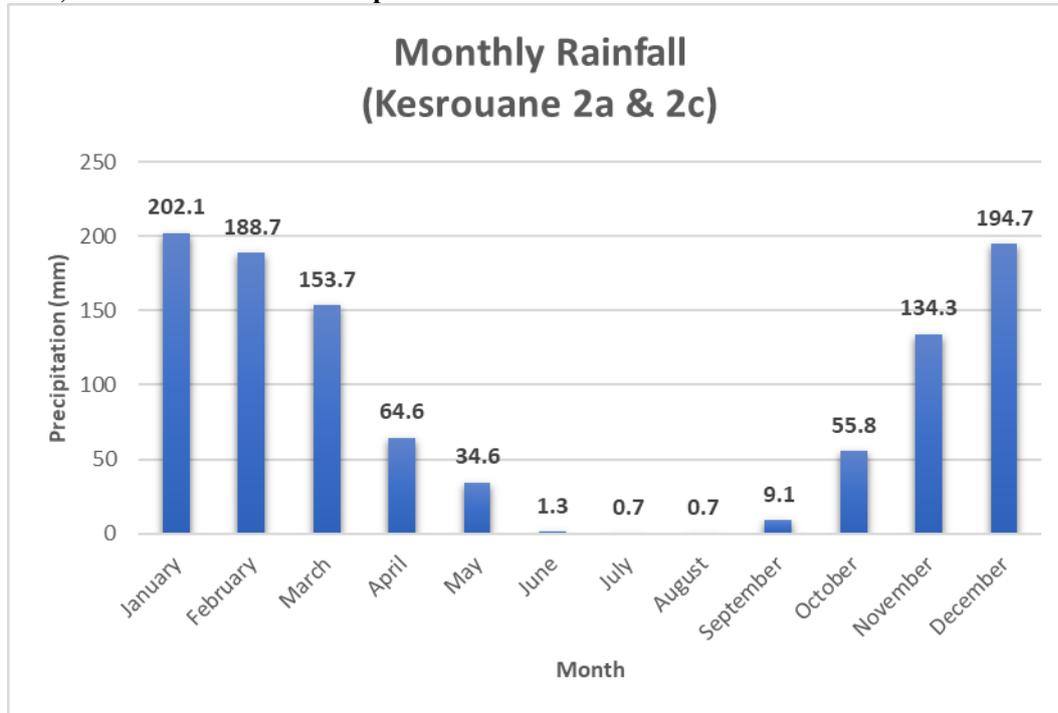
Figure M Precipitations values along Kesrouane R2a & R2c alignments (period extending between 1996-2018) CHIRPS satellite 4.5 km spatial resolution

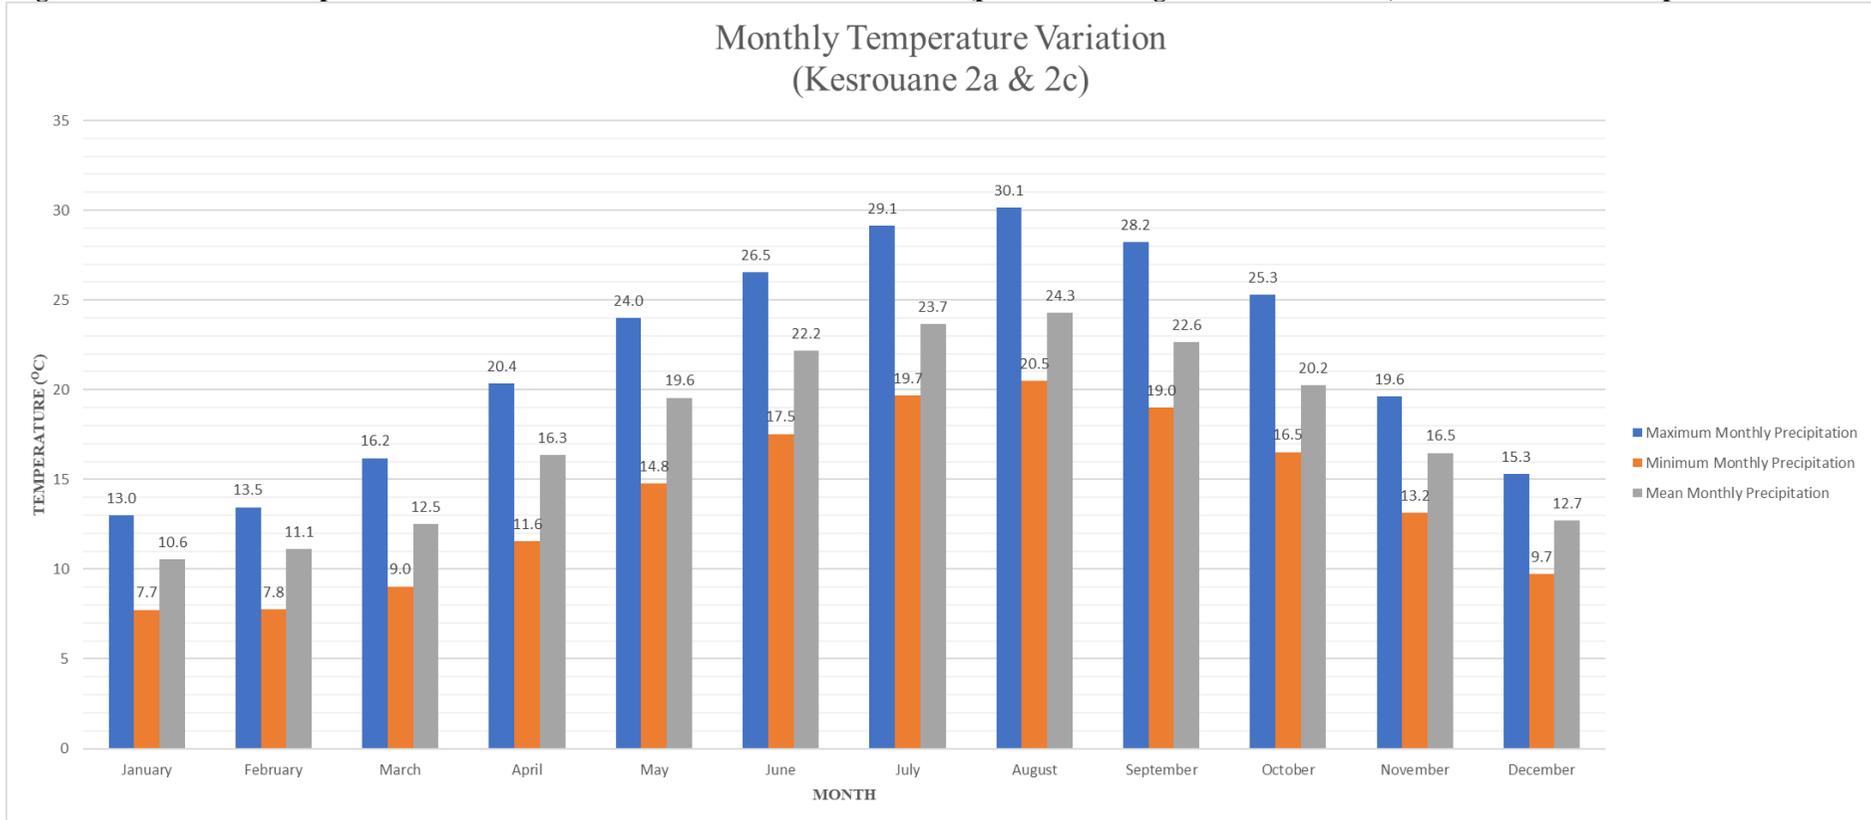
Figure N Land surface temperature variation for Kesrouane R2a & Kesrouane R2c (period extending between 2000-2018) MODIS satellite 1km spatial resolution

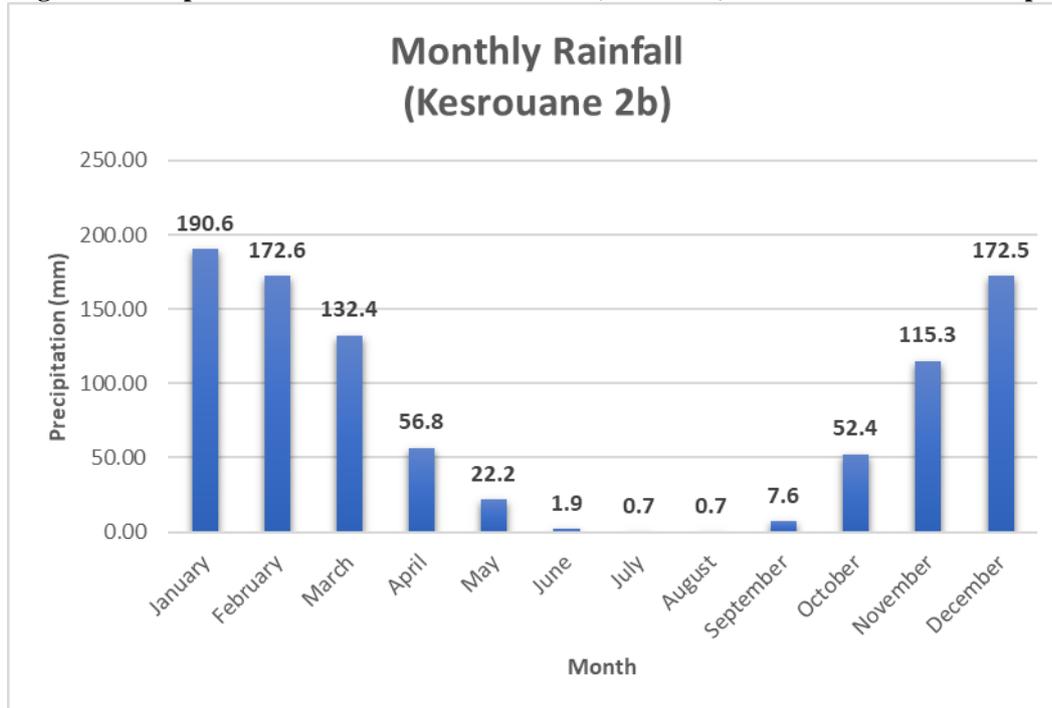
Figure O Precipitations values for Kesrouane R2b (1996-2018) CHIRPS satellite 4.5km spatial resolution

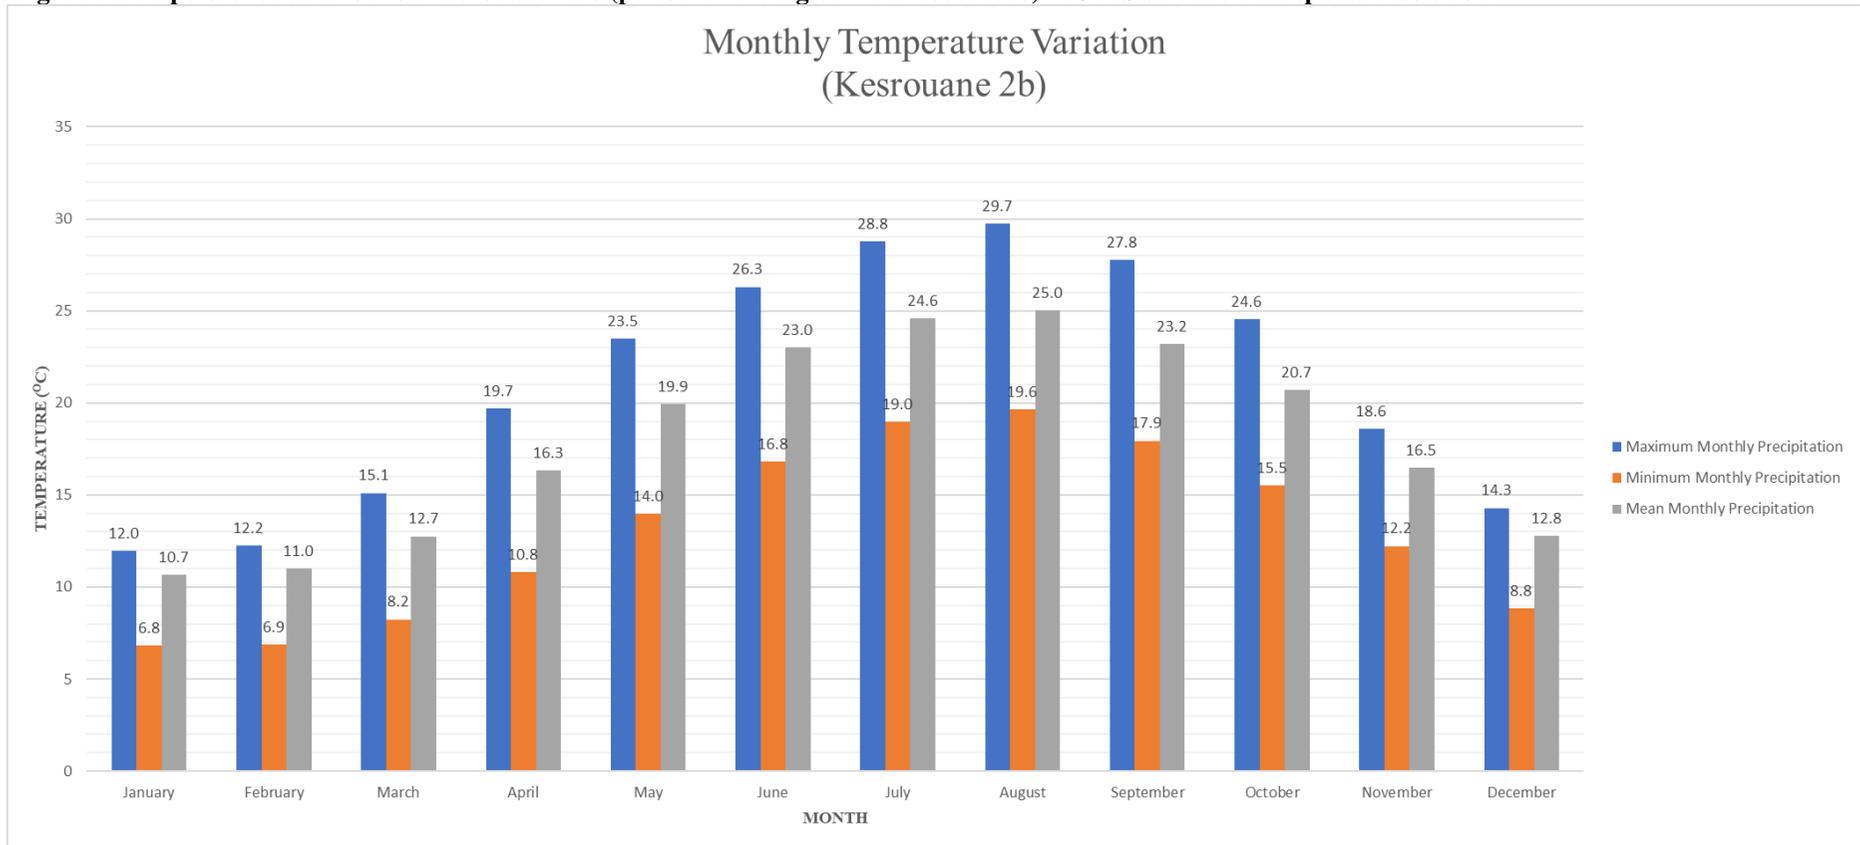
Figure P Temperature variation for Kesrouane R2b (period extending between 2000-2018) MODIS satellite 1km spatial resolution

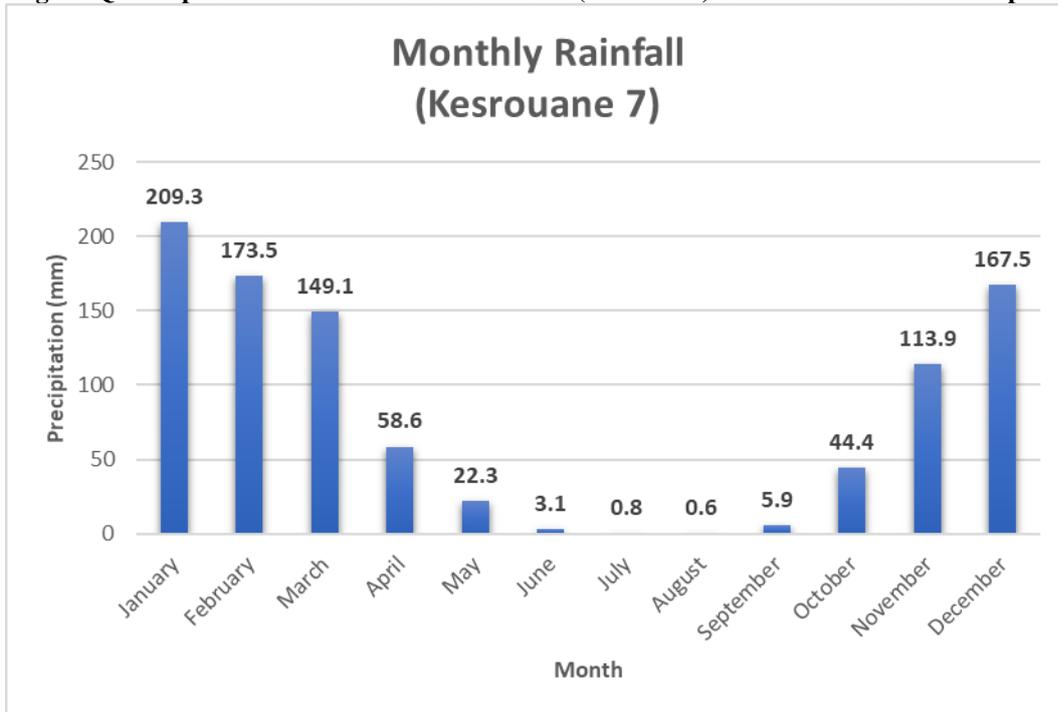
Figure Q Precipitations values for Kesrouane R7 (1996-2018) CHIRPS satellite 4.5km spatial resolution

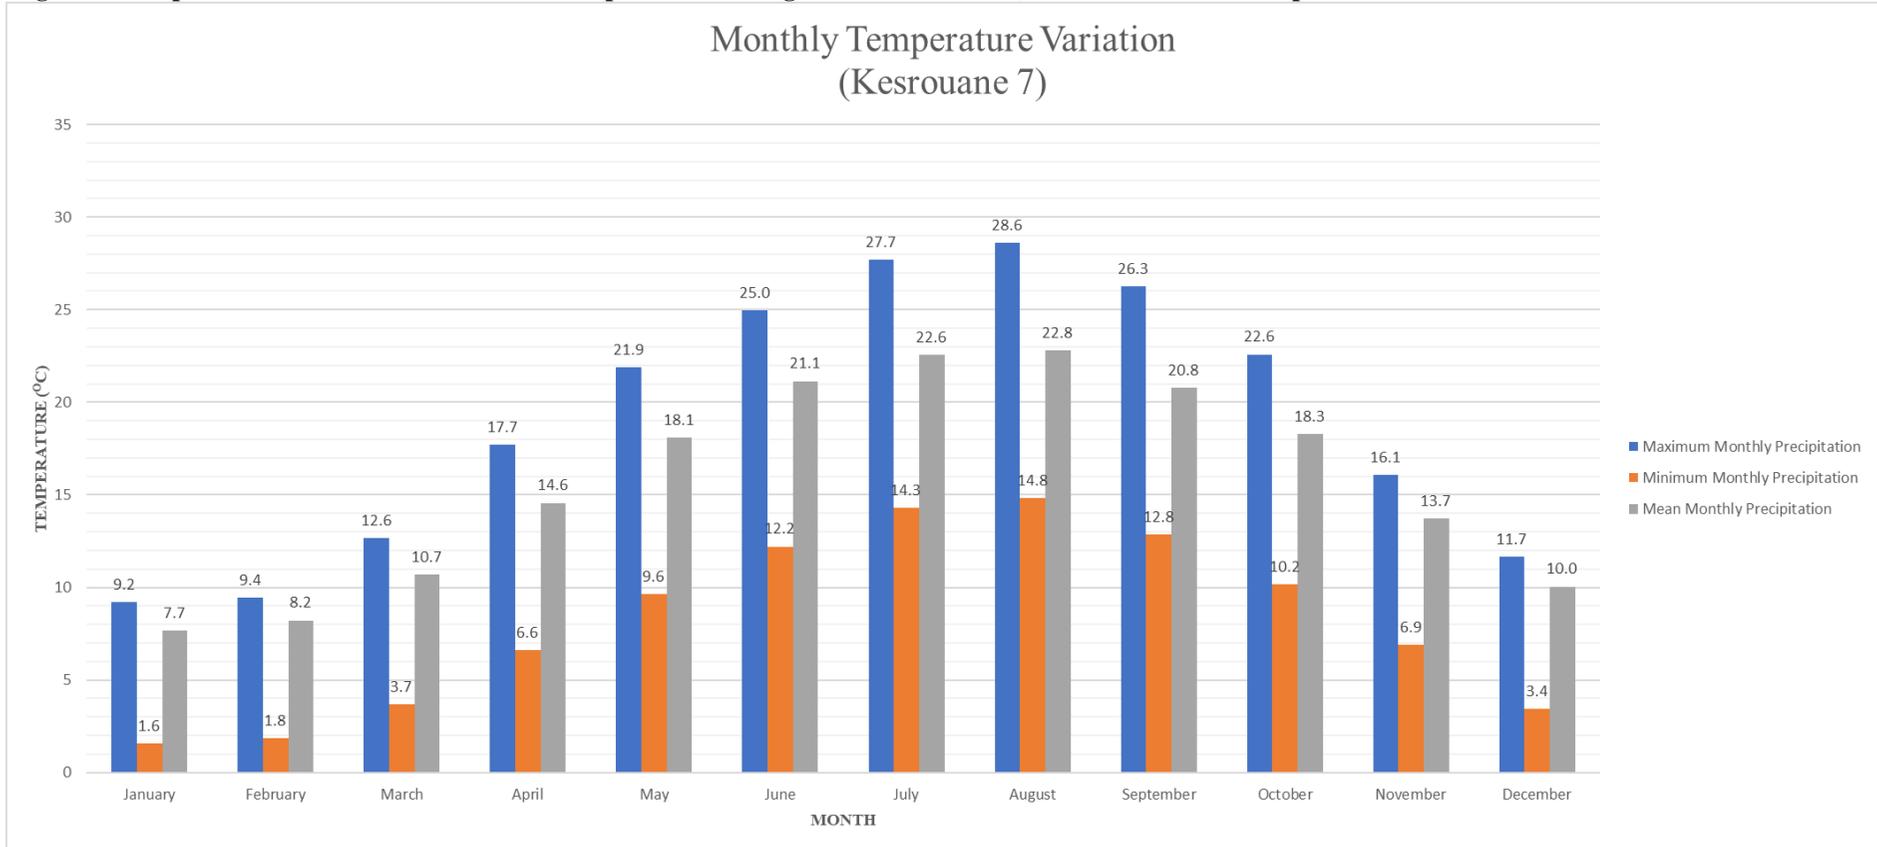
Figure R Temperature variation for Kesrouane R7 (period extending between 2000-2018) MODIS satellite 1km spatial resolution

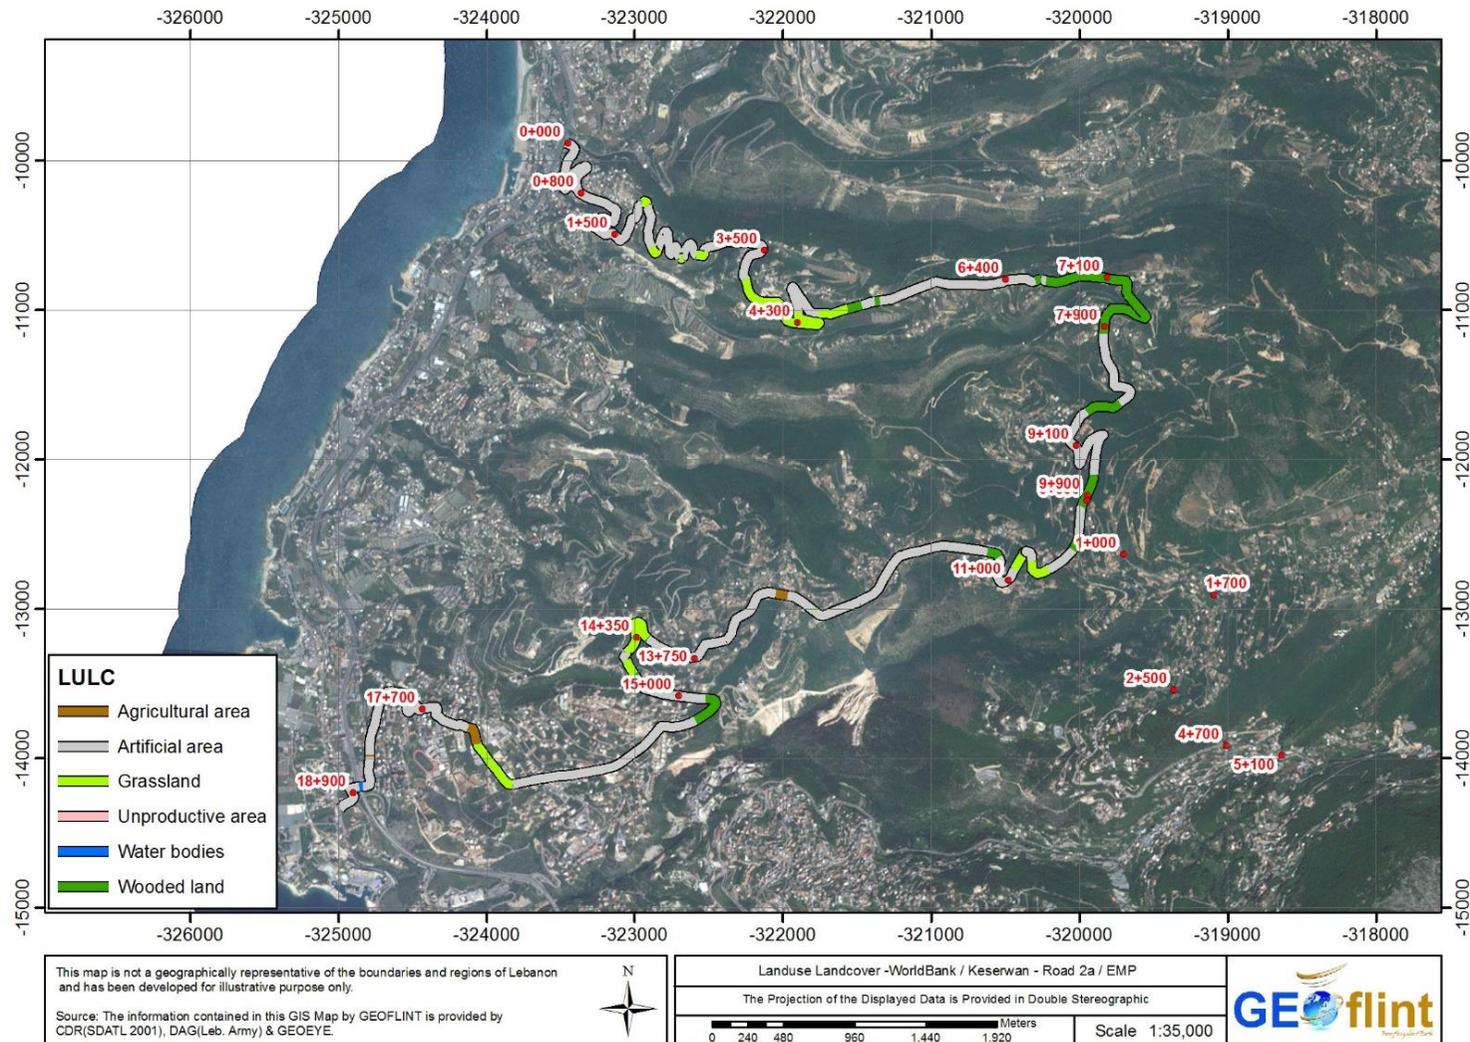
Figure S LULC map with work stations shown in red along Kesrouane R2a alignment

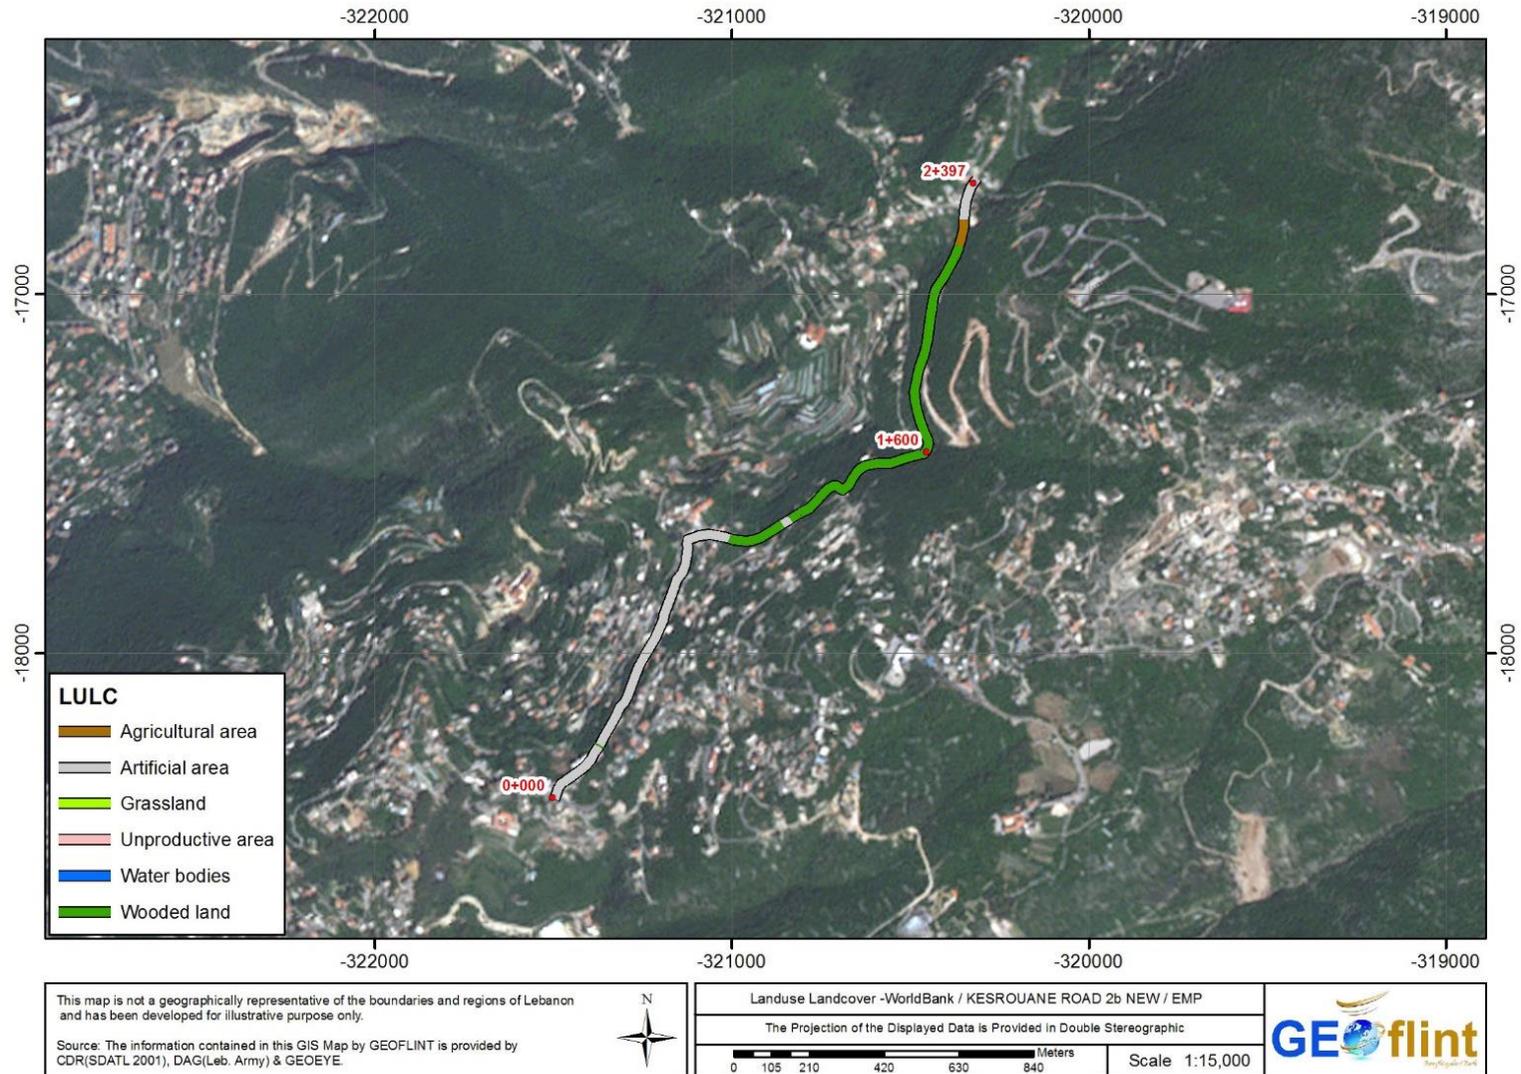
Figure T LULC map with work stations shown in red along Kesrouane R2b alignment
