Republic of Lebanon - Council for Development and Reconstruction

Road and Employment Project (REP)

Environmental and Social Management Plan (ESMP)
Final Report

LOT 1: Caza of Kesrouane

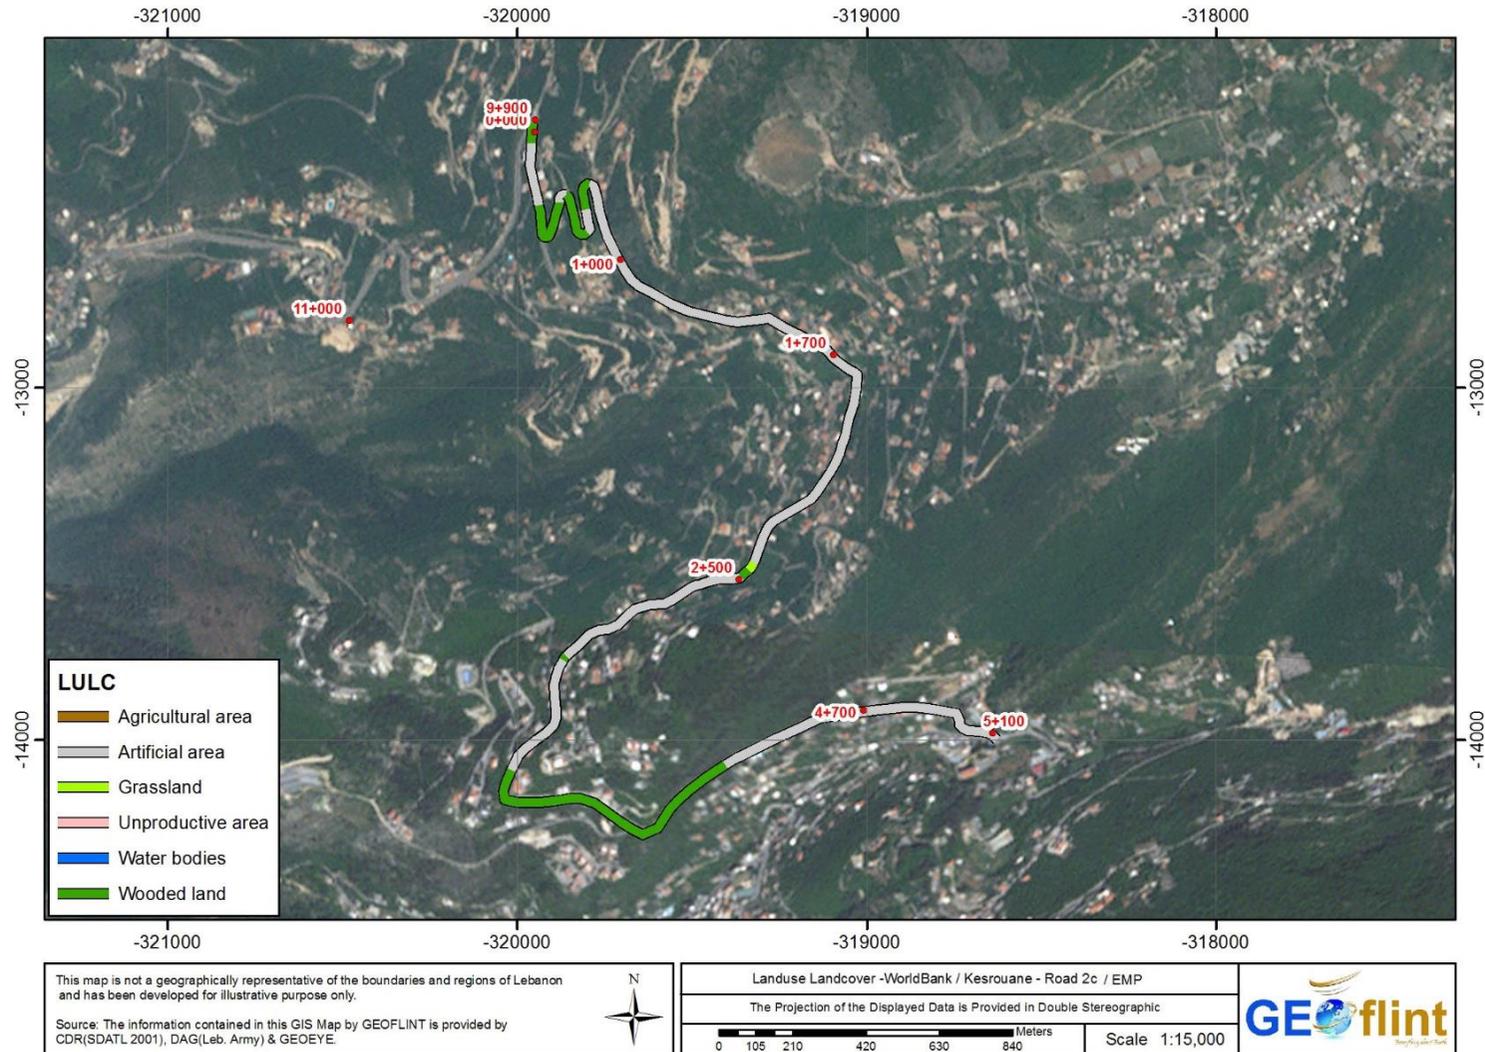
Figure U LULC map with work stations shown in red along Kesrouane R2c

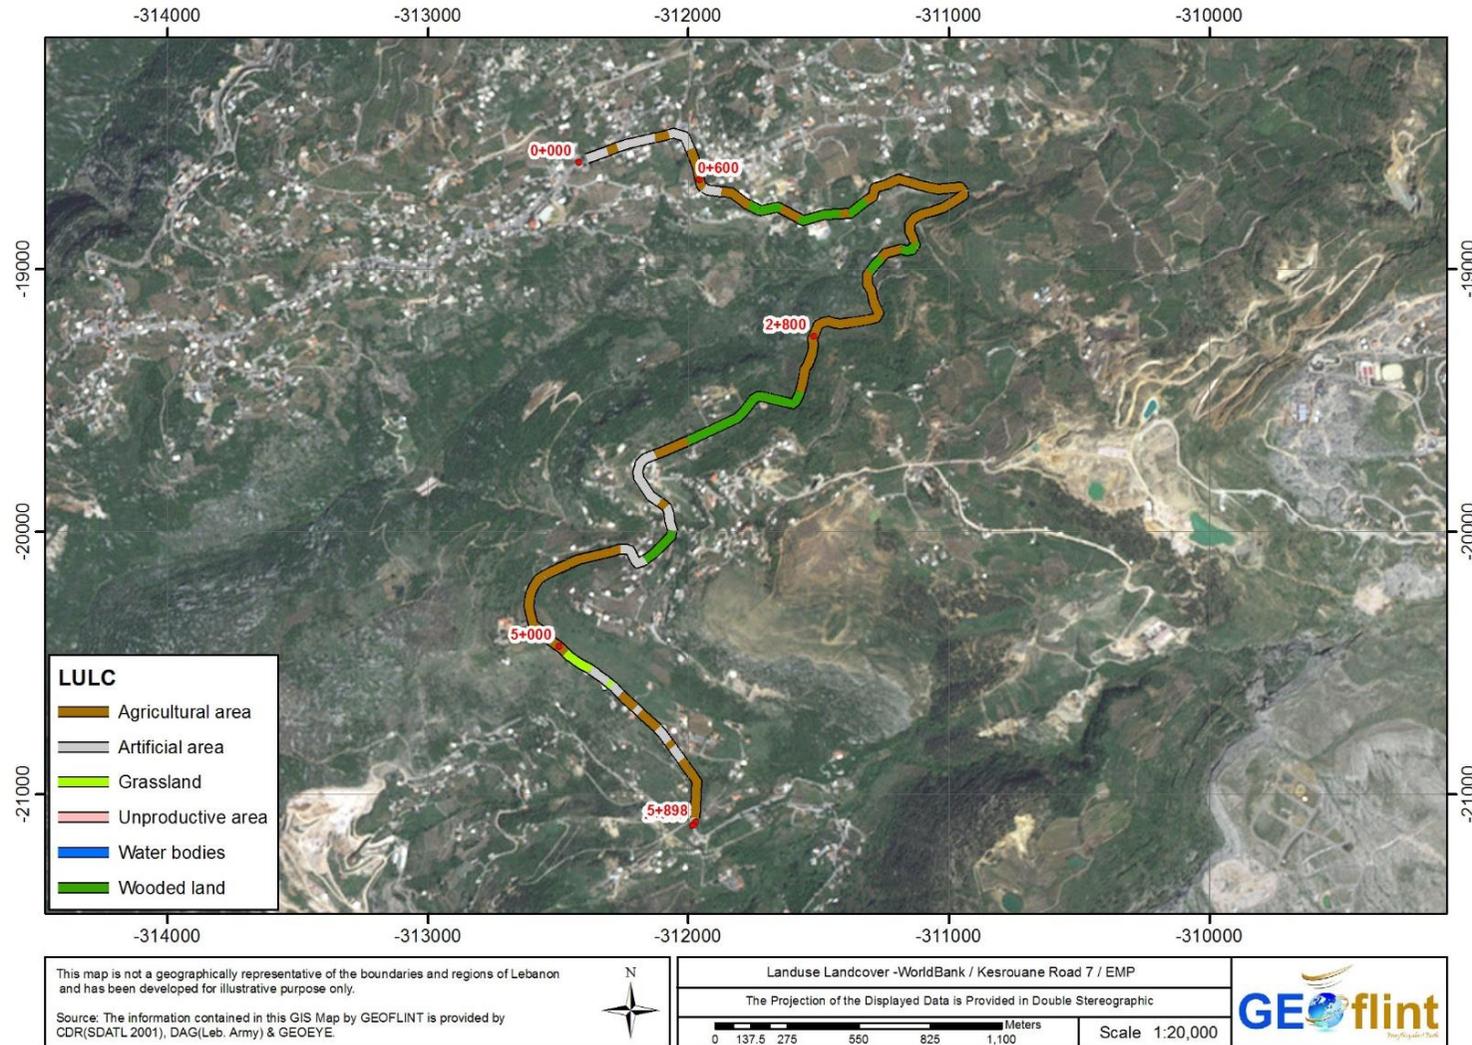
Figure V LULC map with work stations shown in red along Kesrouane R7 alignment

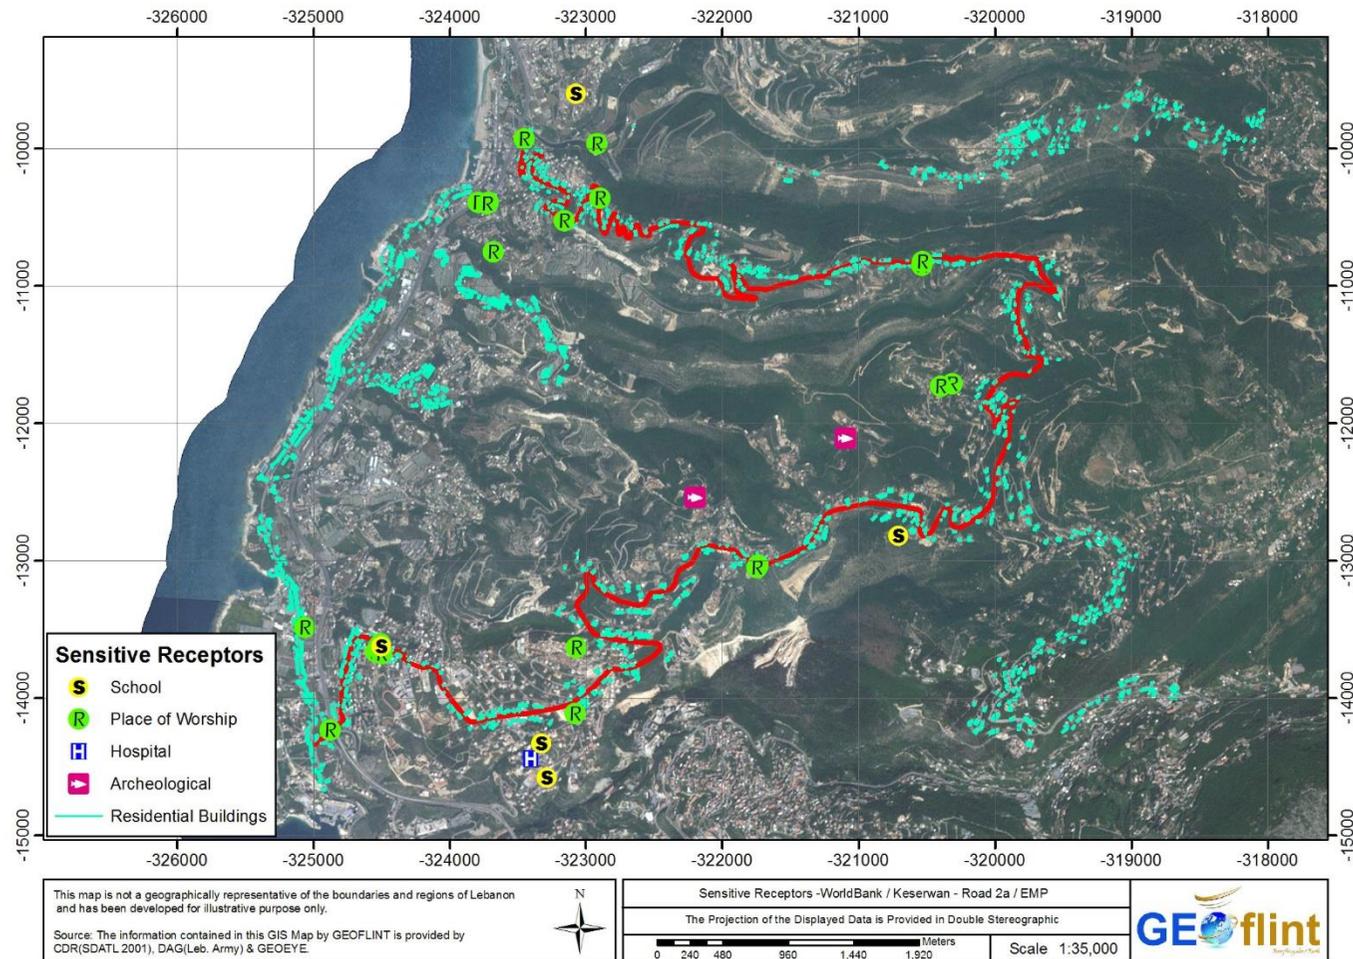
Figure X Closest sensitive receptors along Kesrouane R2a

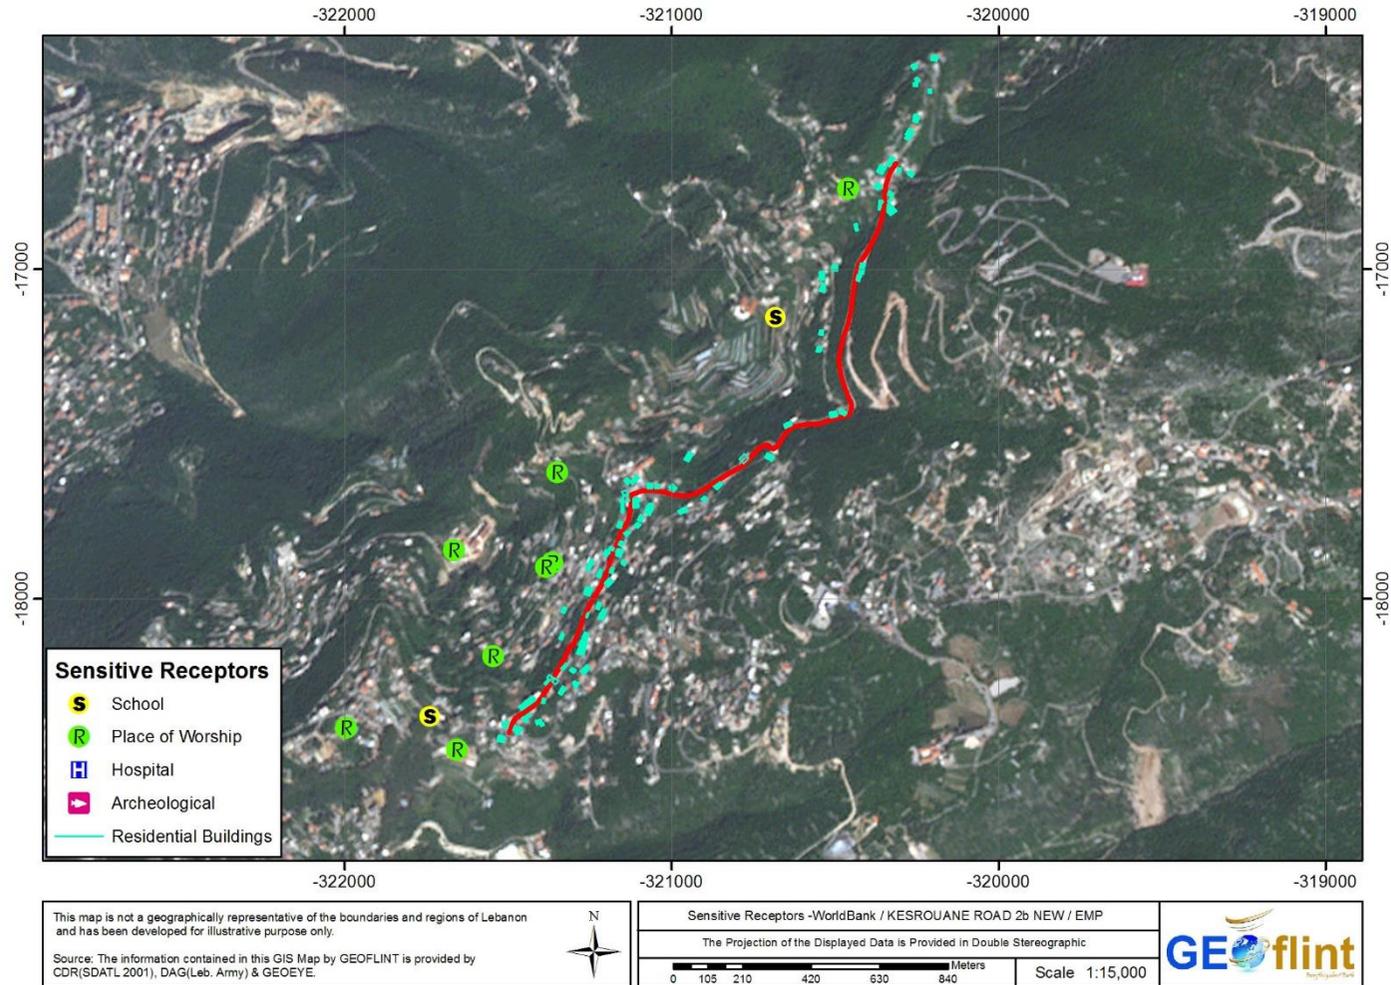
Figure Y Closest sensitive receptors along Kesrouane R2b

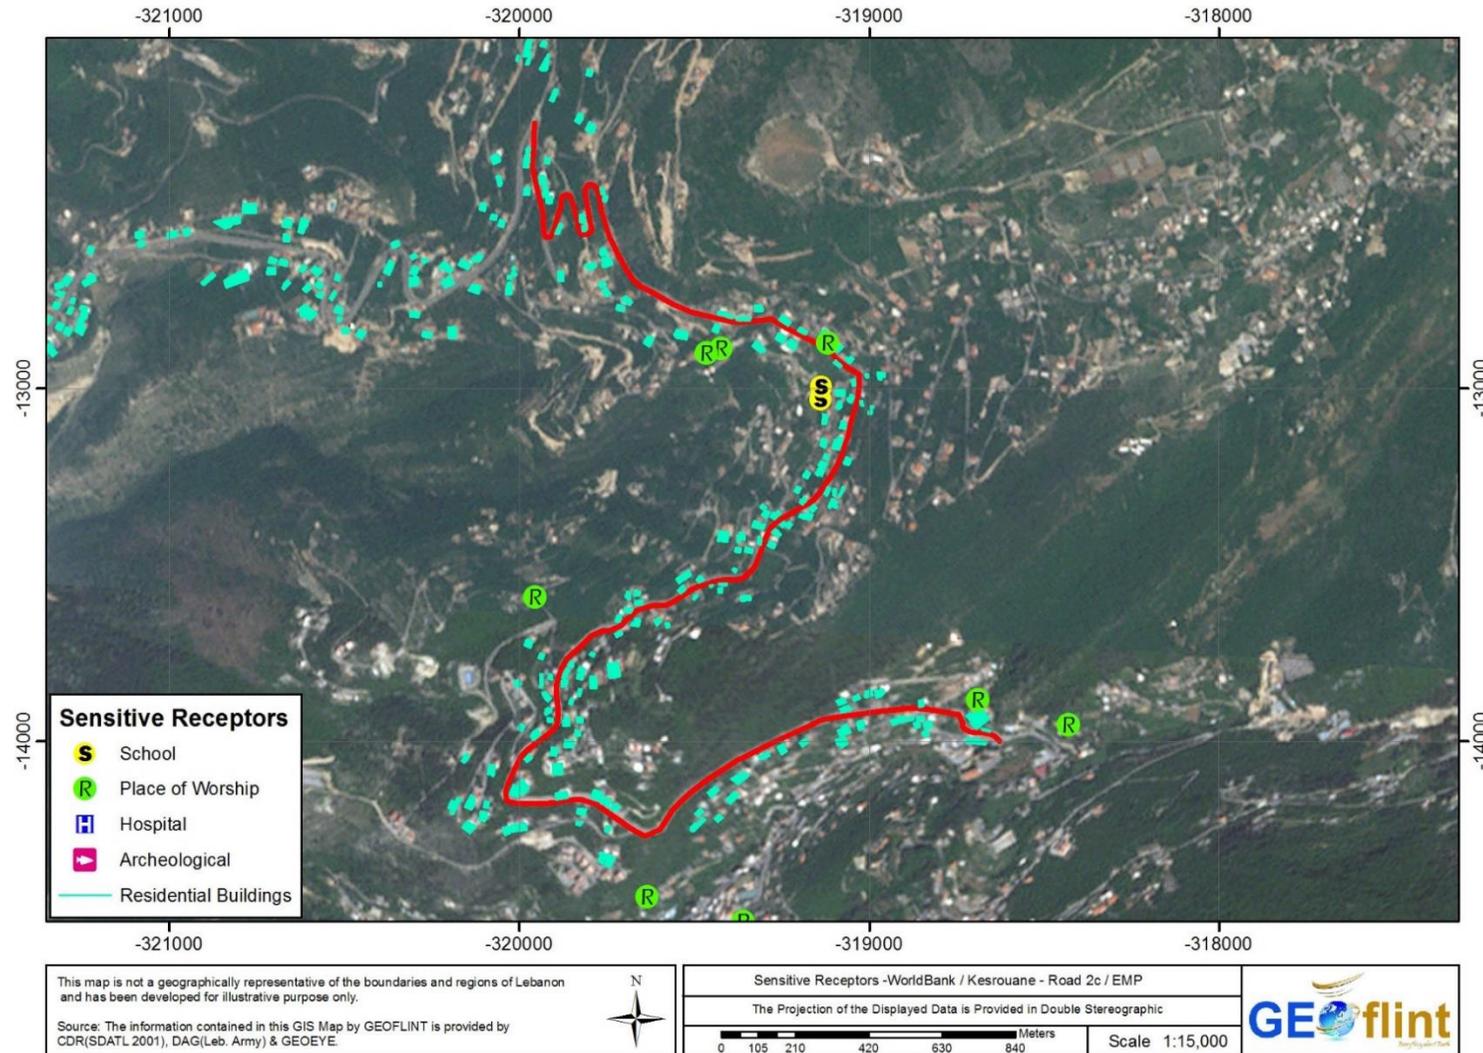
Figure Z Closest sensitive receptors along Kesrouane R2c

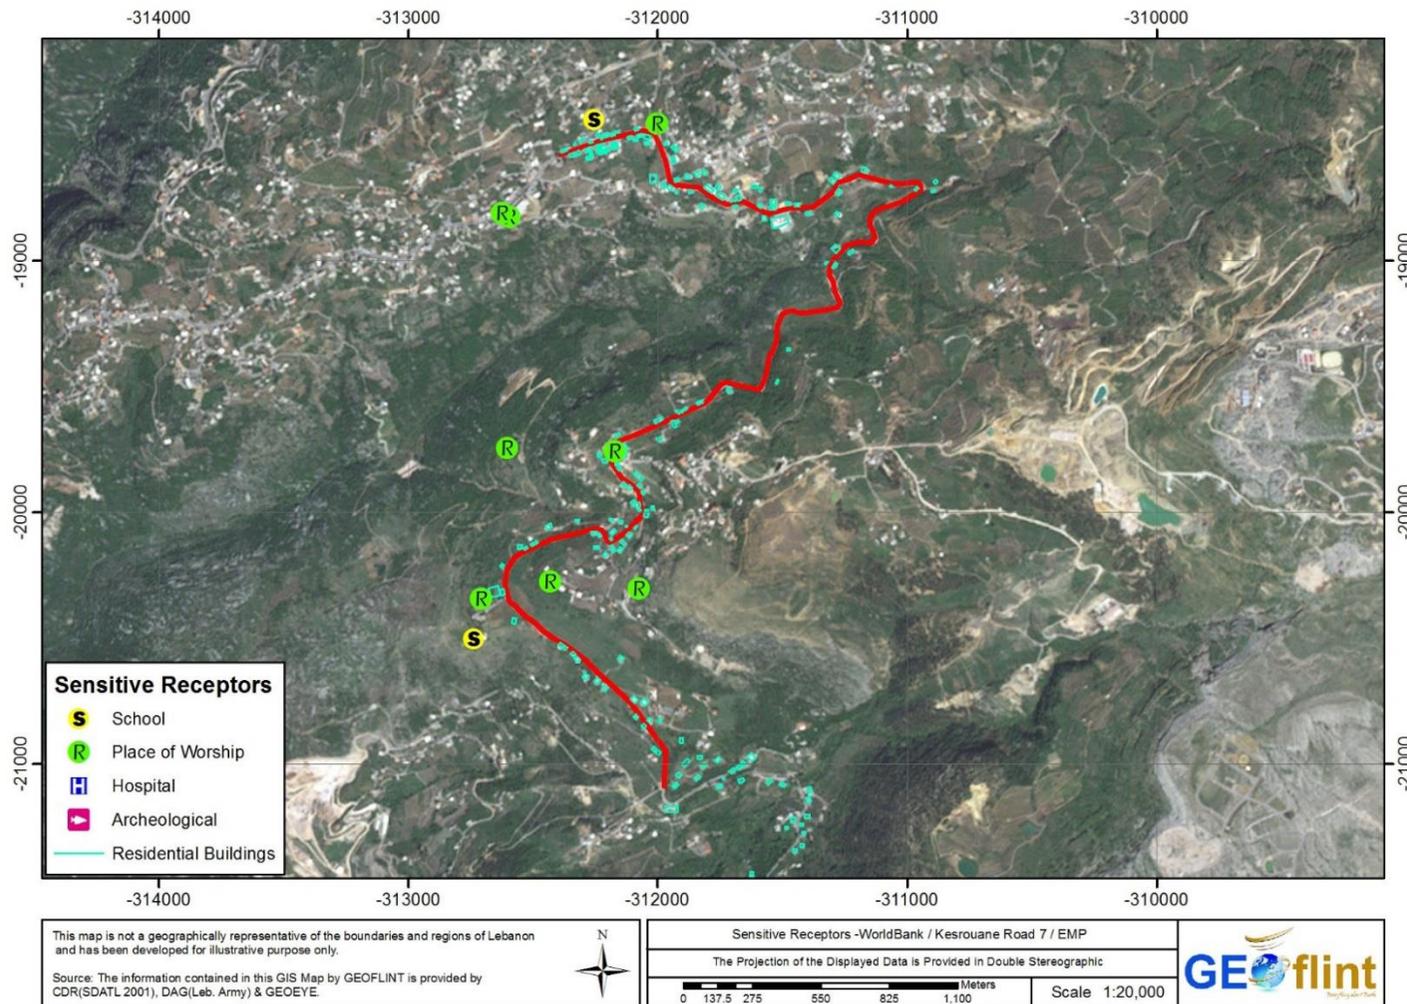
Figure AA Closest sensitive receptors along Kesrouane R7

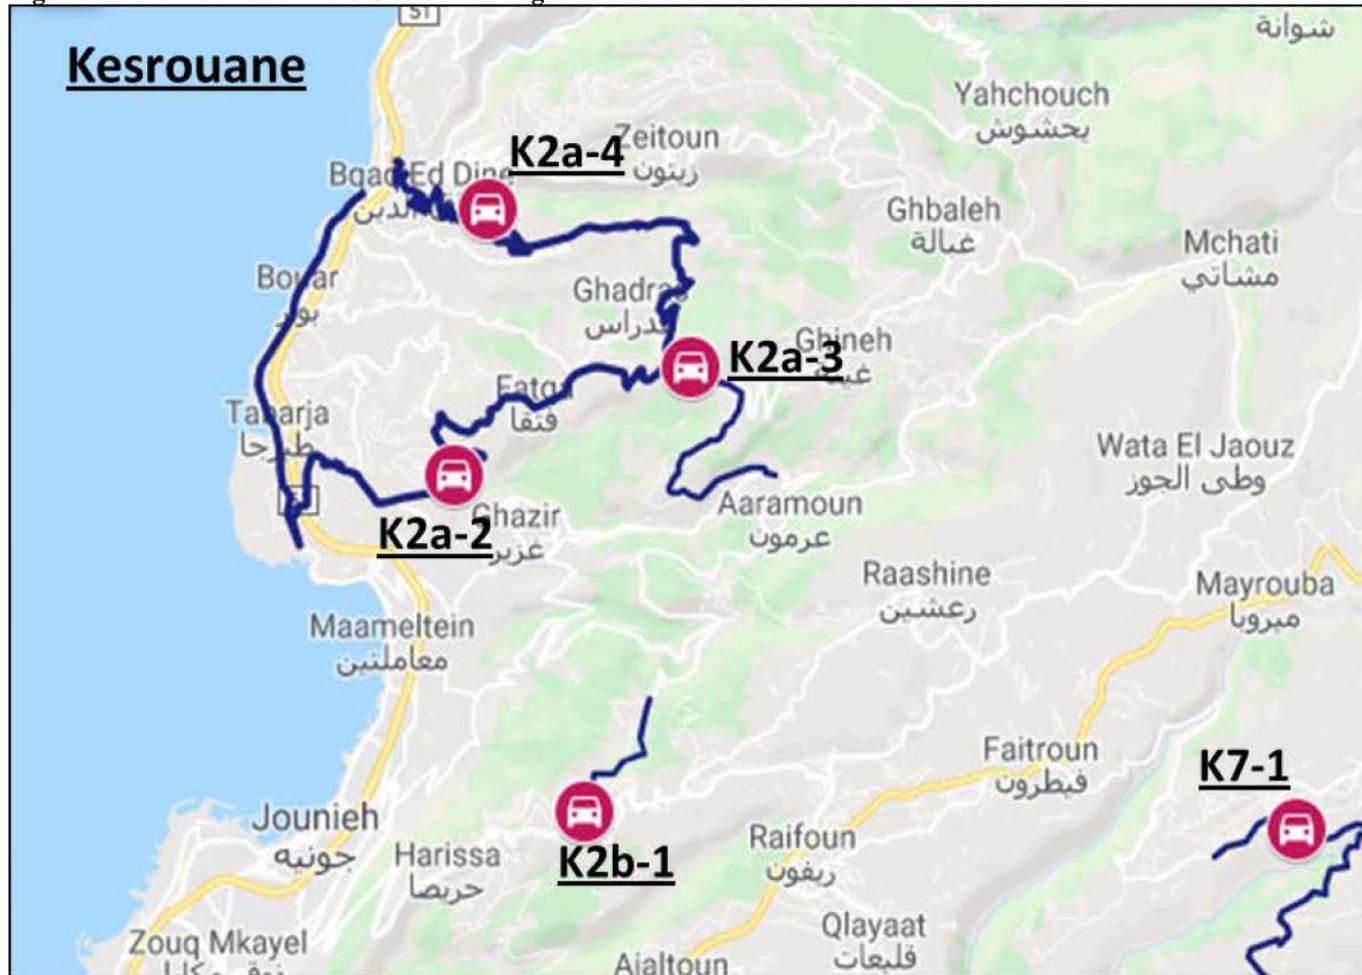
Figure BB Distribution of ATC Stations throughout Kesrouane Caza
