# ROADS & EMPLOYMENT PROJECT

DETAILED ENGINEERING DESIGN FOR THE  
REHABILITATION OF SELECTED ROAD LINKS IN LEBANON

## LOT 3A

NABATIYEH - MARJAYOUN - BEKAA WEST - RACHAYA - HASBAIYA

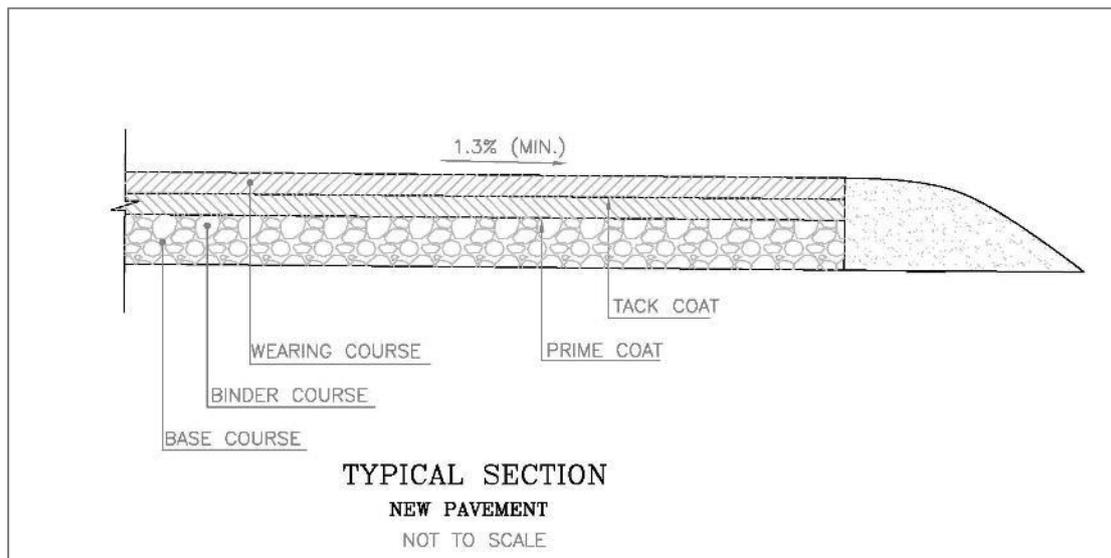
**Figure 3-6: New Pavement Cross Section Scheme**

- C.7- Spray tack coat over the newly executed asphalt binder course in order to receive asphalt wearing course layer.
- C.8- Spread and compact asphalt wearing course layer as per the required specifications and thicknesses).

The road sections in Marjayoun Caza that require new pavement are as follows:

- Station 600 m – 800 m, 1 km 200 m – 2 km 600 m, 7 km 500 m - 8 km 350 m of L3-MA-RD05
- Station 0 m – 5 km 300 m, 5 km 900 m- 7 km 200 m of L3-MA-RD06
- Station 0 m – 100 m, 3km – 3km100m of L3-MA-RD07

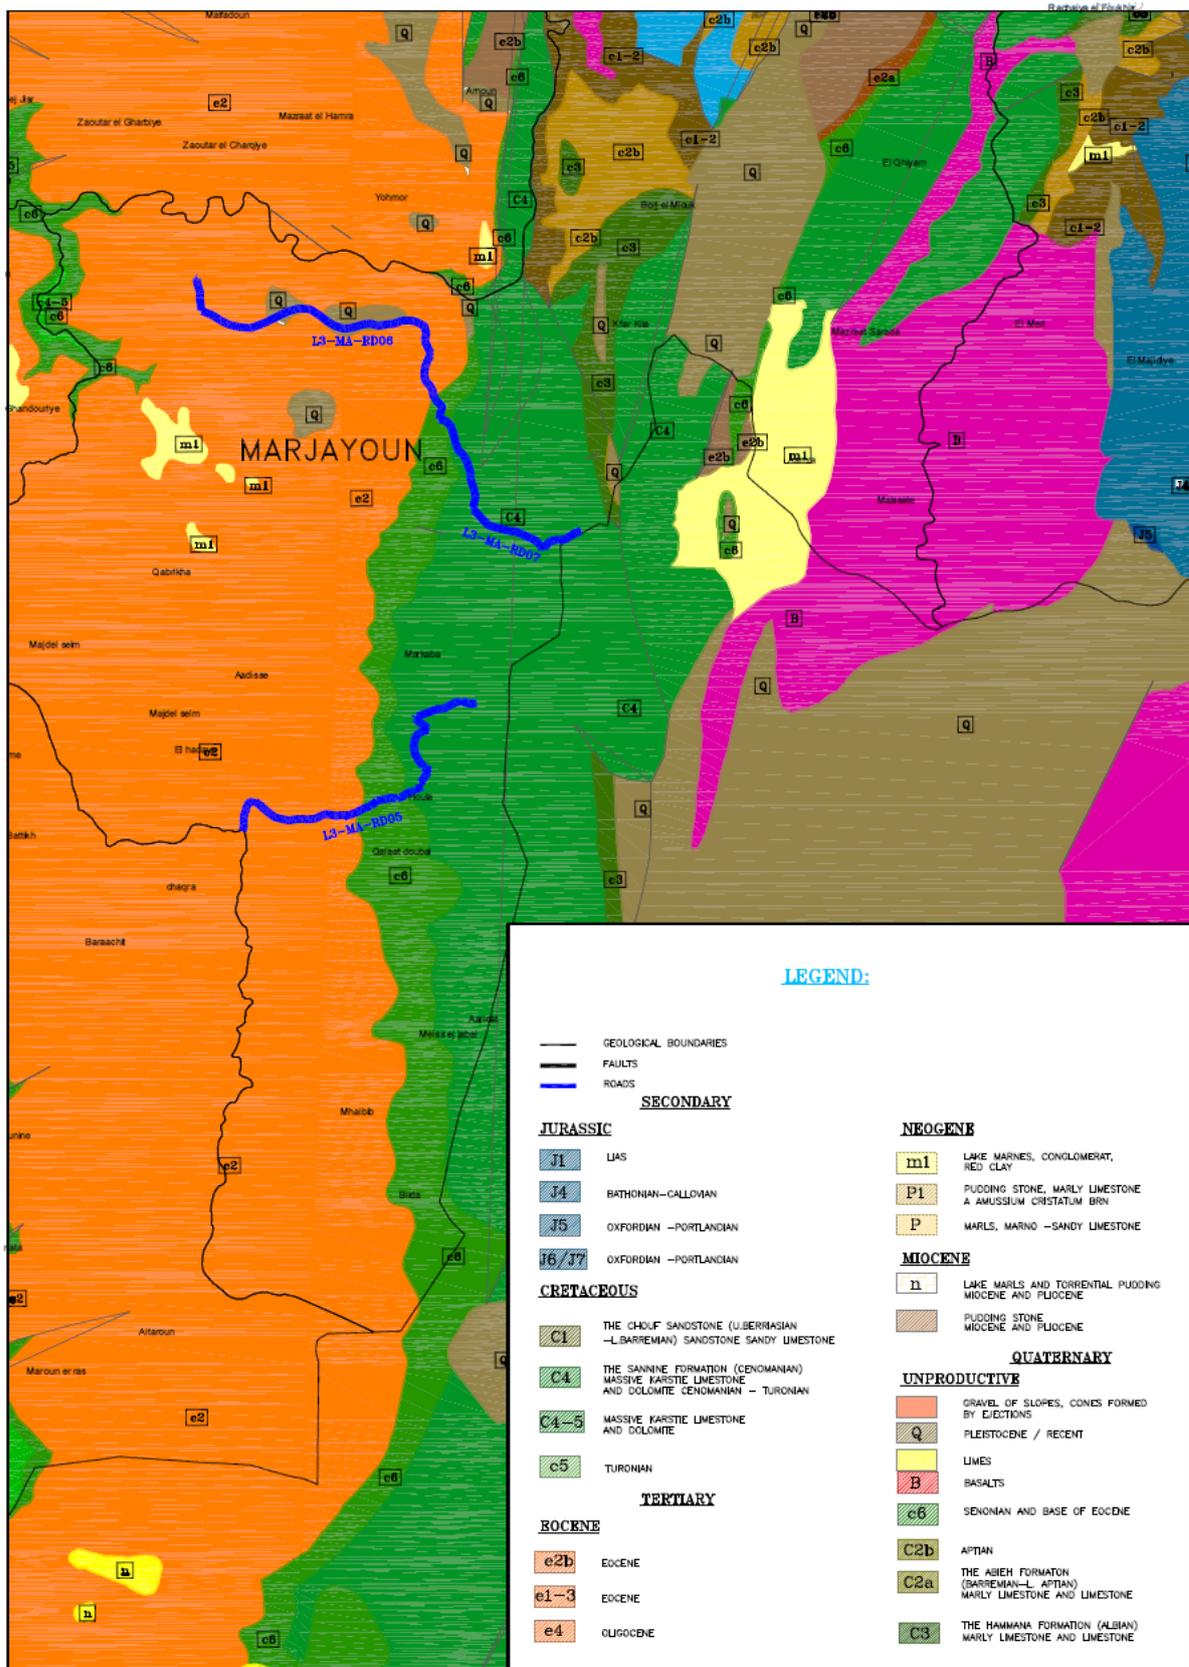
Figure 4-1 Geology Map of the Study Area

- E2: Eocene
- Pleistocene (Q): this formation belongs to the quaternary geological unit. It is composed of loose Eolian and cemented sands. Also, residual soil including Terra Rosa are found in this formation. In addition, this geological unit is composed of loose alluvium, unconsolidated soil and sediments.

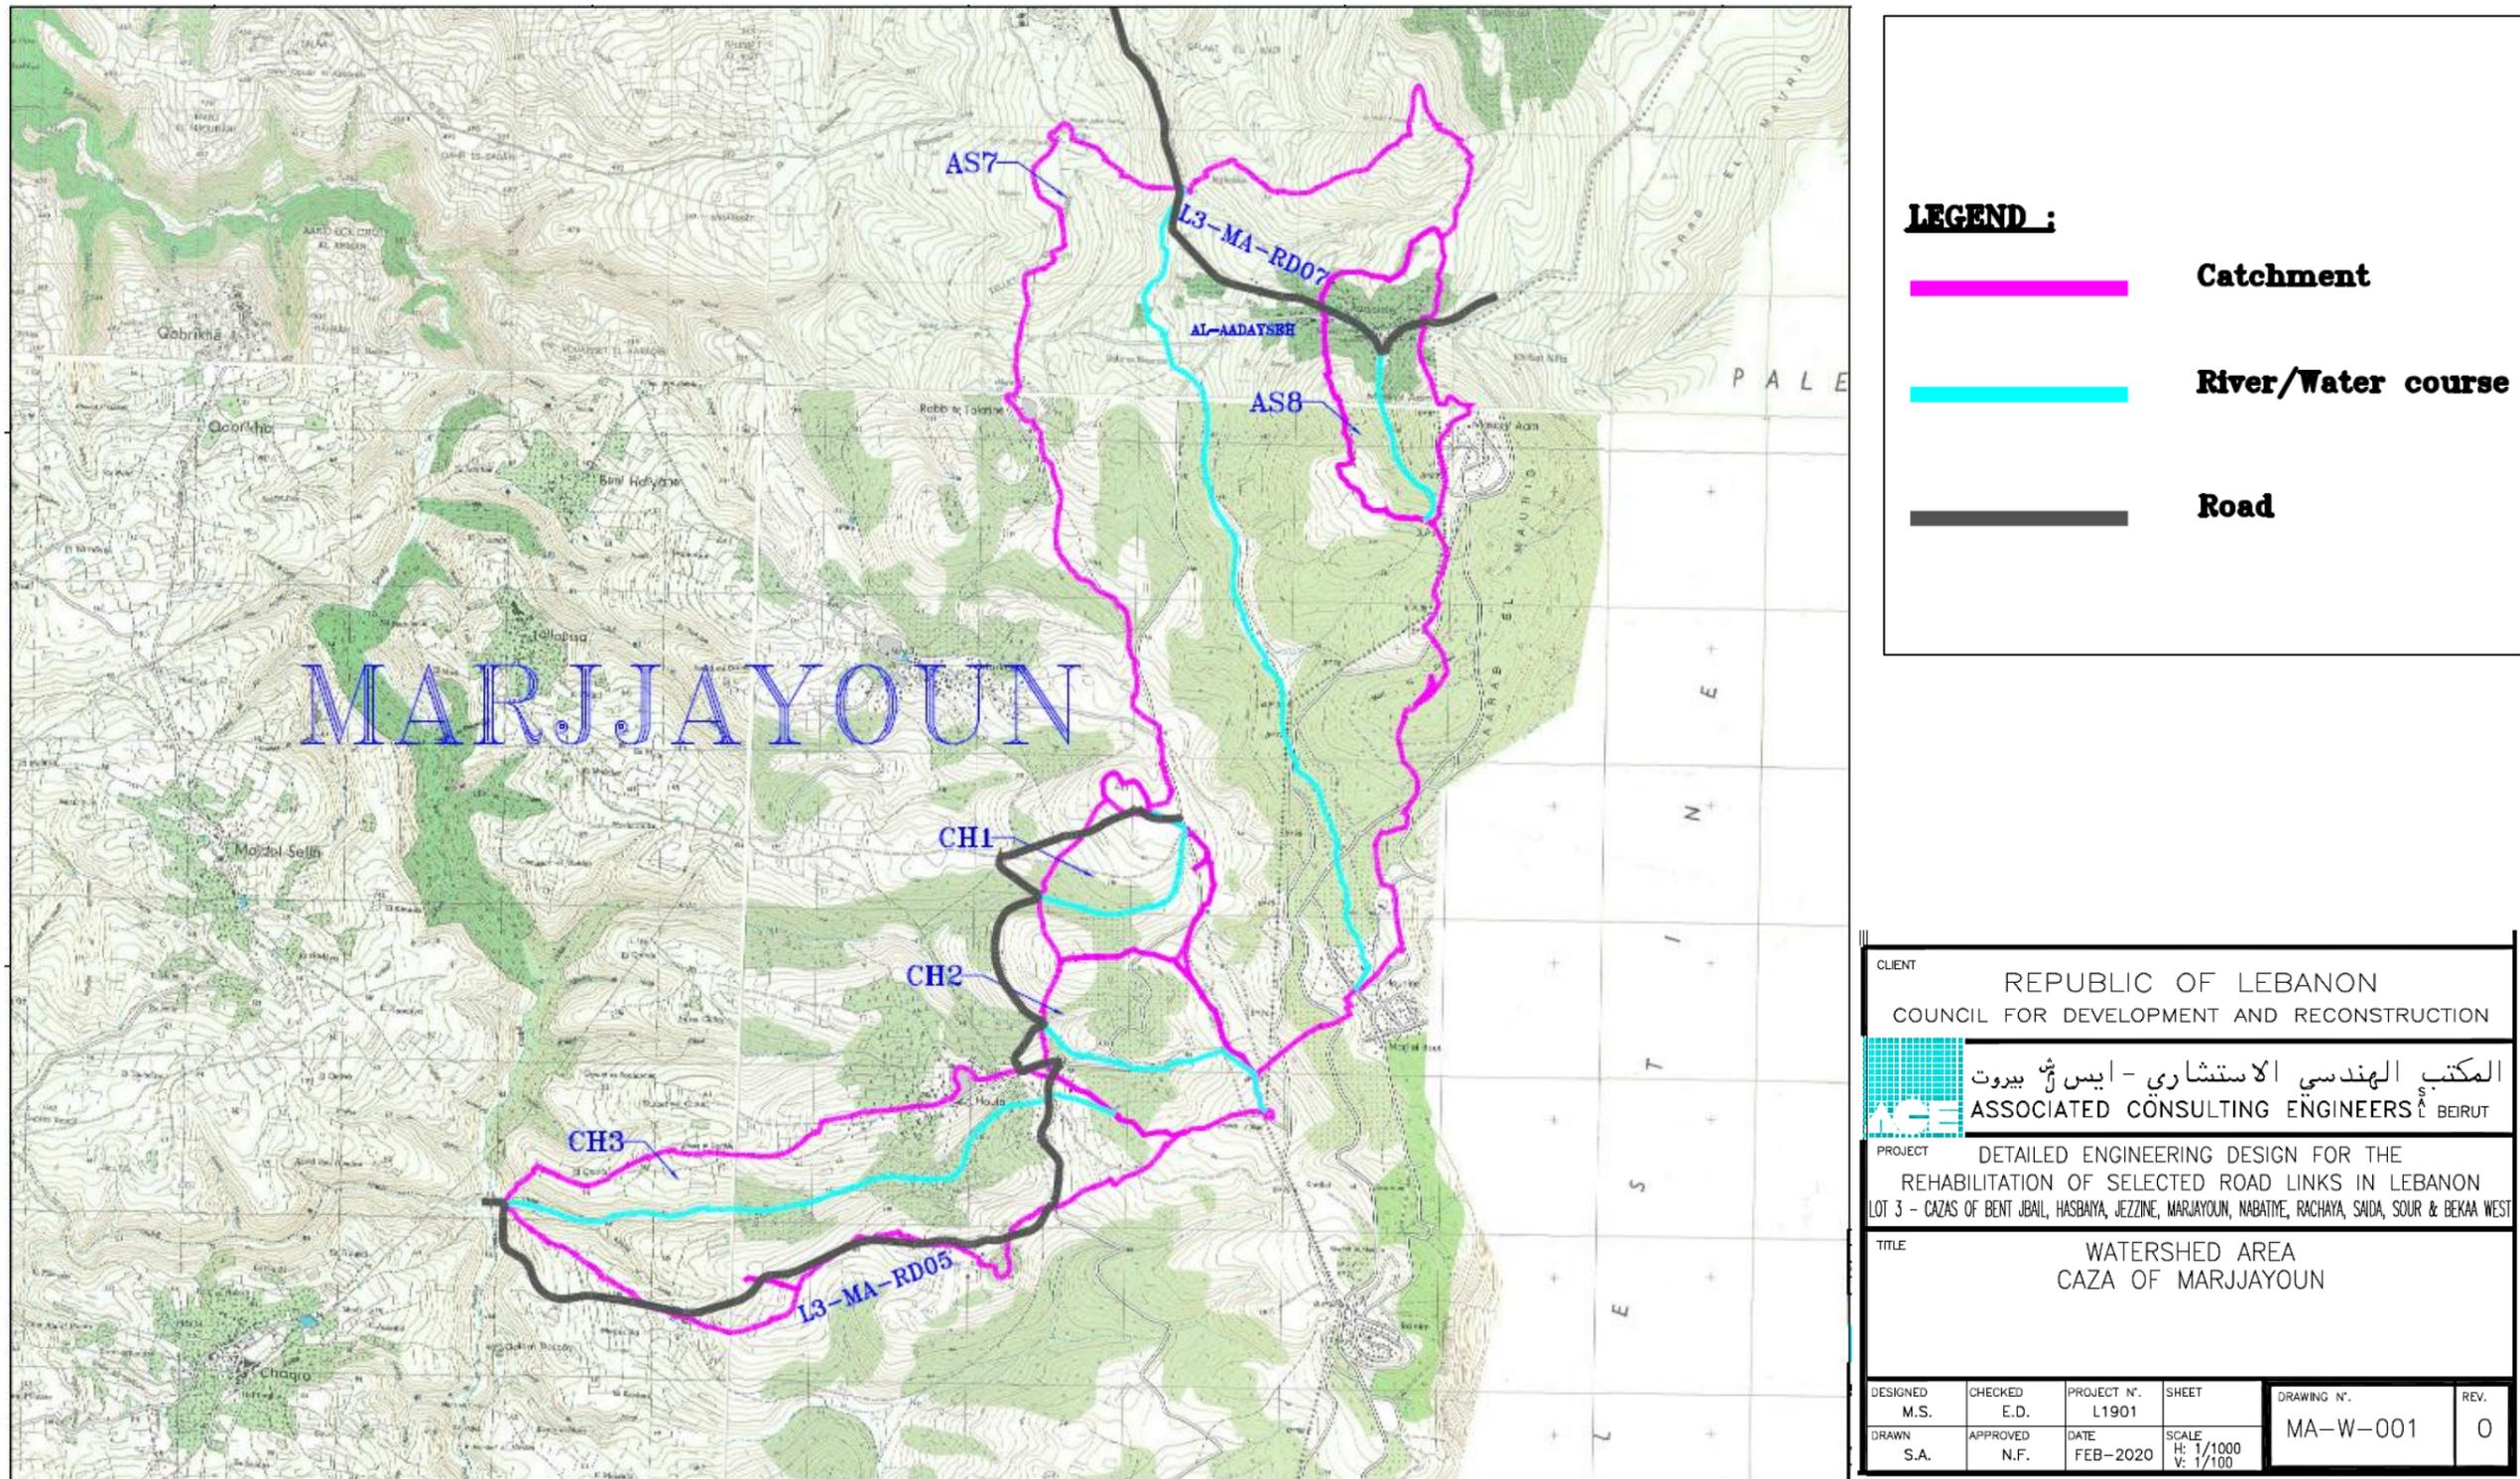
Figure 4-2: Major Rivers in Marjayoun District and Location of Existing Project Road (L3-MA-RD05 and L3-MA-RD07)

The nearest river to the project area is the Litani River that is the longest and most abundant river in Lebanon. The banks of this river have been used for many hydraulic, agriculture, and electric projects such as the water project in Markaba and the project in Al Taybeh that is under implementation to provide potable water for Marjayoun and Bent Jbeil (NNA, 2016). The Litani River spans around 1.2 Km from the nearest road of Aalmane Marjayoun (L3-MA-RD06). Moreover, several water courses are located within the study area. L3-MA-RD06 does not include a watershed. Figure 4-2 represents the hydrological maps of the proposed area including the roads of the project L3-MA-RD05 and L3-MA-RD07 with respect to the rivers and their watersheds in the Caza of Marjayoun, the villages of Houla, Chaqra and Aadaisseh are crossed at some section with these water courses.

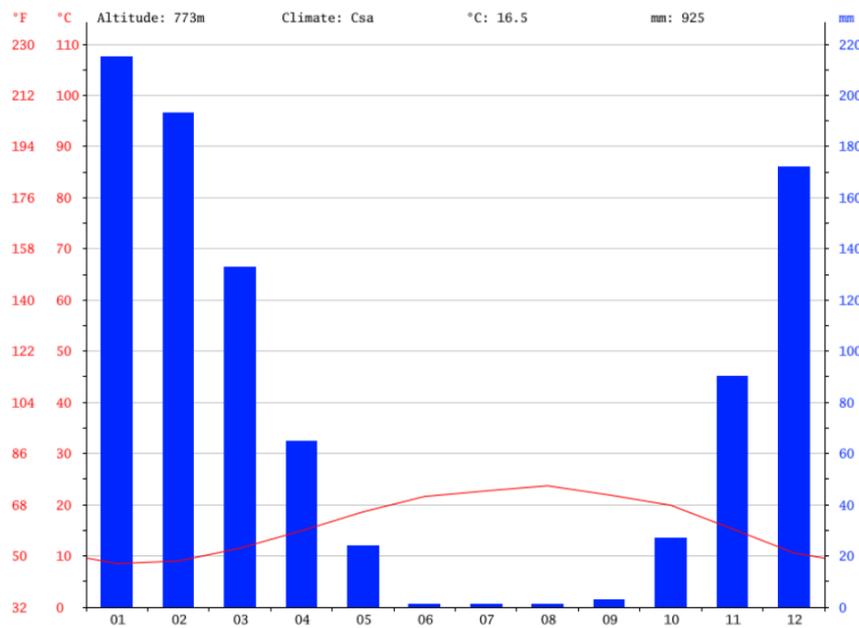
**Figure 4-3: Climograph of Marjayoun at 773 m (Historical Data between 1982-2012)**

The average annual temperature in the Caza of Marjayoun is 16.5 °C. The month of August is the warmest month with an average temperature of 23.7 °C, however, the average temperature occurring in the coldest month that is January is 8.5 °C. The driest month is June with 1 mm of precipitation. Most of the precipitation here falls in January, averaging 215 mm. However, the average annual precipitation is 925 mm (climate-data.org, 2020). The Climograph of Marjayoun village is represented in Figure 4-3.

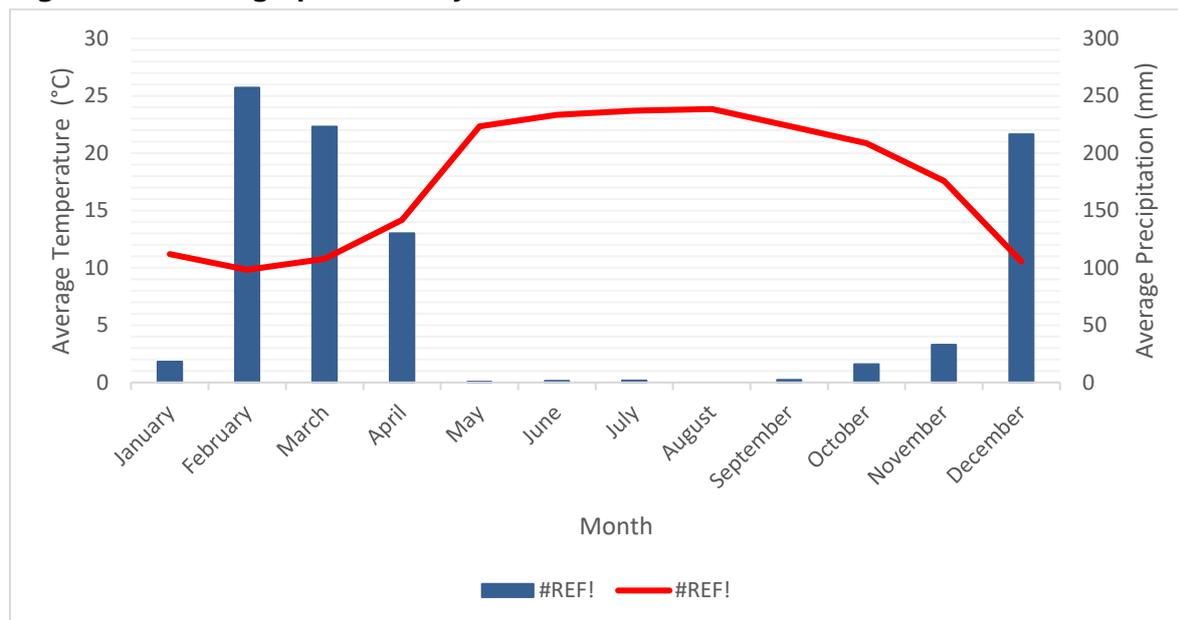
**Figure 4-4: Climograph of El Khyem at 695 m from LARI Station for the Year 2019**

Additional data on climate in the area was obtained from the Lebanese Agriculture Research Institute (LARI) from its station in the village of El Khyem located at the altitude 695 meters and at around 10 Km away from the village of Taybeh (L3-MA-RD05). This data represents the average temperatures and average precipitation of the year 2019 (Figure 4-4).

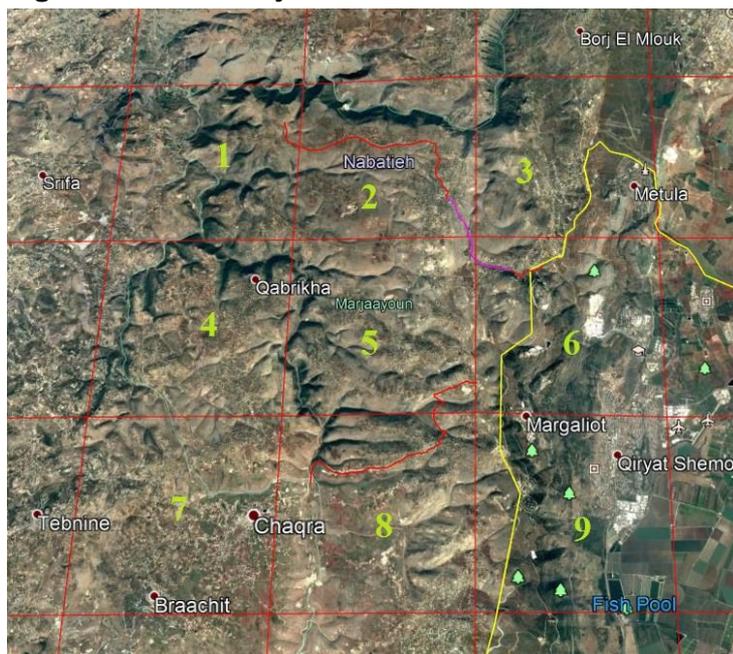
**Figure 4-5: The Project Area Divided into Different Cells**

Ambient air quality of the project area was requested from MOE. Data was available from the UNDP project "Air quality assessment in an East Mediterranean country: the case of Lebanon" which is based at the Ministry of Environment for the year 2010. The available data is for criteria pollutants: Particulate Matter (PM), Ozone (O<sub>3</sub>), Carbon monoxide (CO), Nitrogen dioxide (NO<sub>2</sub>), Sulfur dioxide (SO<sub>2</sub>). The project area was divided into different cells (Figure 4-5) and the data of the annual background average concentrations in µg/m<sup>3</sup> was obtained. Table 4-2 shows the detected annual concentrations, the national limit values dictated in Decision 52/1 dated 1996 and WHO Guidelines. For some parameters, the obtained data on air quality is the annual concentrations while some of the standards are available only for intervals of 8 hours or 24 hours.

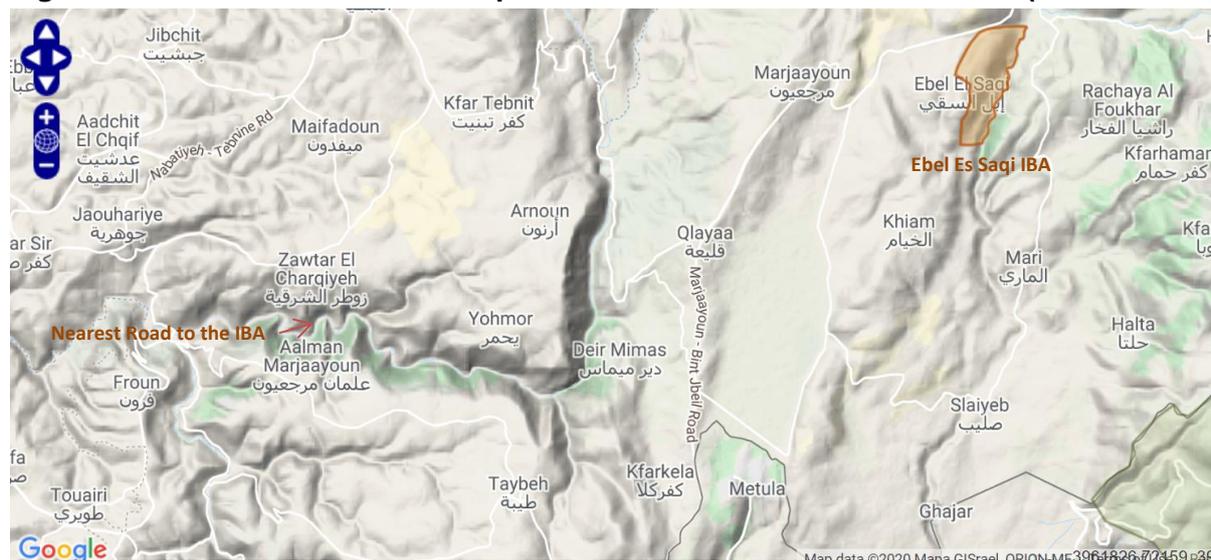
**Figure 4-8: Location of Ebel Es Saqi IBA in reference to the nearest road (L3-MA-RD06)**

The District of Marjayoun comprises Ebel Es Saqi area that was declared as an Important Bird Area (IBA) by BirdLife International where different bird species were observed such as the Common Cranes, White Storks, Pallid Harrier, European Honey-buzzard, Egyptian Vulture, Black-headed Bunting and Masked Shrike. However, the nearest road L3-MA-RD06 in Alman Marjayoun is about 12 km away from this IBA (Figure 4-8).

Moreover, the MOE has declared in 2006 Ebel Es Saqi a Hima that was among the list of sites of natural and/or ecological importance in need for protection and the word Hima refers to protected area (SPNL, 2020). As mentioned before the Hima of Ebel Es Saqi is around 12 Km away from the project area. The Hima is divided into six land use zones of a pine forest, scrubland, Hasbani river Ecotone, Hasbani river, crop fields and olive groves (State of Lebanon's Birds and IBAs, 2014). Moreover, the non-avian fauna of interest are bats, hyrax, wild cat, fox, jackal, river otter, wild boar, freshwater fish, terrestrial turtles, chameleon and lizards, three species of amphibians, and scorpions (BirdLife International, 2020).
