ROADS & EMPLOYMENT PROJECT

DETAILED ENGINEERING DESIGN FOR THE
REHABILITATION OF SELECTED ROAD LINKS IN LEBANON

LOT 3B

ENVIRONMENTAL & SOCIAL MANAGEMENT PLAN (ESMP)
FOR REHABILITATION OF THE SELECTED ROADS IN
SAIDA CAZA

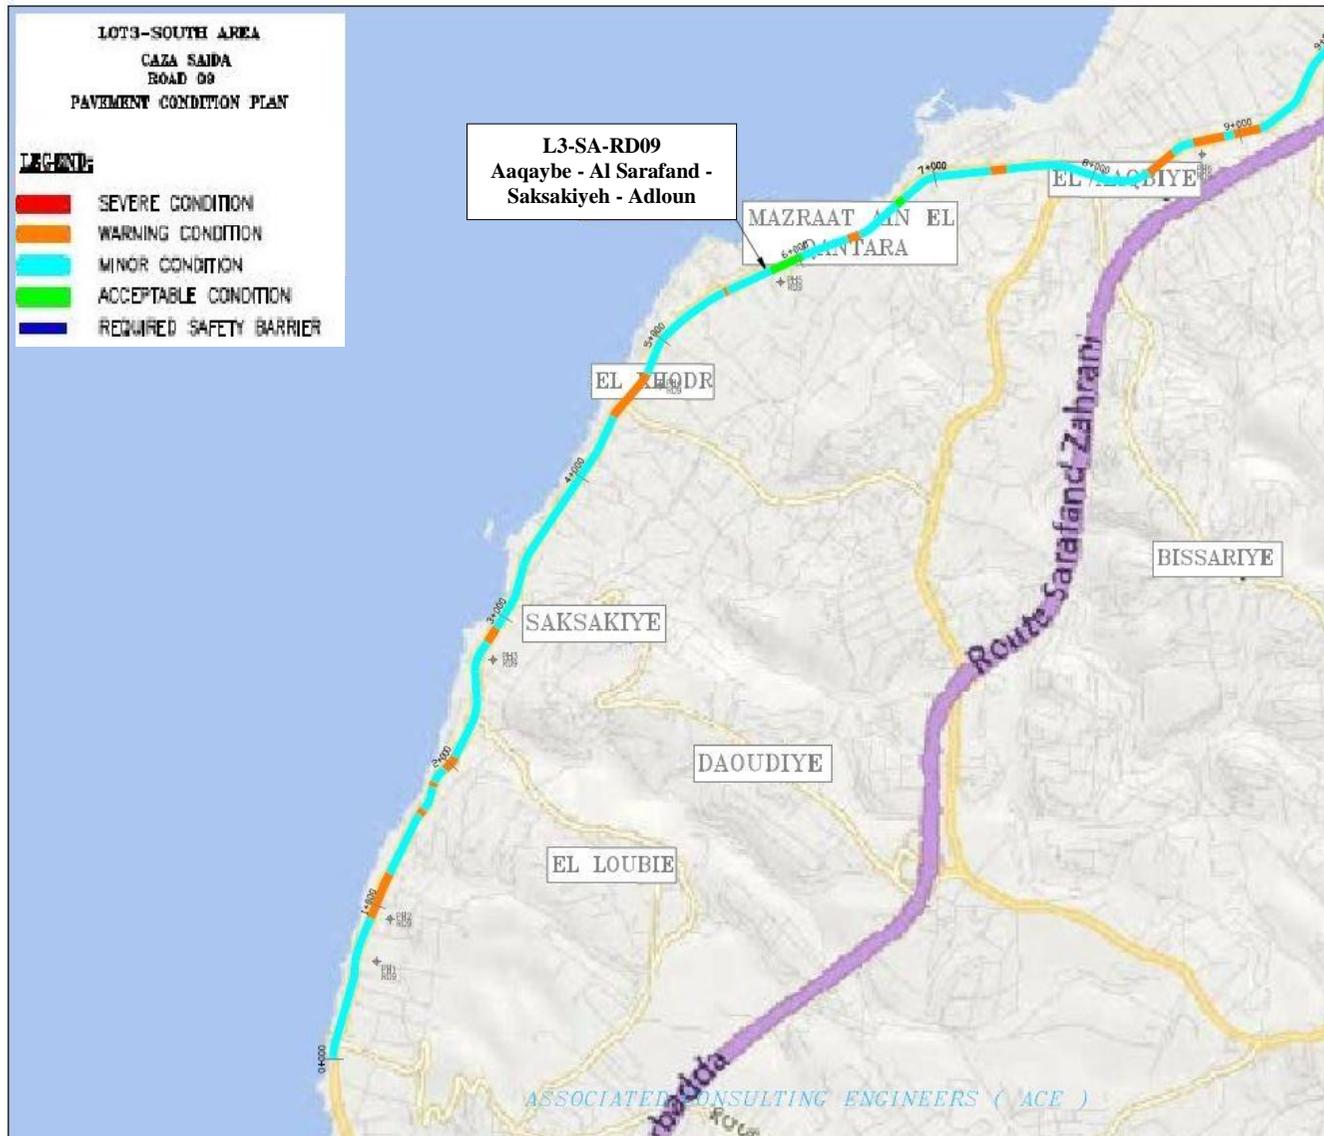
Source: Google Earth, 2019 Figure 3-2: Pavement Condition Plan of Road L3-SA-RD09 in Saida Caza

An overview of the proposed road locations is presented in Figure 3-1, Figure 3-3 and Figure 3-4 and their respective pavement condition plans are presented in Figure 3-2 and Figure 3-5.

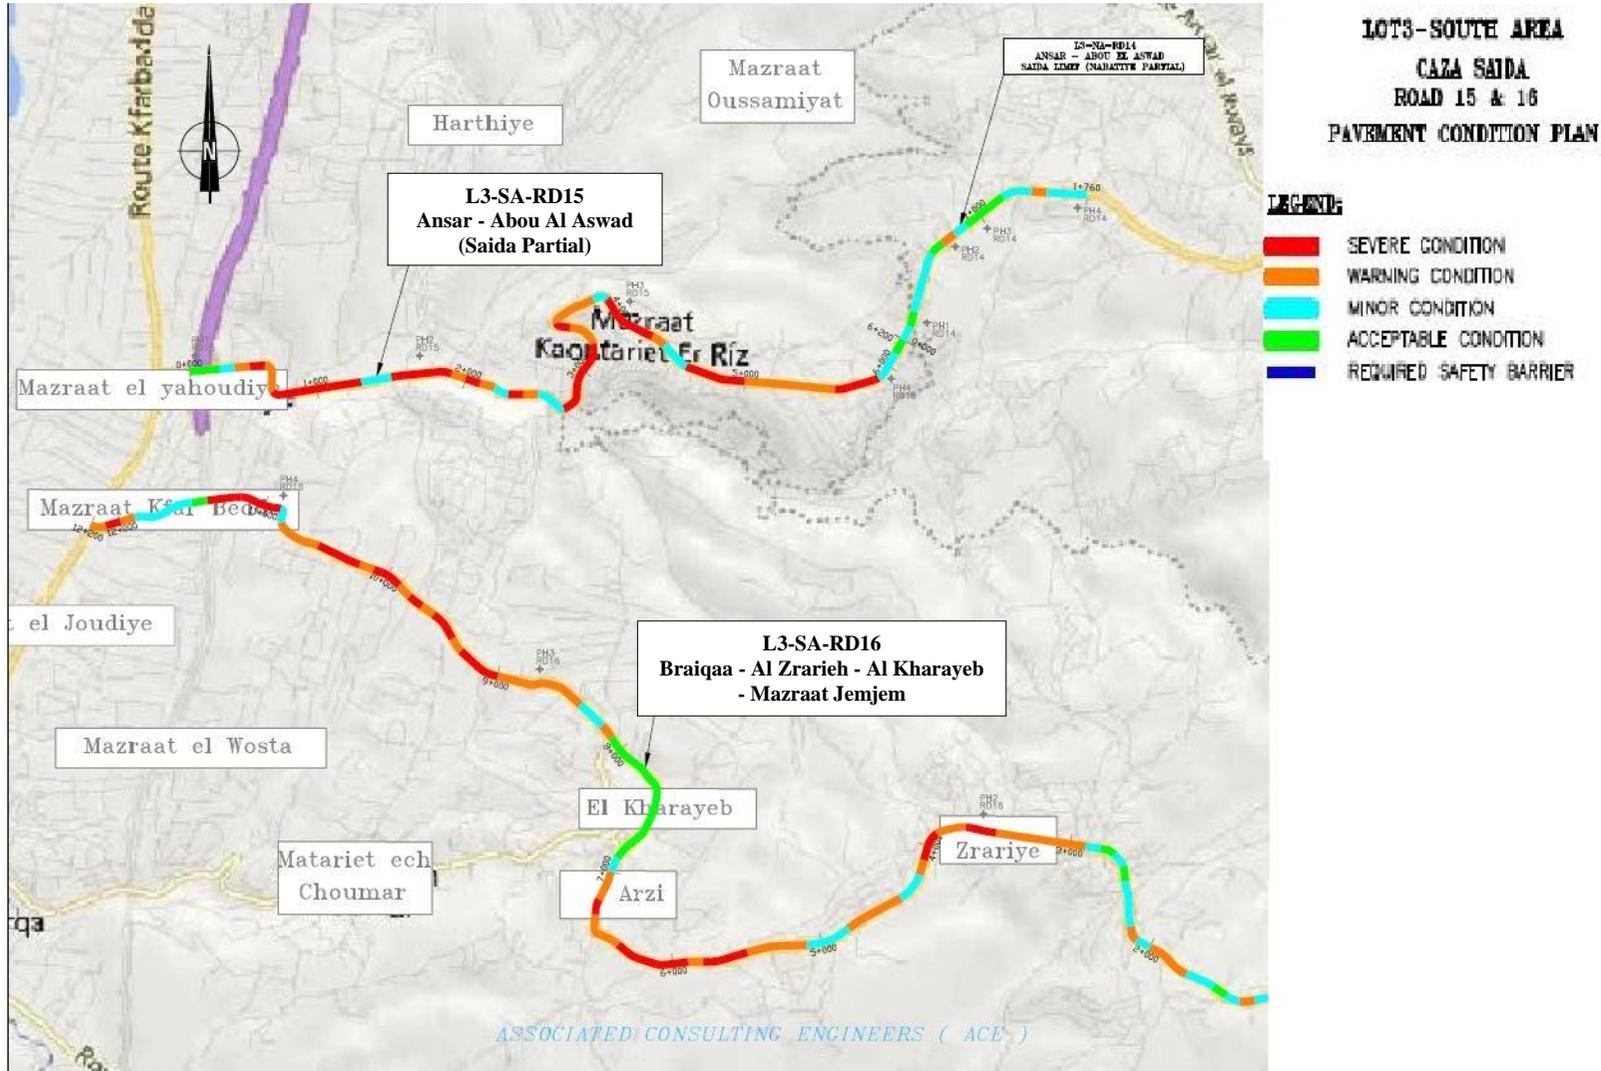
Figure 3-5: Pavement Condition Plan of Road L3-SA-RD15 and Road L3-SA-RD16 in Saida Caza

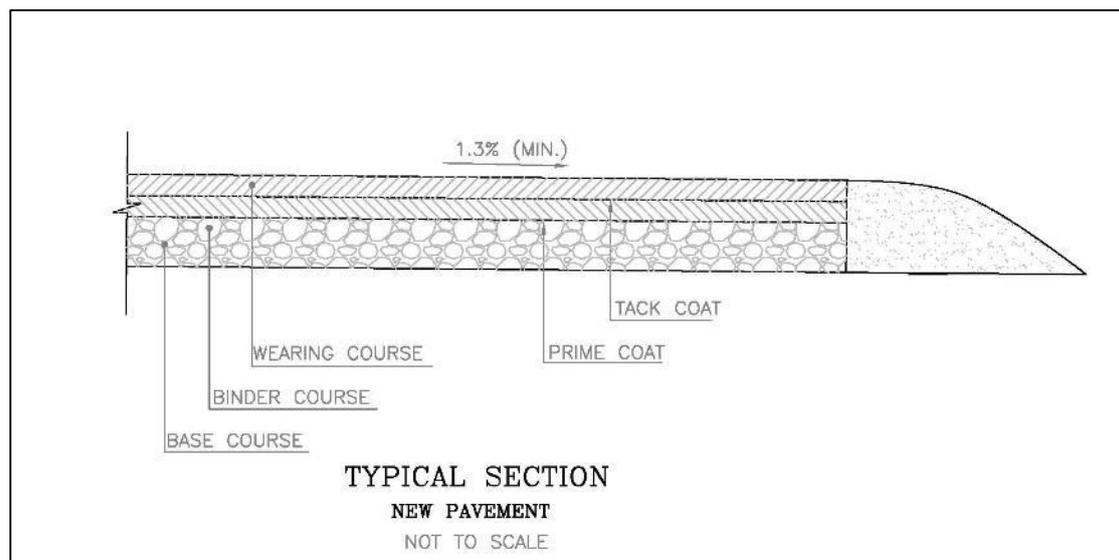
Figure 3-11: New Pavement Cross Section Scheme

- C.4- Execute sub-base/base course layers as per specifications and thicknesses according to tender documents. Compact sub-base/base-course layers to reach required compaction level/percentage.
- C.5- Spray prime coat over the prepared and leveled surface of base course in order to receive asphalt binder course layer(s).
- C.6- Spread and compact asphalt binder course layer(s) as per the thicknesses and specifications specified in tender documents.
- C.7- Spray tack coat over the newly executed asphalt binder course in order to receive asphalt wearing course layer.
- C.8- Spread and compact asphalt wearing course layer as per the required specifications and thicknesses).

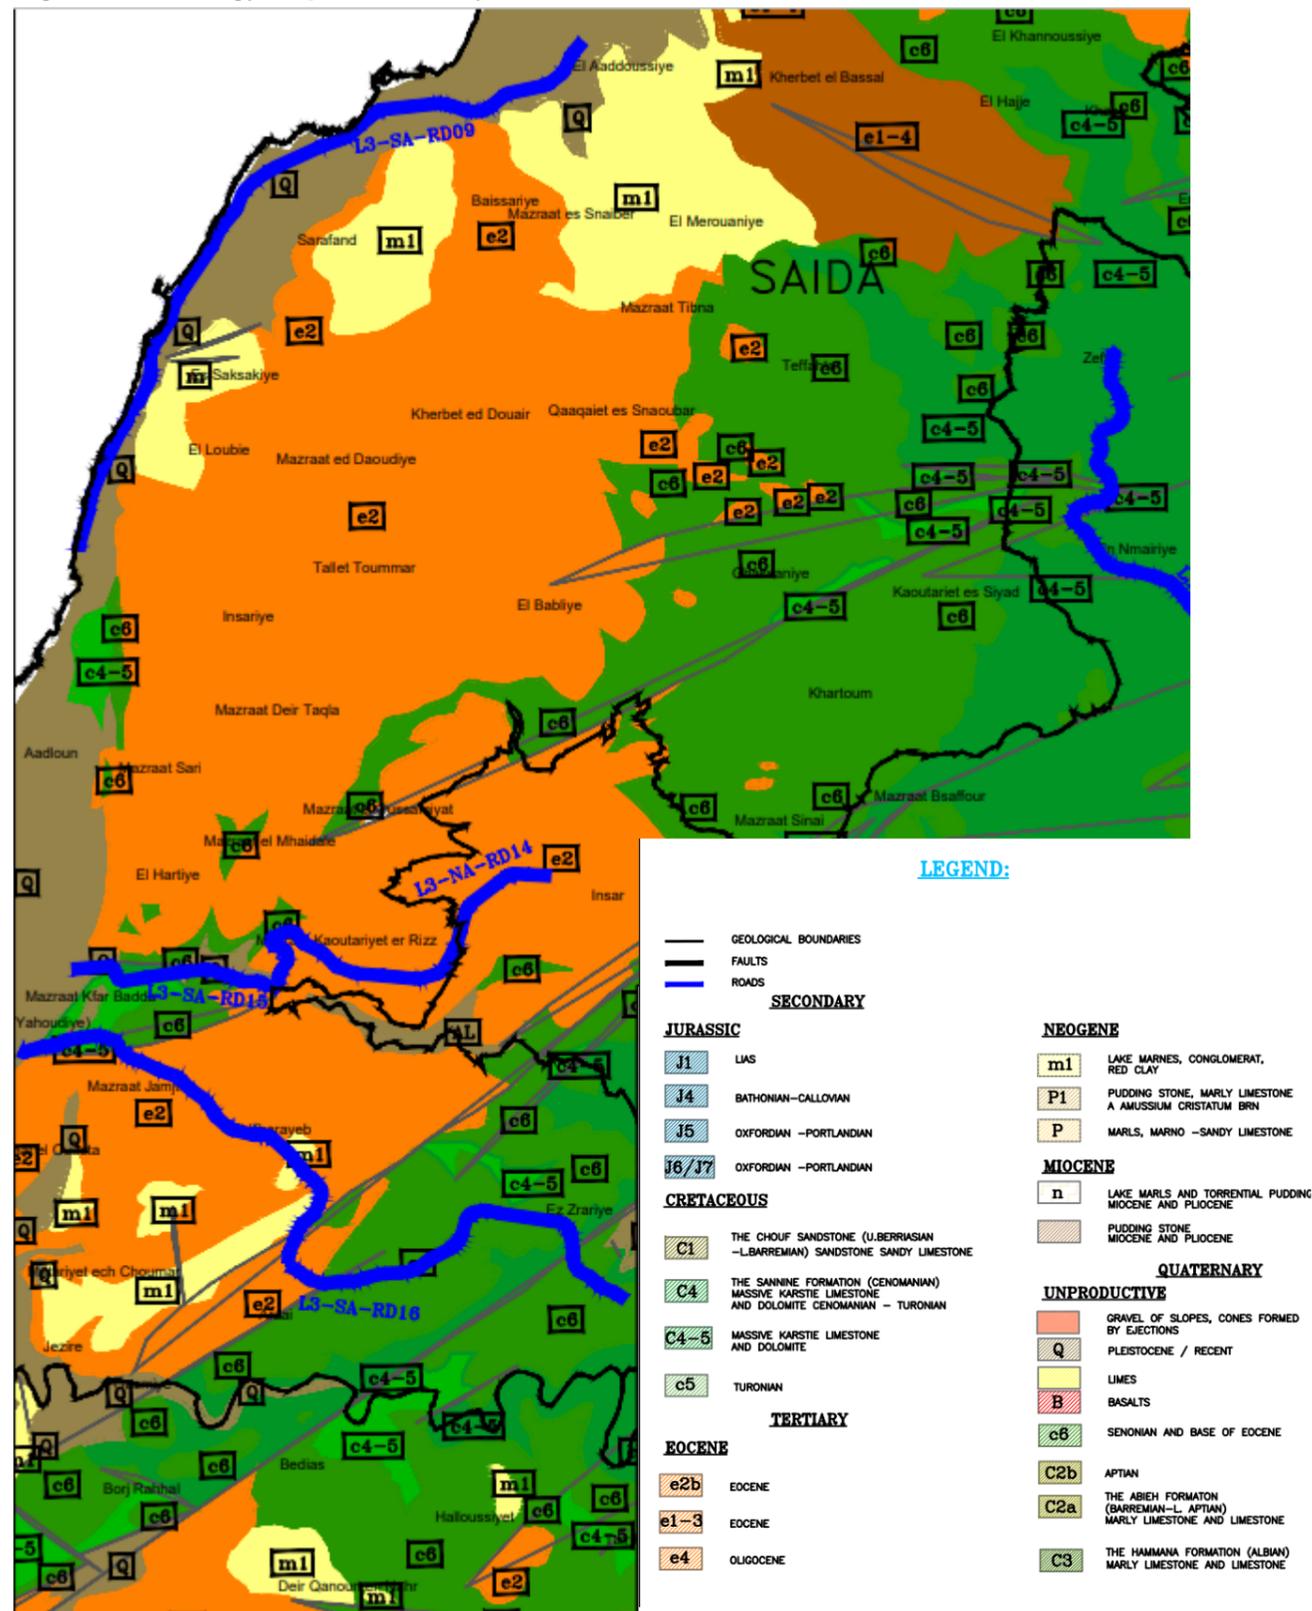
Figure 4-1 Geology Map of the Study Area

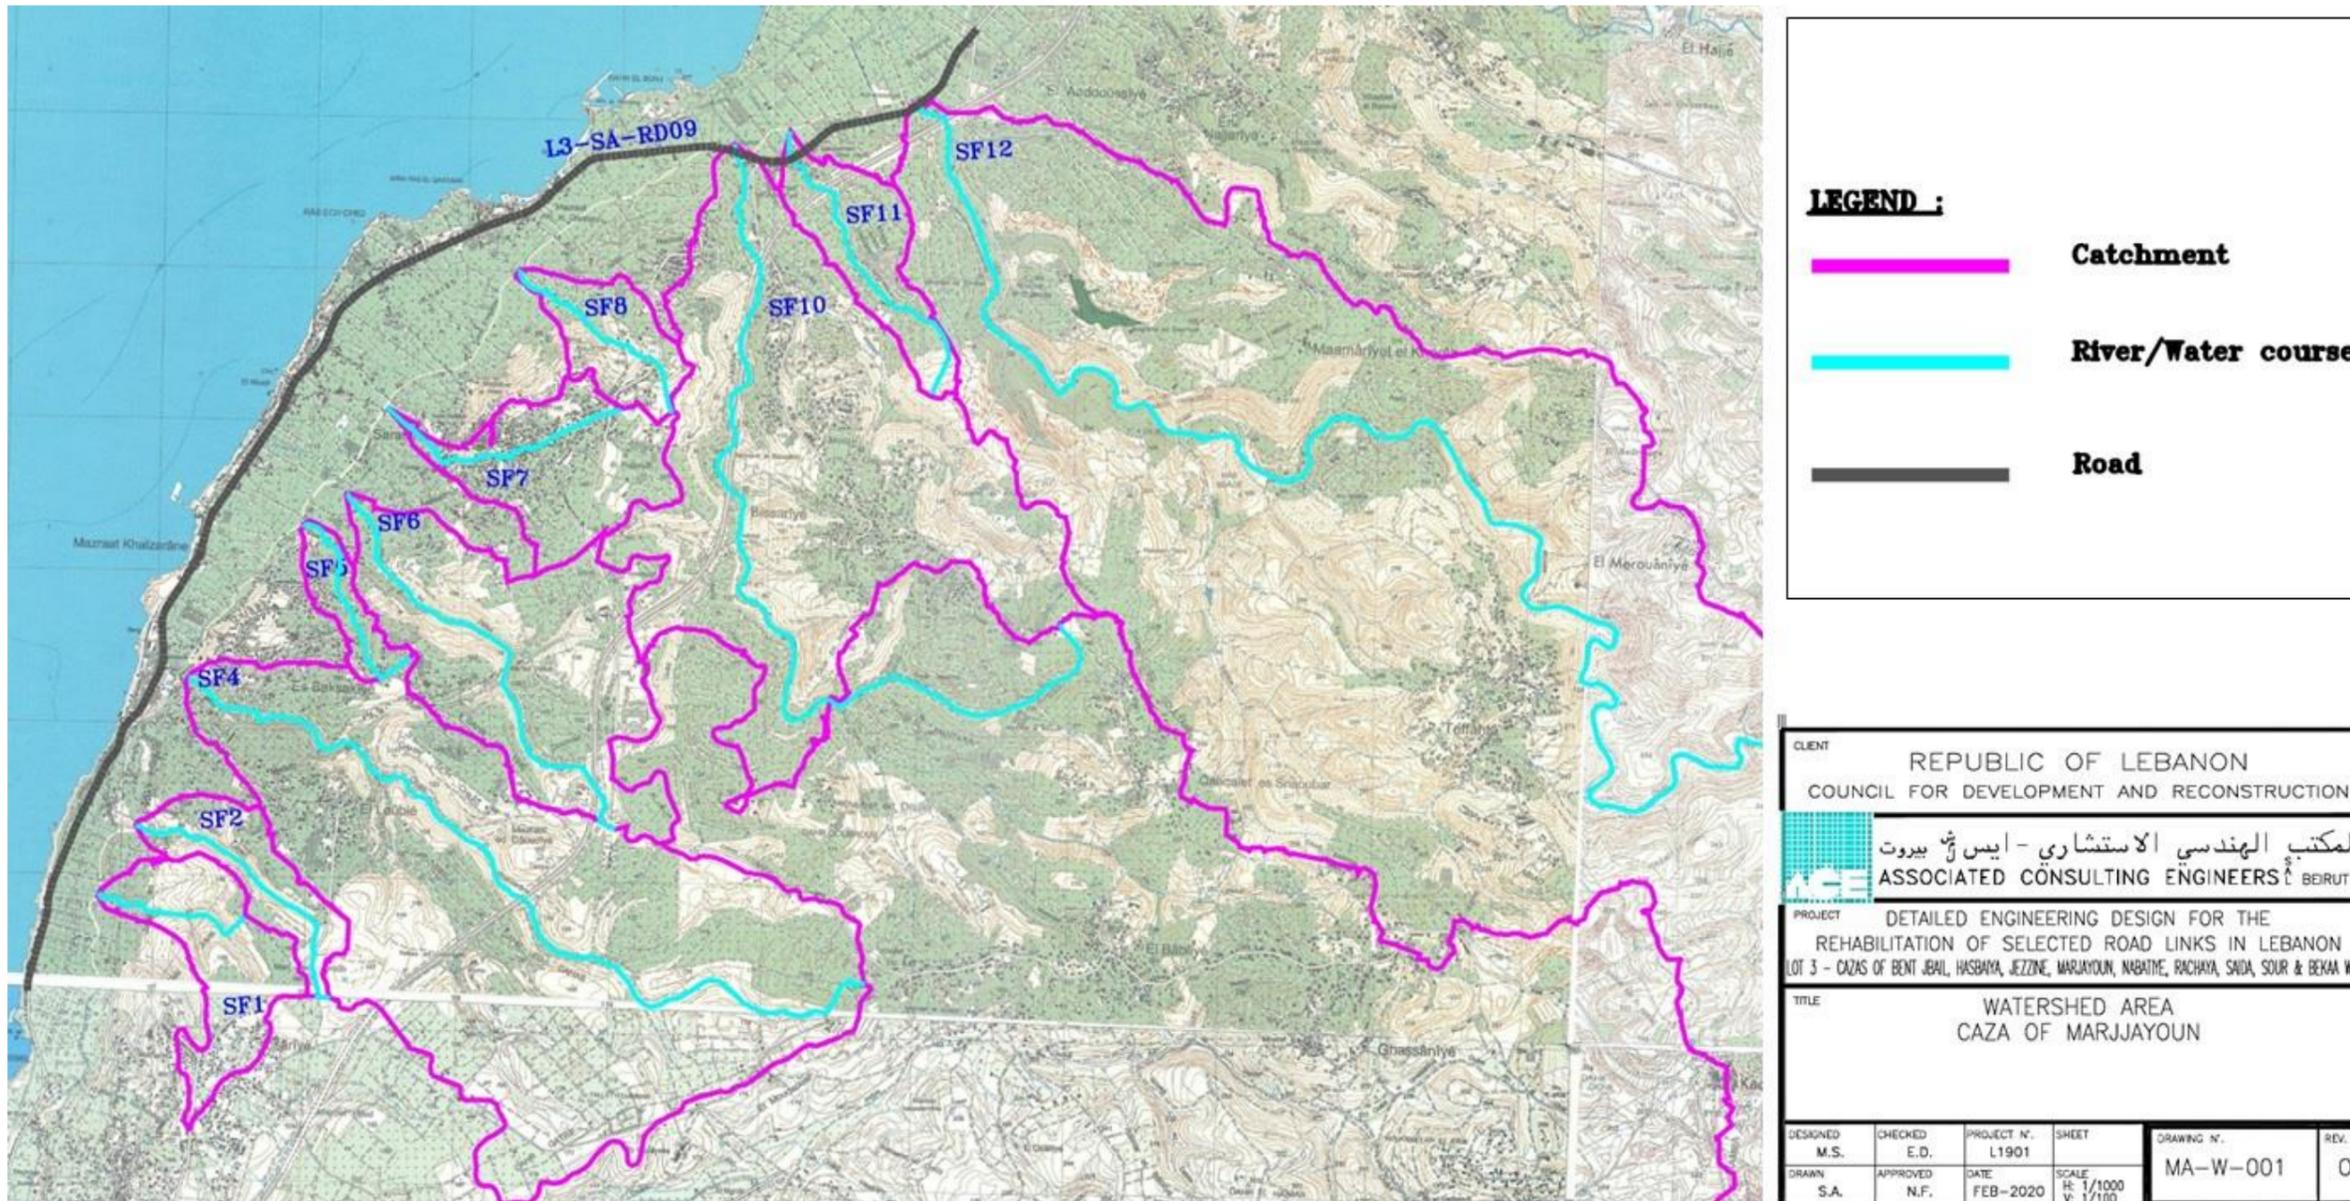
Figure 4-2: Major Rivers in Saida District and Location of Existing Project Road (L3-SA-RD09)

The Caza of Saida is surrounded by the Aouali River from the north and the Litani River from the south. The nearest river to the project area is Litani River. This river is the longest and most abundant river in Lebanon. Road L3-SA-RD15 is around 5 km away from Litani River namely at the village of Abou Al Aswad and Mazraat Khoutaryet Al Rez towards Ansar. This river is also in the area of road L3-SA-RD16 whereby the village of Mazraat Jemjem is approximately 3.5 km away. Al Kharayeb and Al Zrarieh villages of the same road (L3-SA-RD16) are around 1.5 km away from Litani River. As for road L3-SA-RD09 (Aaqaybe - Al Sarafand - Saksakiyeh – Adloun) several streams pass within the area of the road however these streams are seasonal and don't flow during the dry season (Figure 4-2 and Figure 4-3).

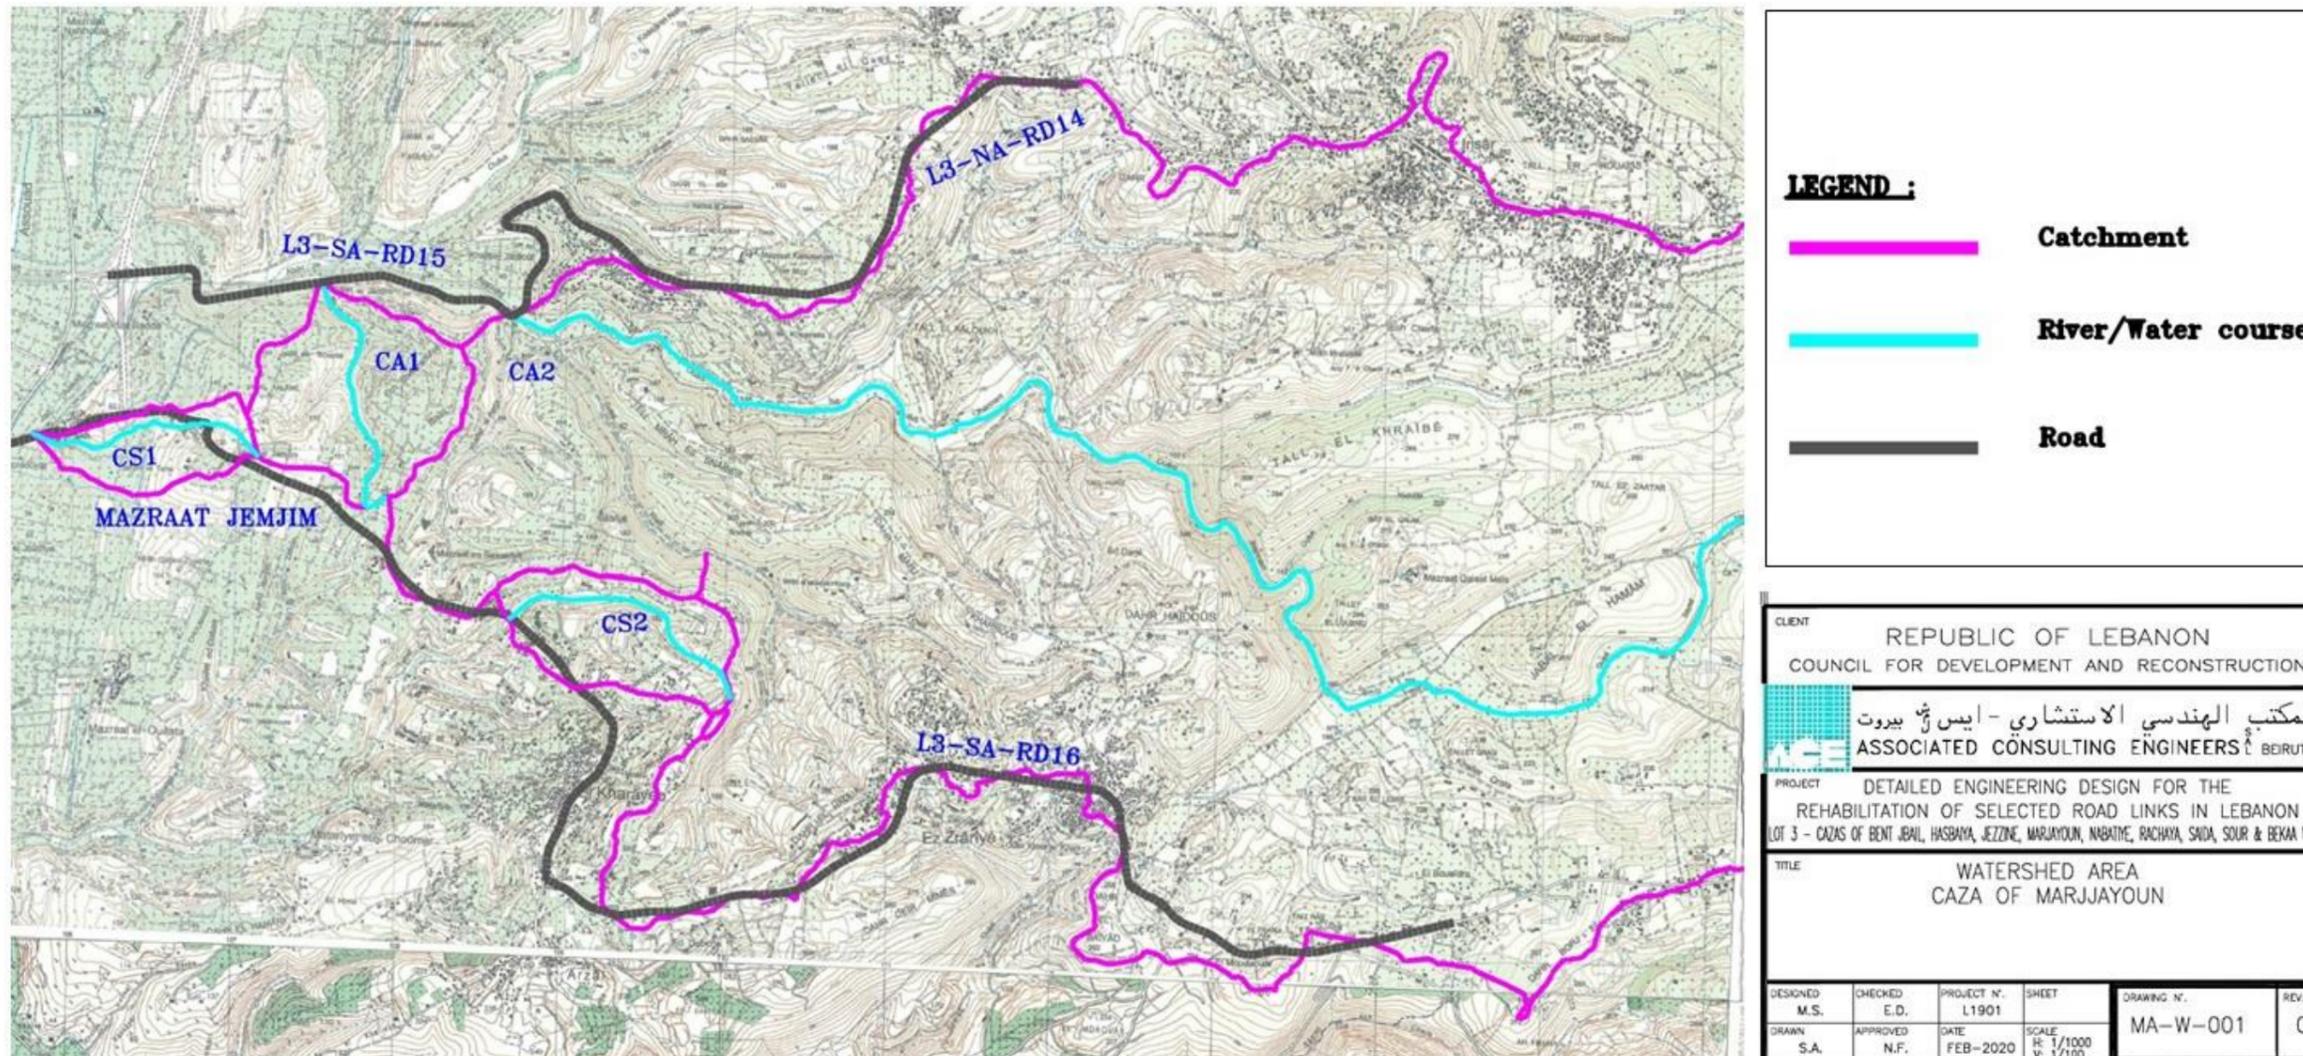
Figure 4-3: Major Rivers in Saida District and Location of Existing Project Road (L3-SA-RD15 and L3-SA-RD16)

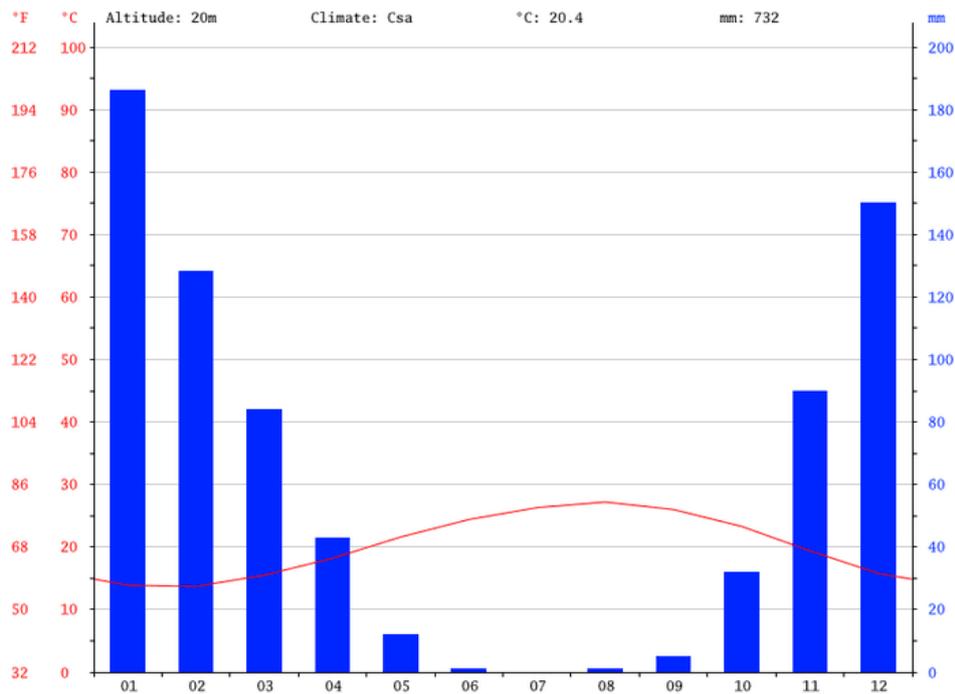
Figure 4-4: Climograph of Saida at 20 m (Historical Data between 1982-2012)

The average annual temperature in the Caza of Saida is 20.4 °C. The month of August is the warmest month with an average temperature of 27.2 °C, however, the average temperature occurring in the coldest month that is February is 13.7 °C. The driest month is July with 0 mm of precipitation. Most of the precipitation here falls in January, averaging 186 mm. However, the average annual precipitation is 732 mm (climate-data.org, 2020). The Climograph of Saida is represented in Figure 4-4.

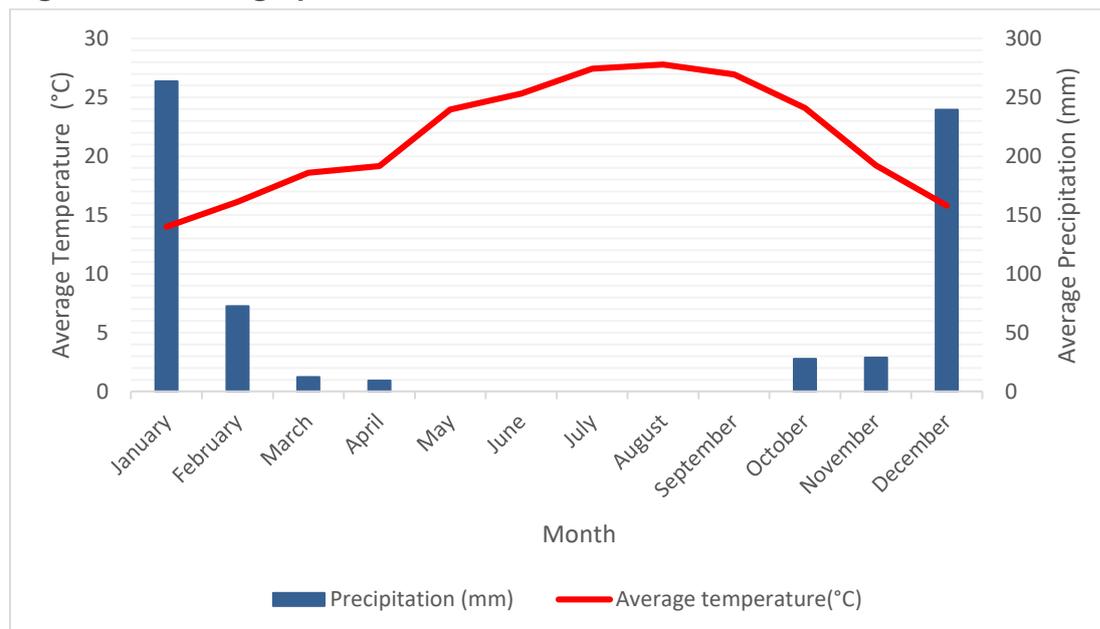
Figure 4-5: Climograph of Saida from LARI Station for the Year 2018

Additional data on climate in the area was obtained from the Lebanese Agriculture Research Institute (LARI) from its station in Saida. This data represents the average temperatures and average precipitation of the year 2018 (Figure 4-5).

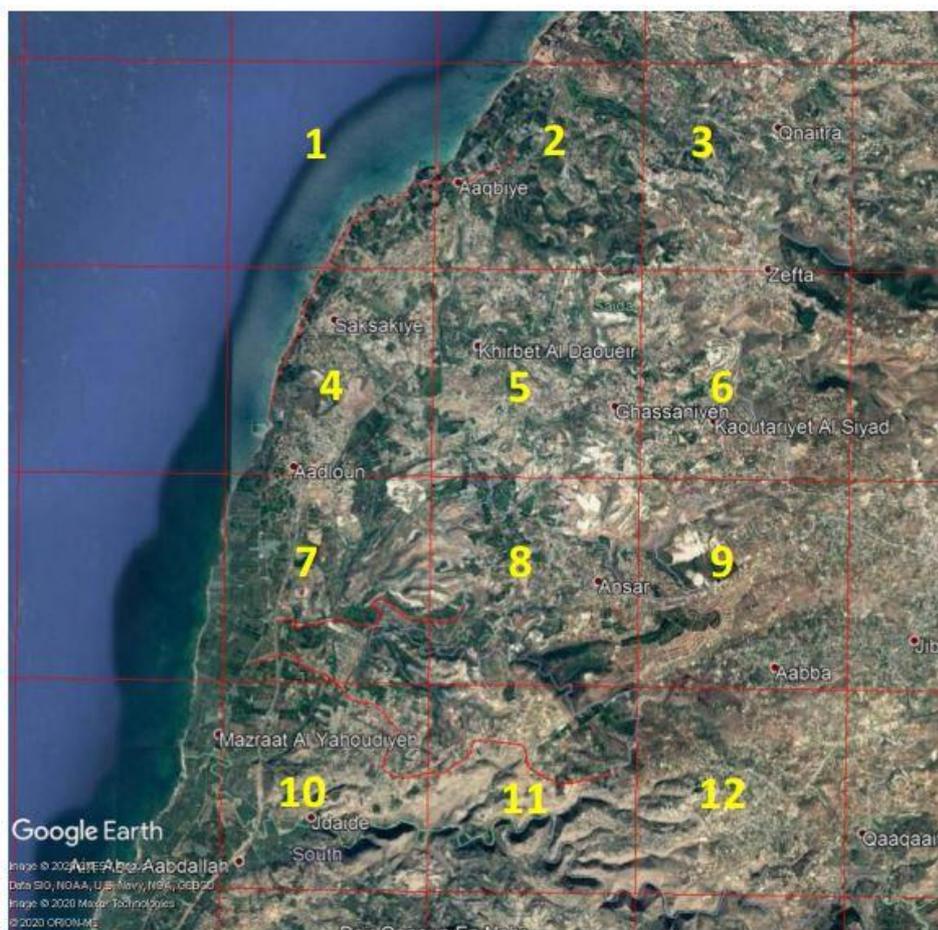
Figure 4-6: The Project Area Divided into Different Cells

Ambient air quality of the project area was requested from MOE. Data was available from the UNDP project "Environmental Resources monitoring in Lebanon" which is based at the Ministry of Environment for the year 2010. The available data is for criteria pollutants: Particulate Matter (PM), Ozone (O₃), Carbon monoxide (CO), Nitrogen dioxide (NO₂), Sulfur dioxide (SO₂). The project area was divided into different cells (Figure 4-6) and the data of the annual background average concentrations in µg/m³ was obtained. Table 4-3 shows the detected annual concentrations, the national limit values dictated in Decision 52/1 dated 1996 and WHO Guidelines. For some parameters, the obtained data on air quality is the annual concentrations while some of the standards are available only for intervals of 8 hours or 24 hours.
