Republic of Lebanon - Council for Development and Reconstruction

Road and Employment Project (REP)

Environmental and Social Management Plan (ESMP)
Final

LOT 2: Caza of Baabda

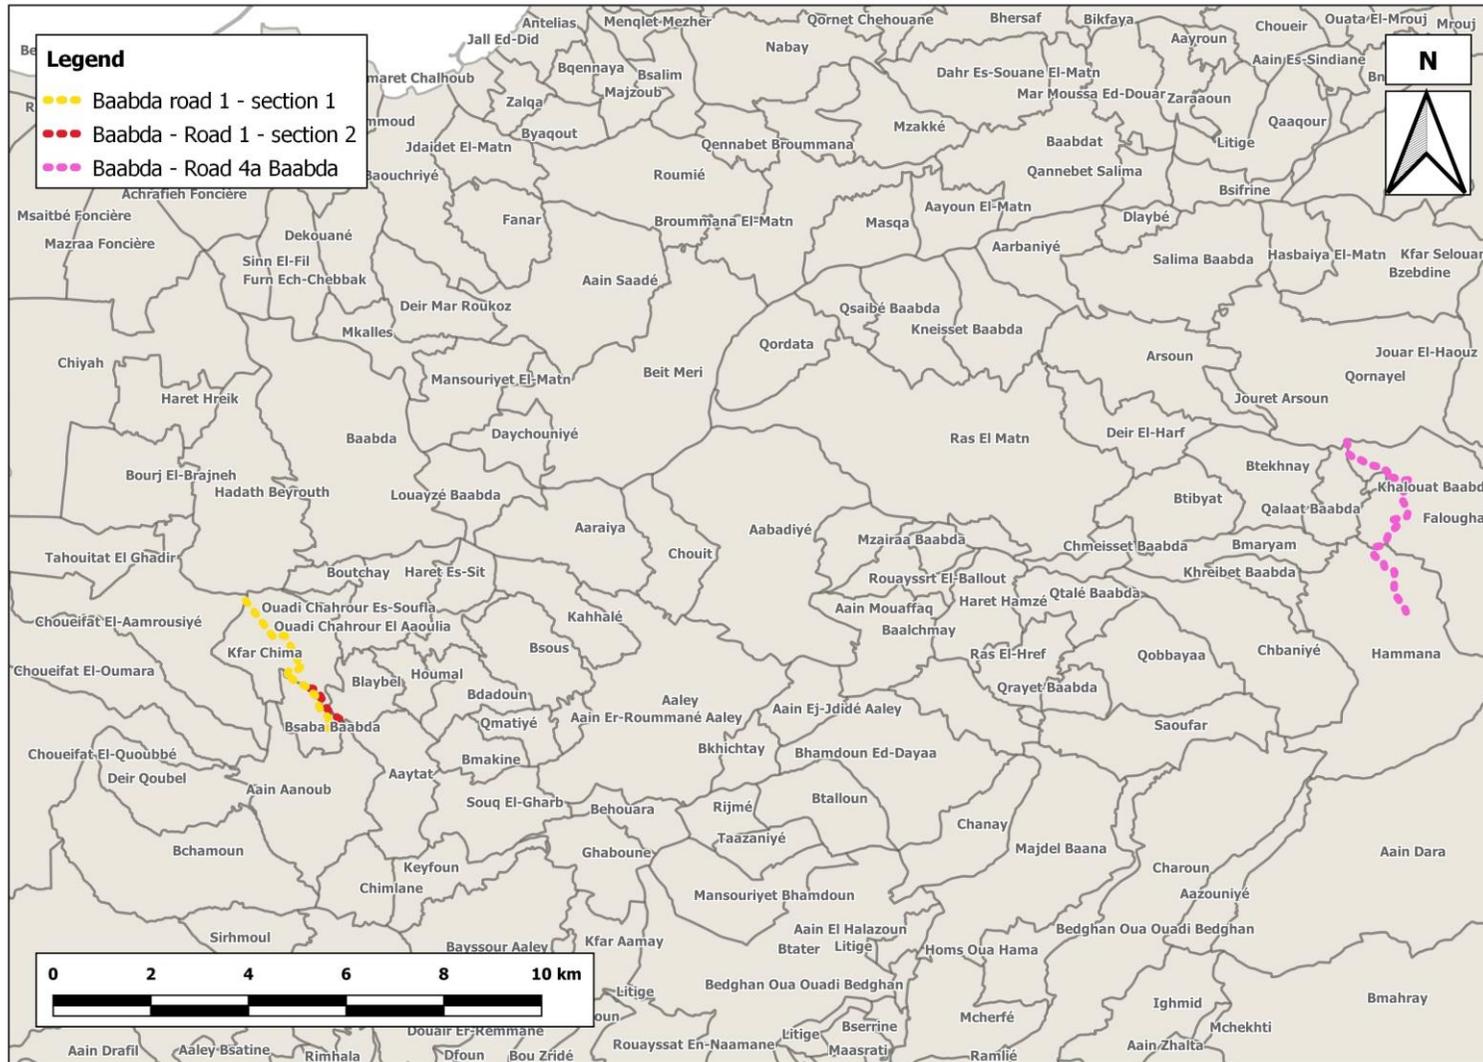
Figure 1-1 Lot 2– Roads Key Plan Drawing (Baabda roads)

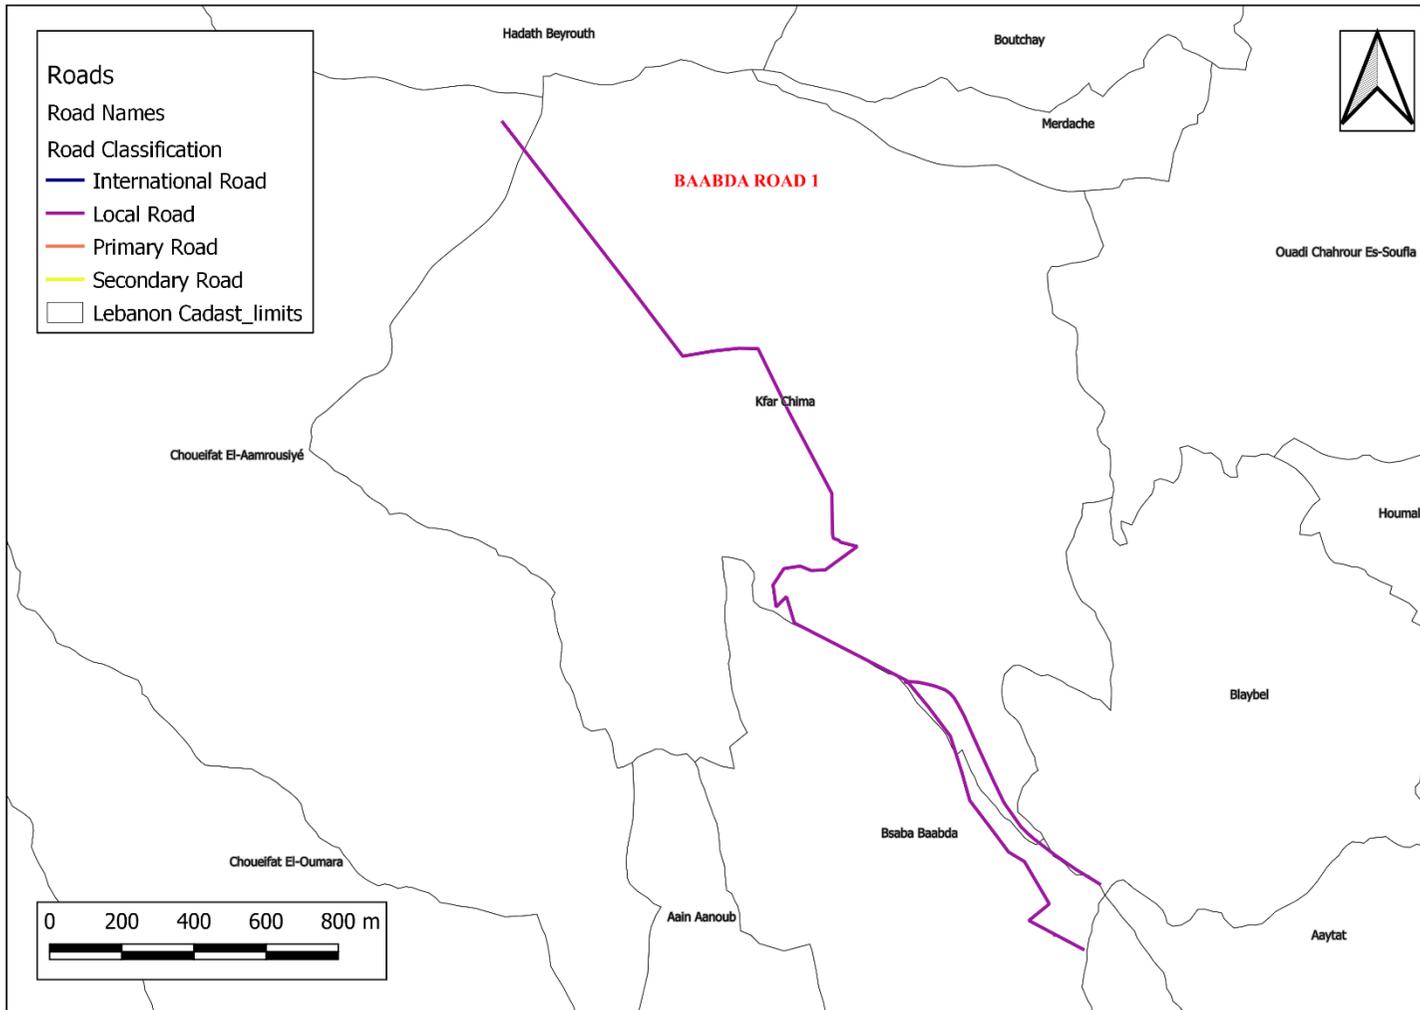
Figure 3-1 Classification of road segments of Baabda R1

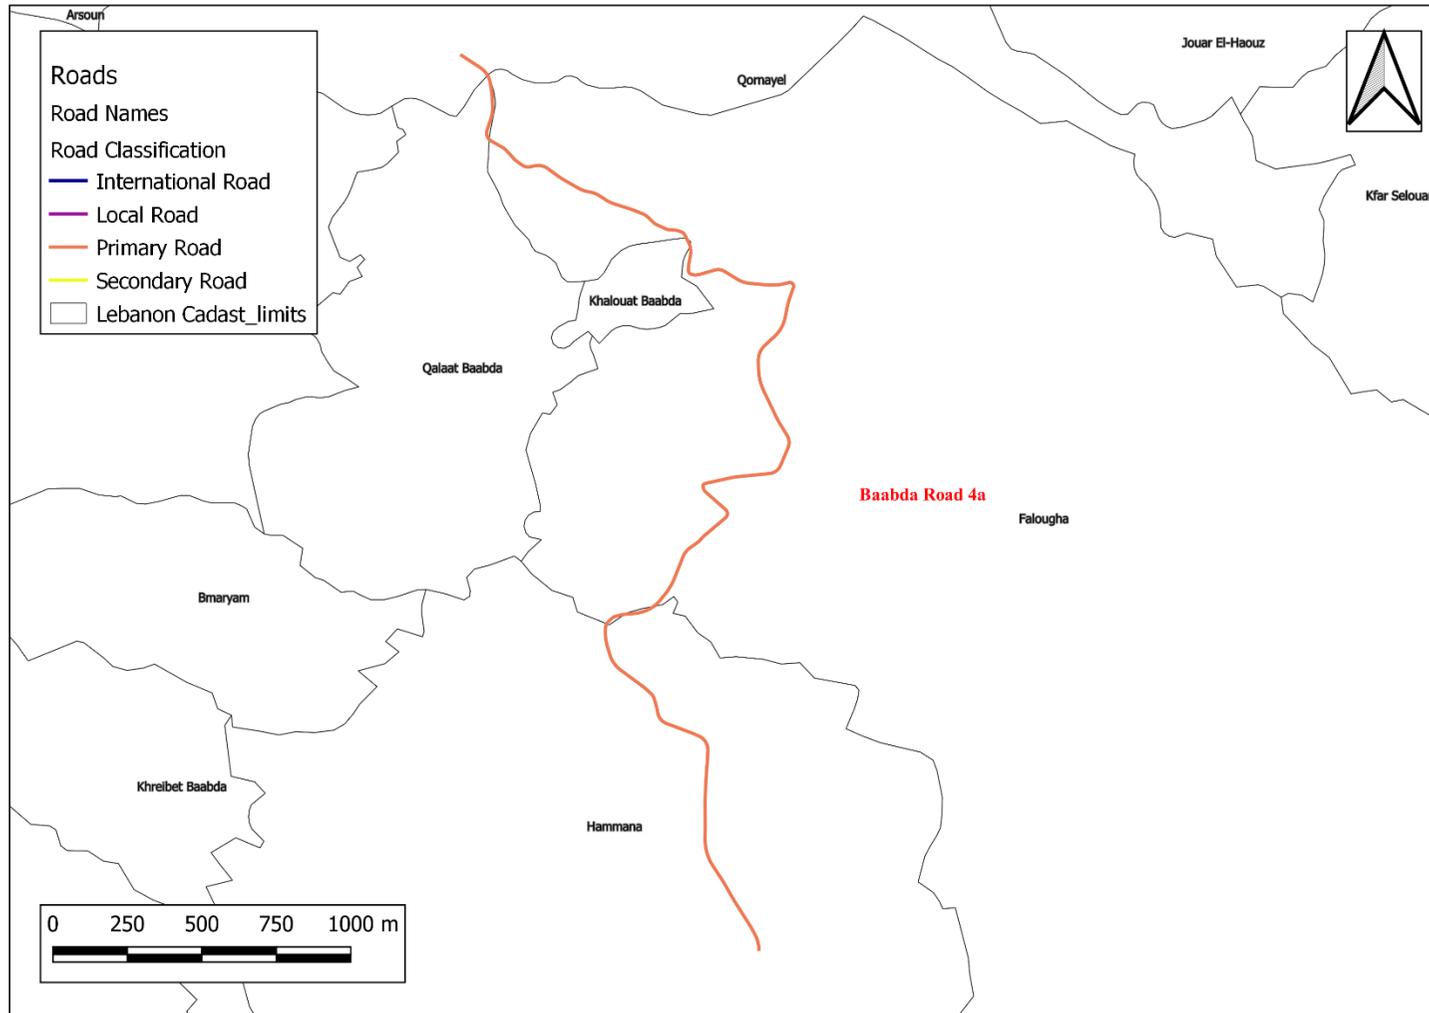
Figure 3-2 Classification of Baabda R4a

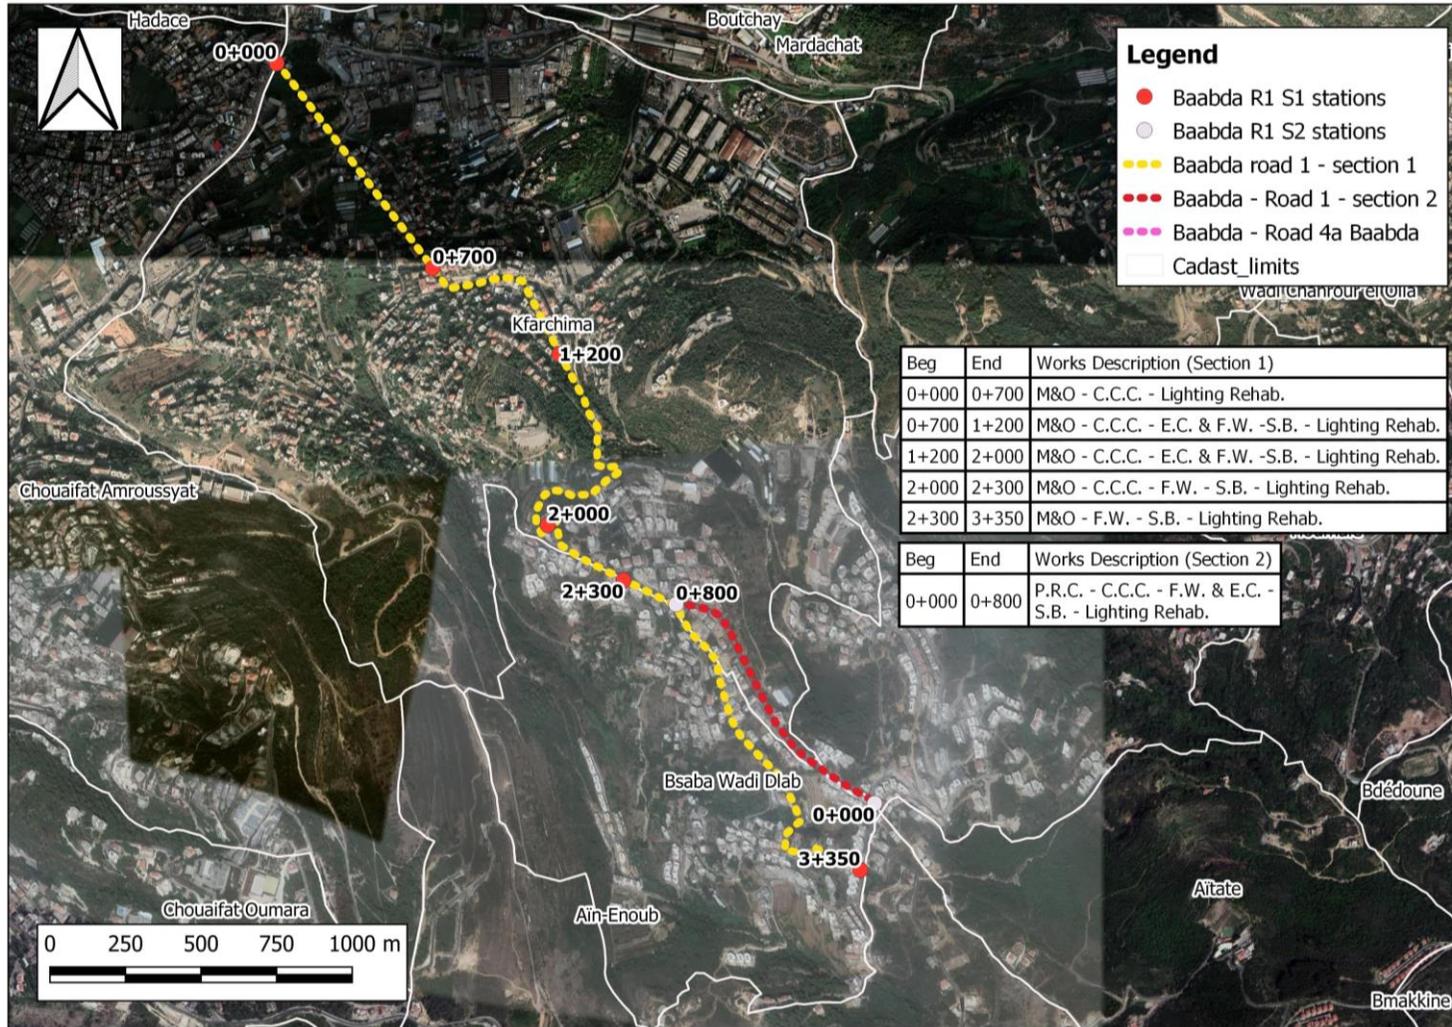
Figure 3-3 Work stations with road rehabilitation activities along Baabda R1 alignments

In summary, a lack of safety barriers and footwalls is observed in most of section 1 and all throughout section 2. The need to provide footwalls at some locations is a must. The absence of signing and marking, in addition to a need for lighting and drainage rehabilitation, is well noticed all over the road.

As for pavement conditions, section 1 requires milling and overlay and section 2 requires pavement reconstruction all throughout their lengths.

Table A Baabda R1 existing acoustic conditions (location of stations shown in Figure 3-3)

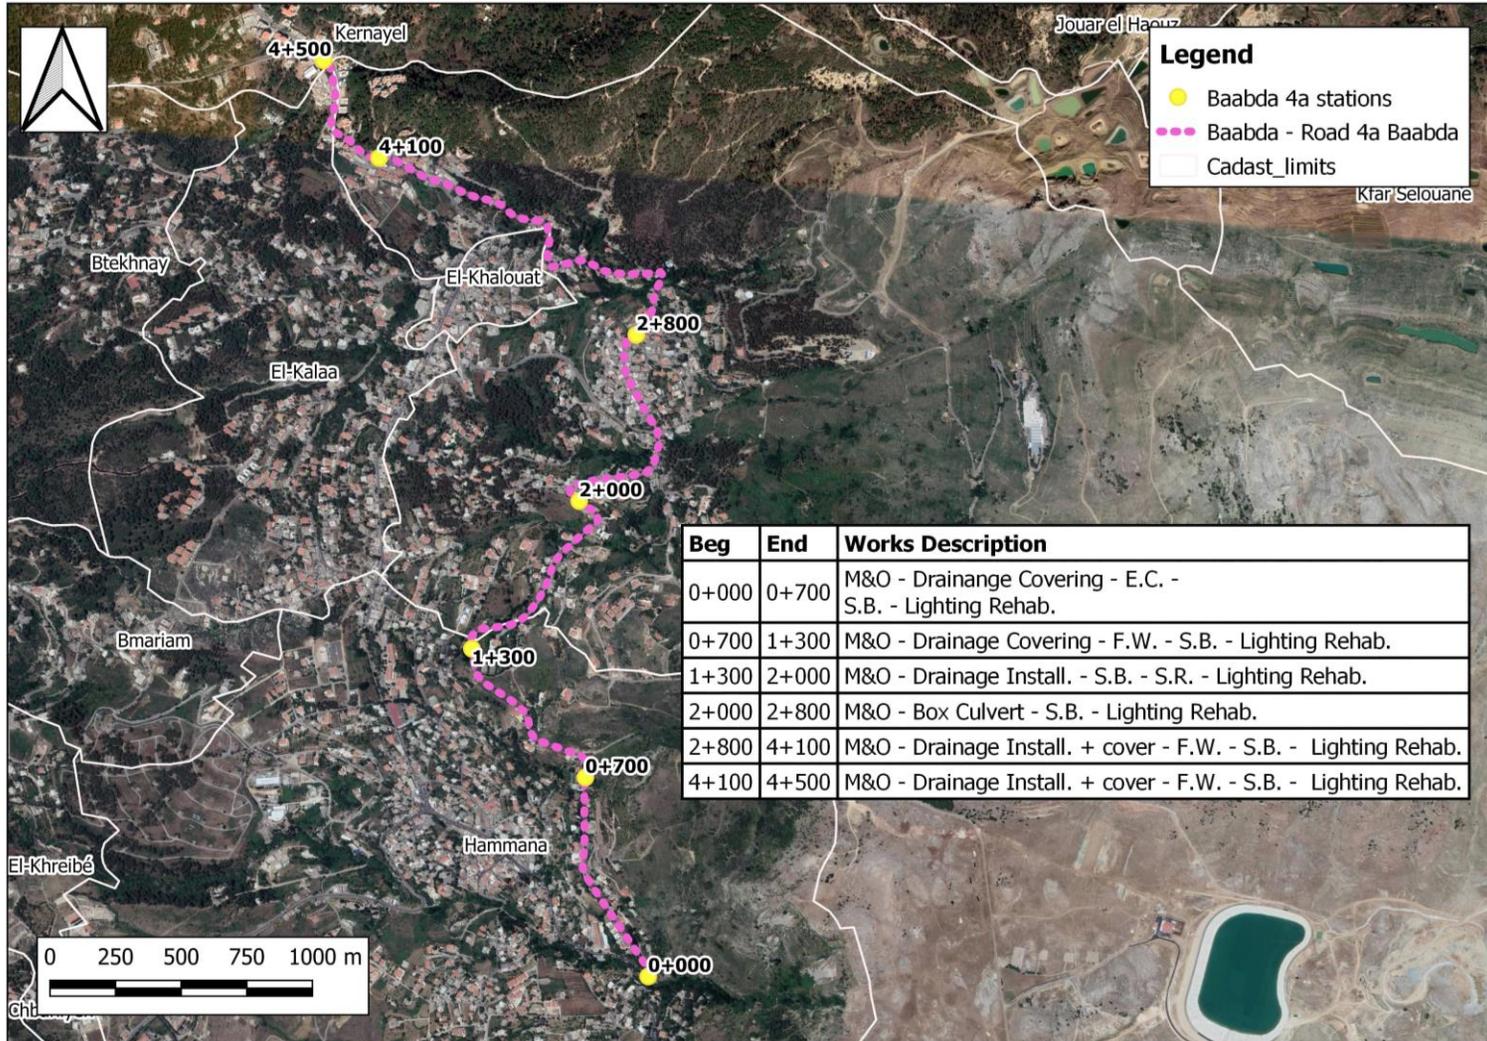
Figure 3-4 Work stations with road rehabilitation activities along Baabda R4a alignment

In summary, the sight distance in the horizontal alignment is not respected at some curve locations. A lack of safety barriers is observed throughout, namely between station 0+700 and station 1+300, where the need to provide footwalls on the cut side is urgent. The absence of signing and marking all over the road is well noticed. Lighting and drainage rehabilitation are required all throughout the road's length.

As for pavement condition, milling and overlay is required throughout the road's length.

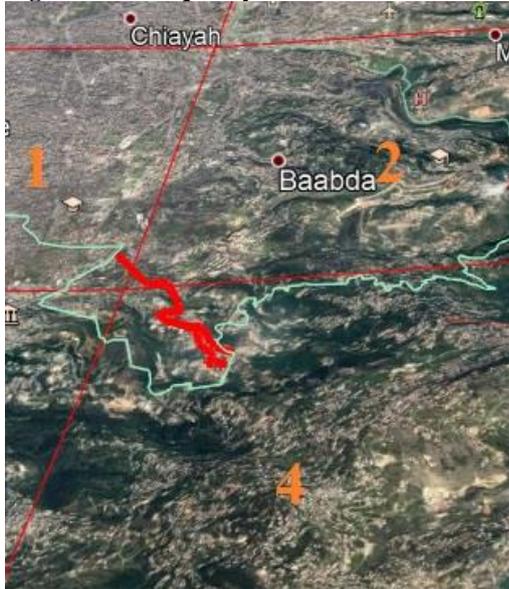
Figure 4-1 Air quality cells for Baabda R1 falling in cells 1, 2, and 4.

Table 4-5 Ambient air quality in $\mu\text{g}/\text{m}^3$ for Baabda R1

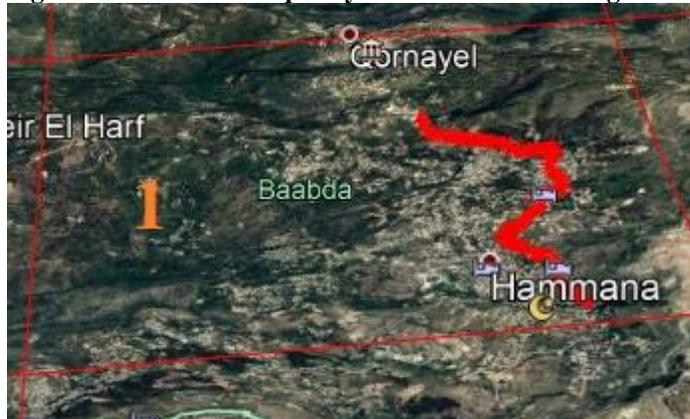
Figure 4-2 Ambient air quality cells of Baabda 4a alignment

Table 4-6 Ambient air quality in $\mu\text{g}/\text{m}^3$ for Baabda R4a

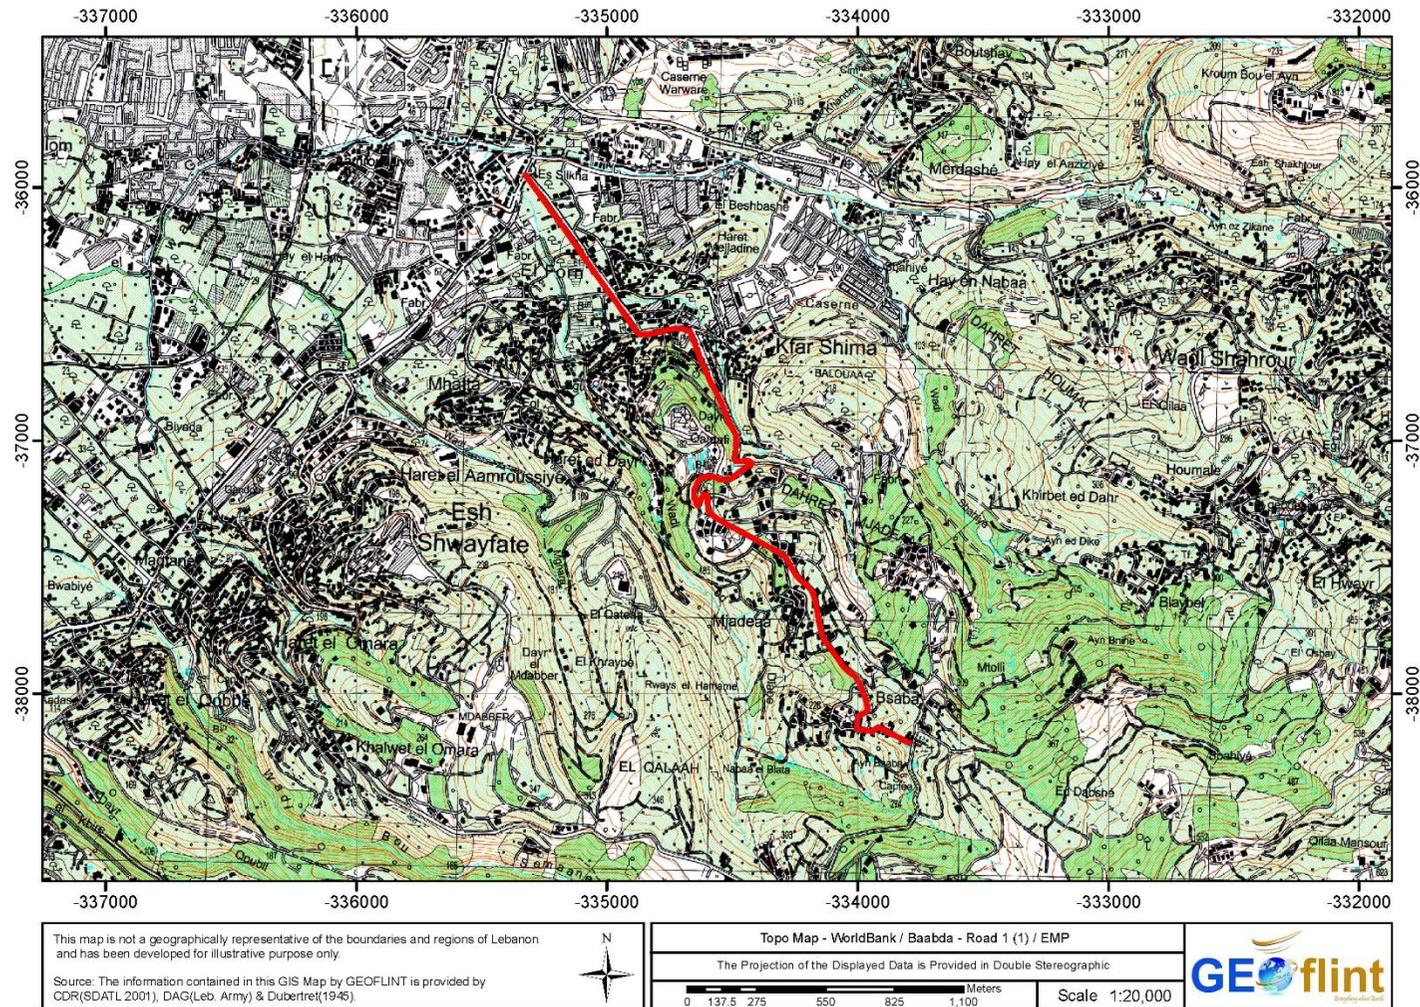
Figure A Elevation contour lines for Baabda R1 section 1 and its surrounding

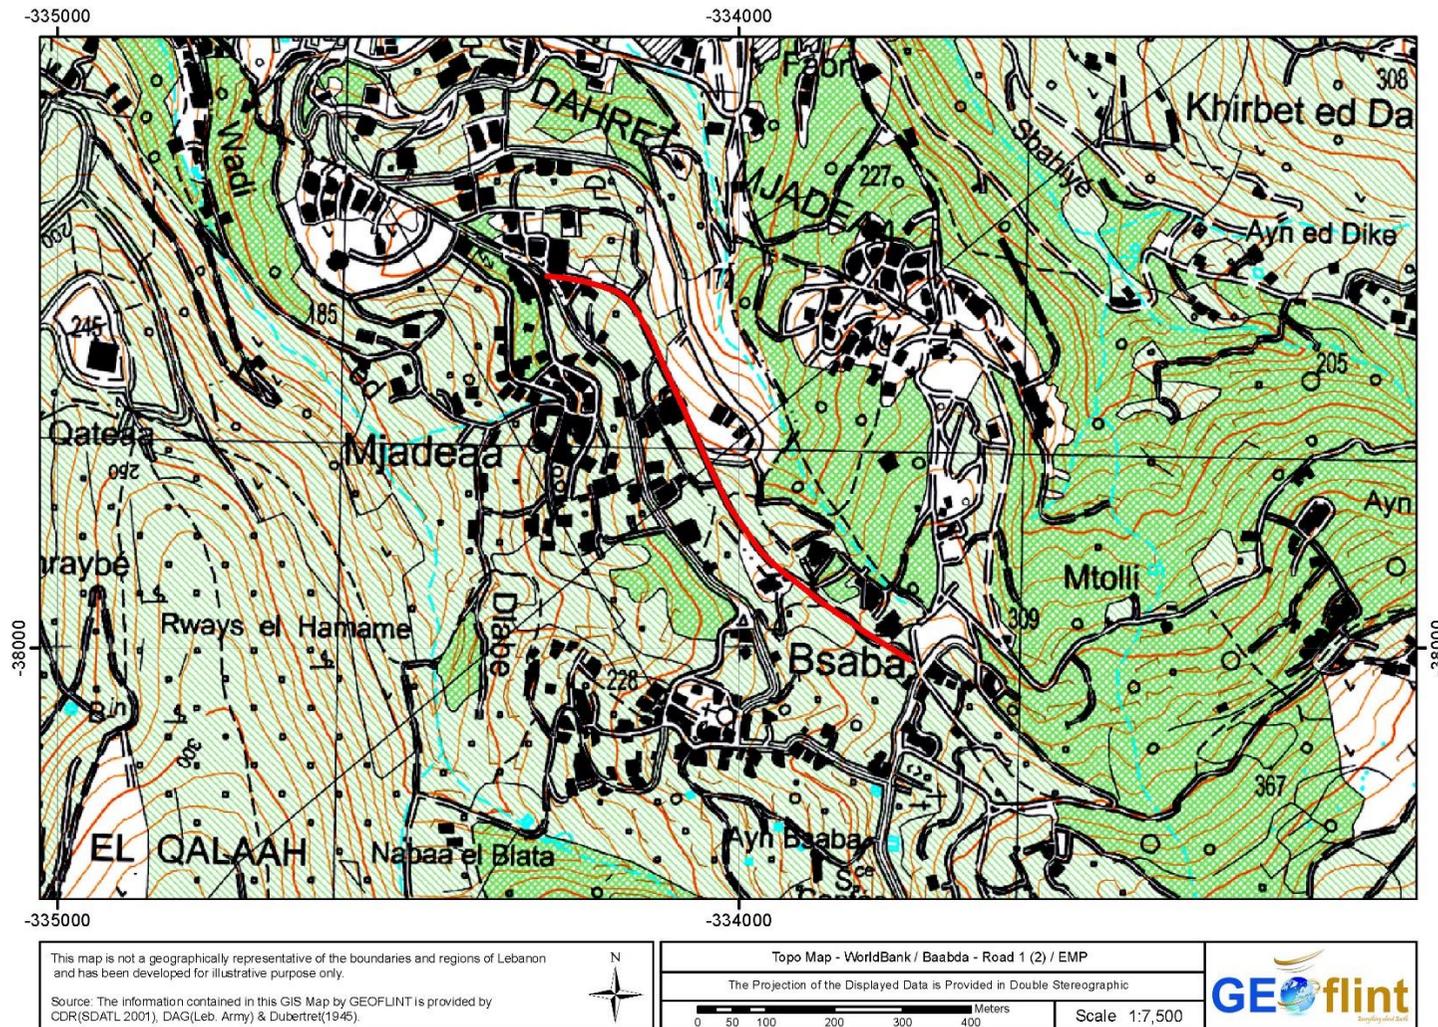
Figure B Elevation contour lines for Baabda R1 section 2 and its surrounding

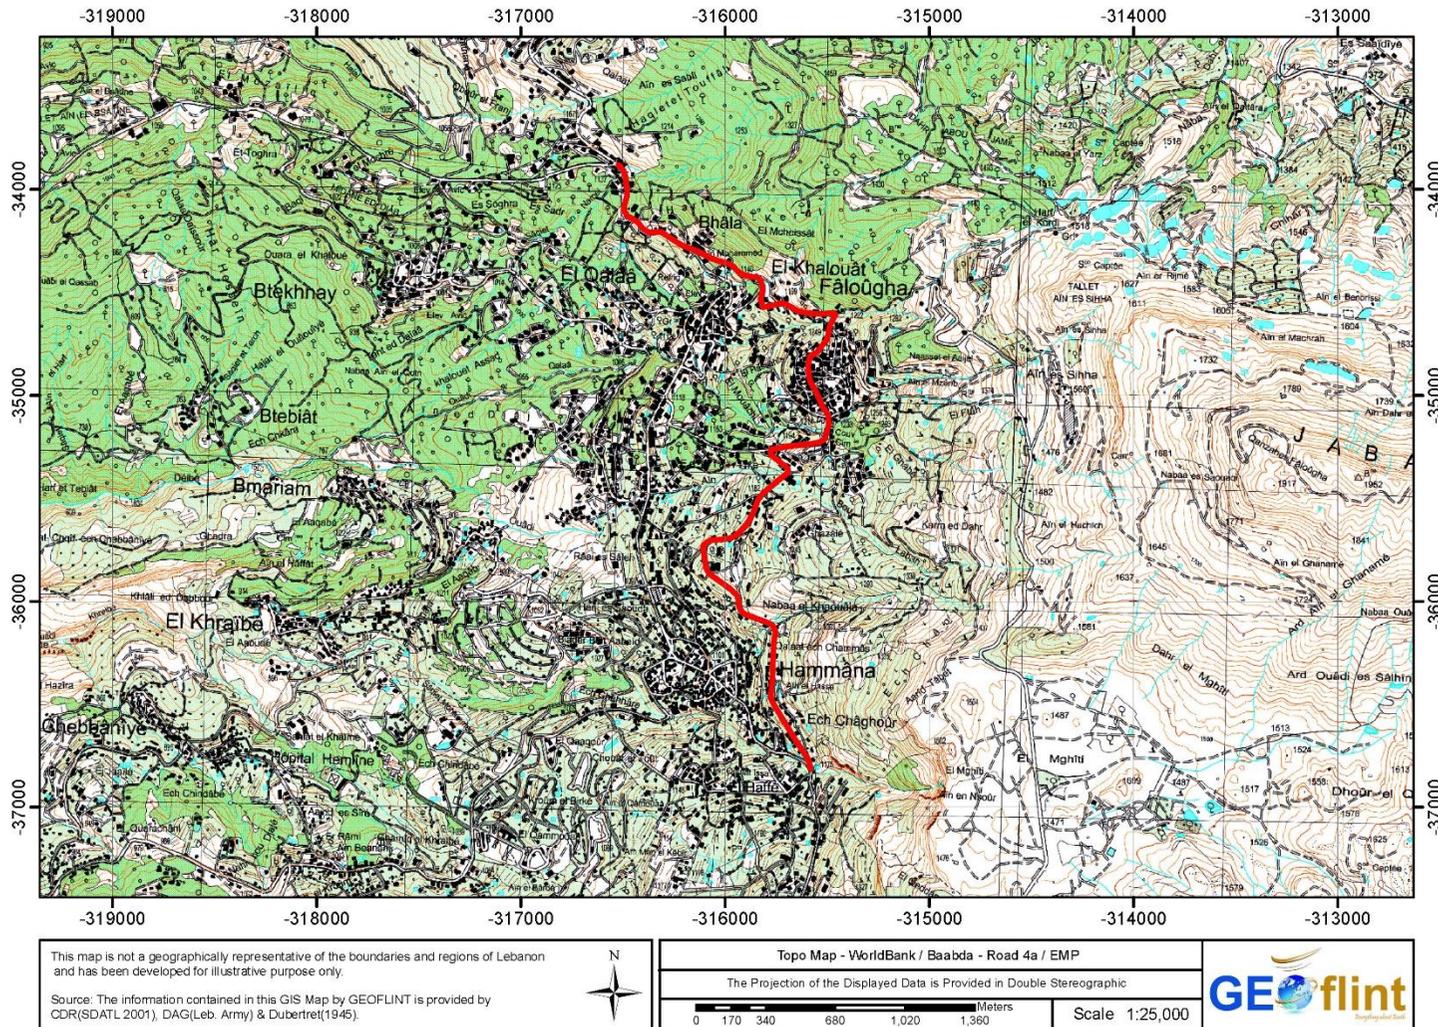
Figure C Elevation contour lines for Baabda R4a and its surrounding

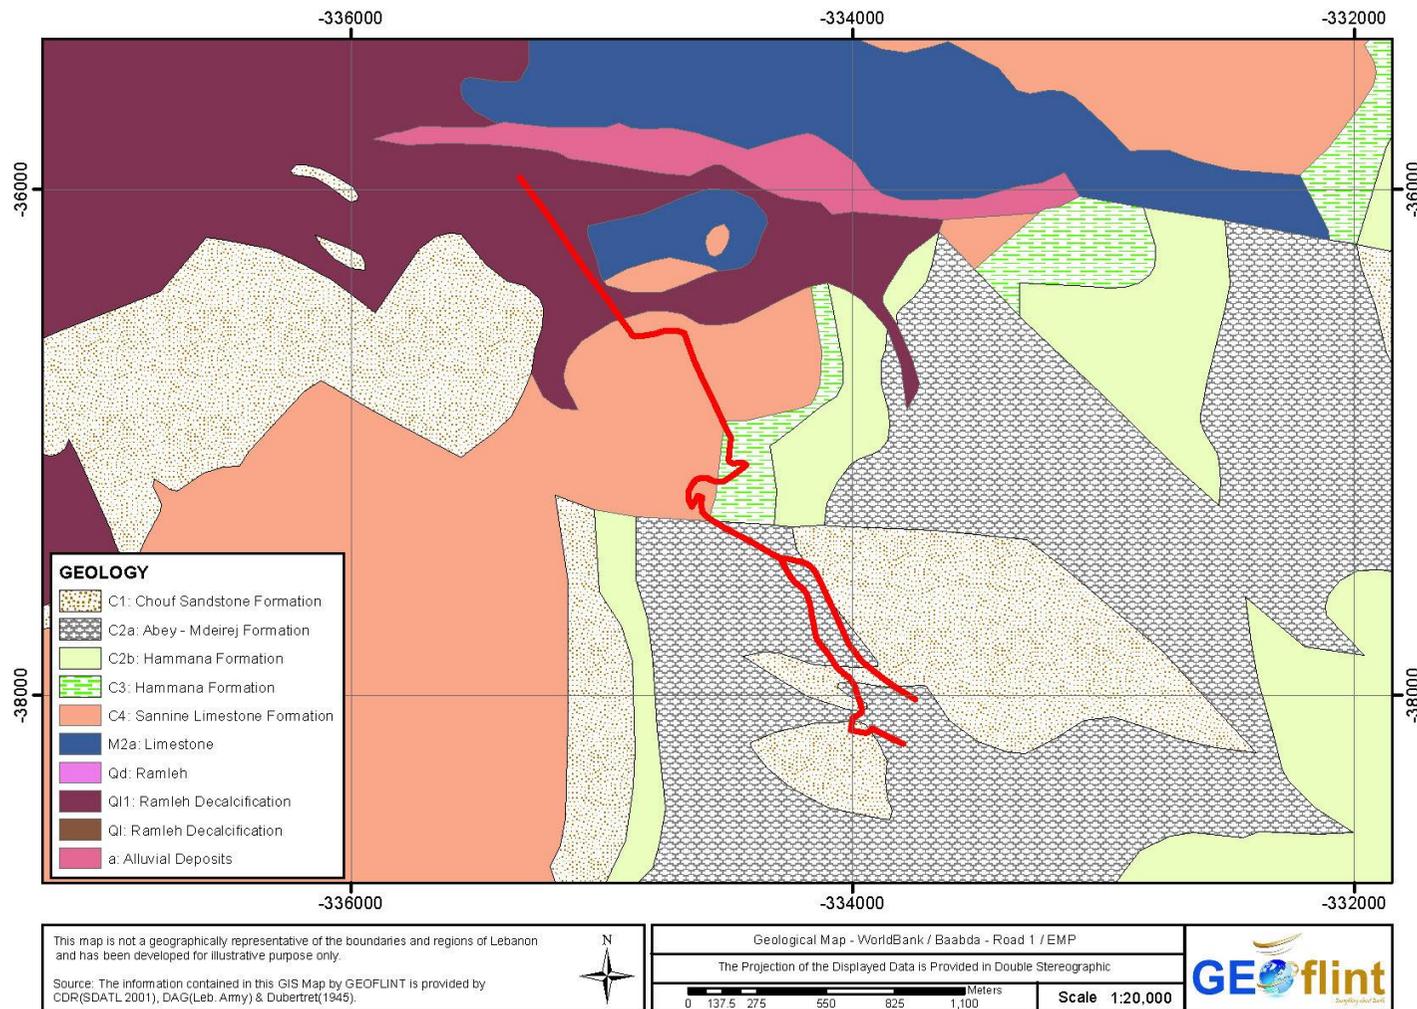
Figure D General Geological map of Baabda R1 and its surrounding (surface outcrops)

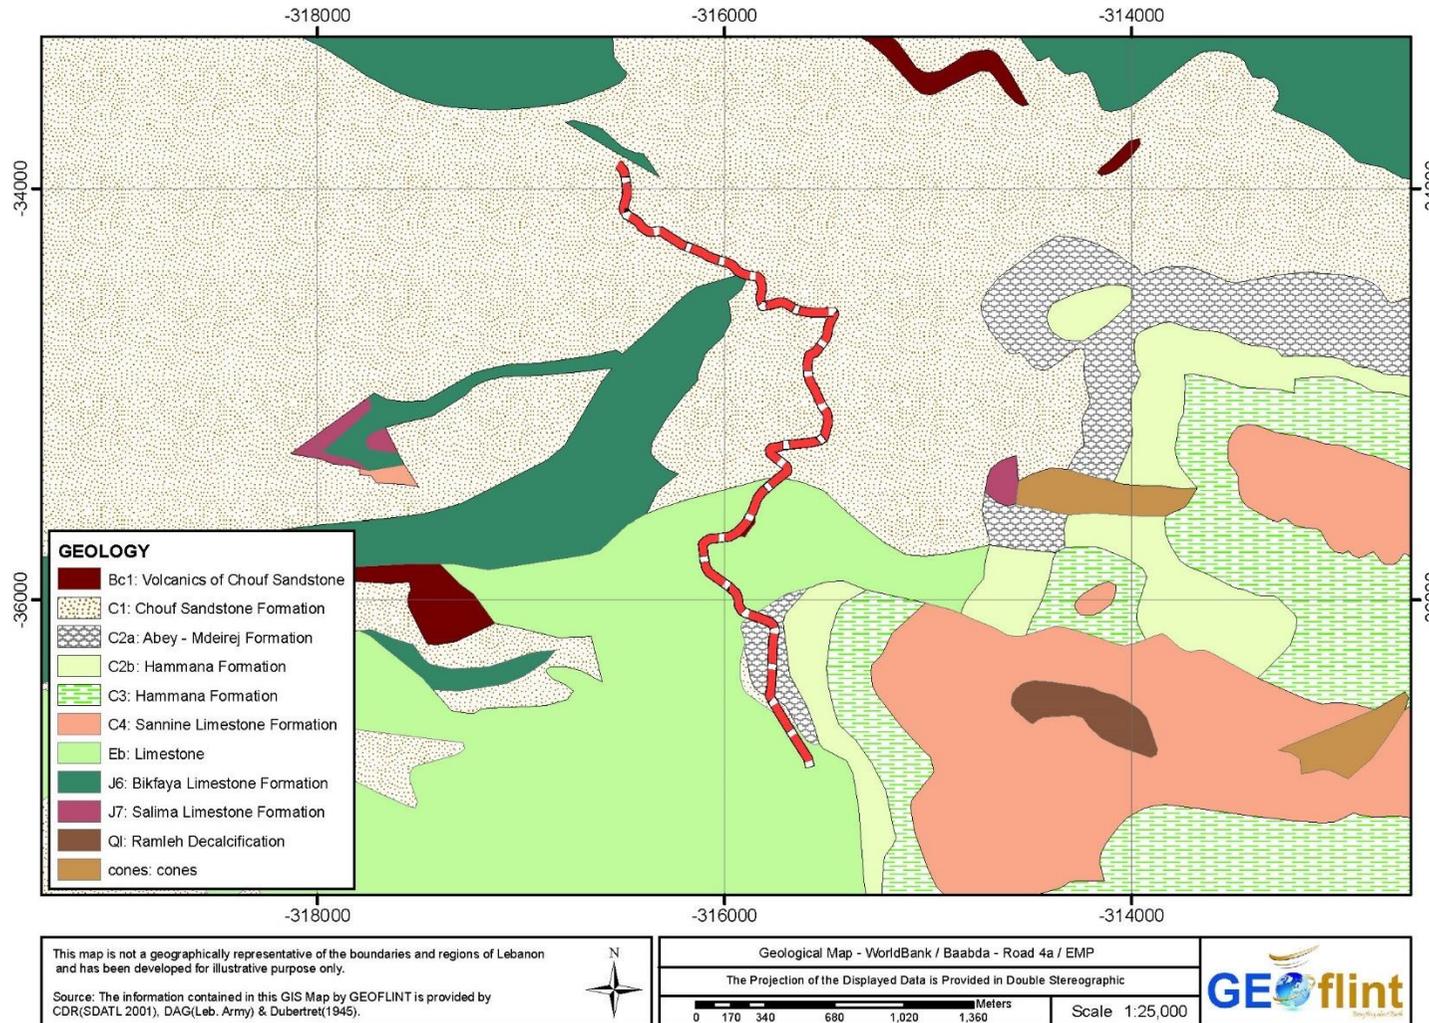
Figure E General Geological map of Baabda R4a and its surrounding (surface outcrops)

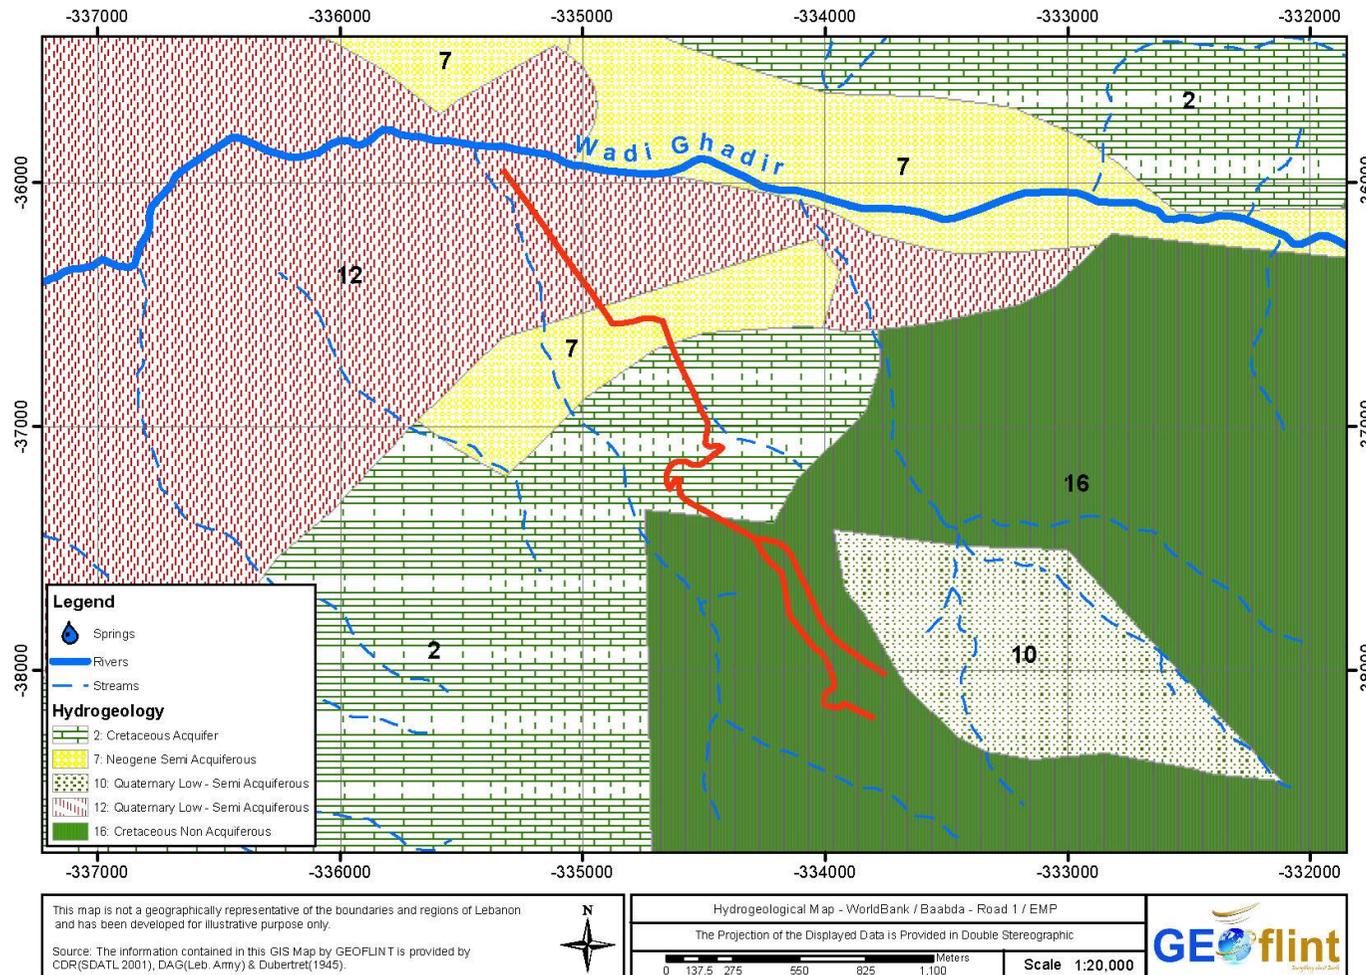
Figure F Hydrogeological map of Baabda R1 and its surrounding (map showing water potential of the subsurface). Refer to Table 4-4 for description of hydrogeology classes.

- Aquifers in the area are Sannine Limestone (C₄), Mdeirej Limestone, and Lower Aptian (C_{2a2}). The limestone formation forms a main part to the study area and is the most important karstic system in the study area characterized by a significant amount of groundwater flowing in channels, faults and fractures. These fractures include solution joints, solution pits, lapiaz, grooves and sinkholes. Cavities in the rocks are often filled with calcite and cave deposits.

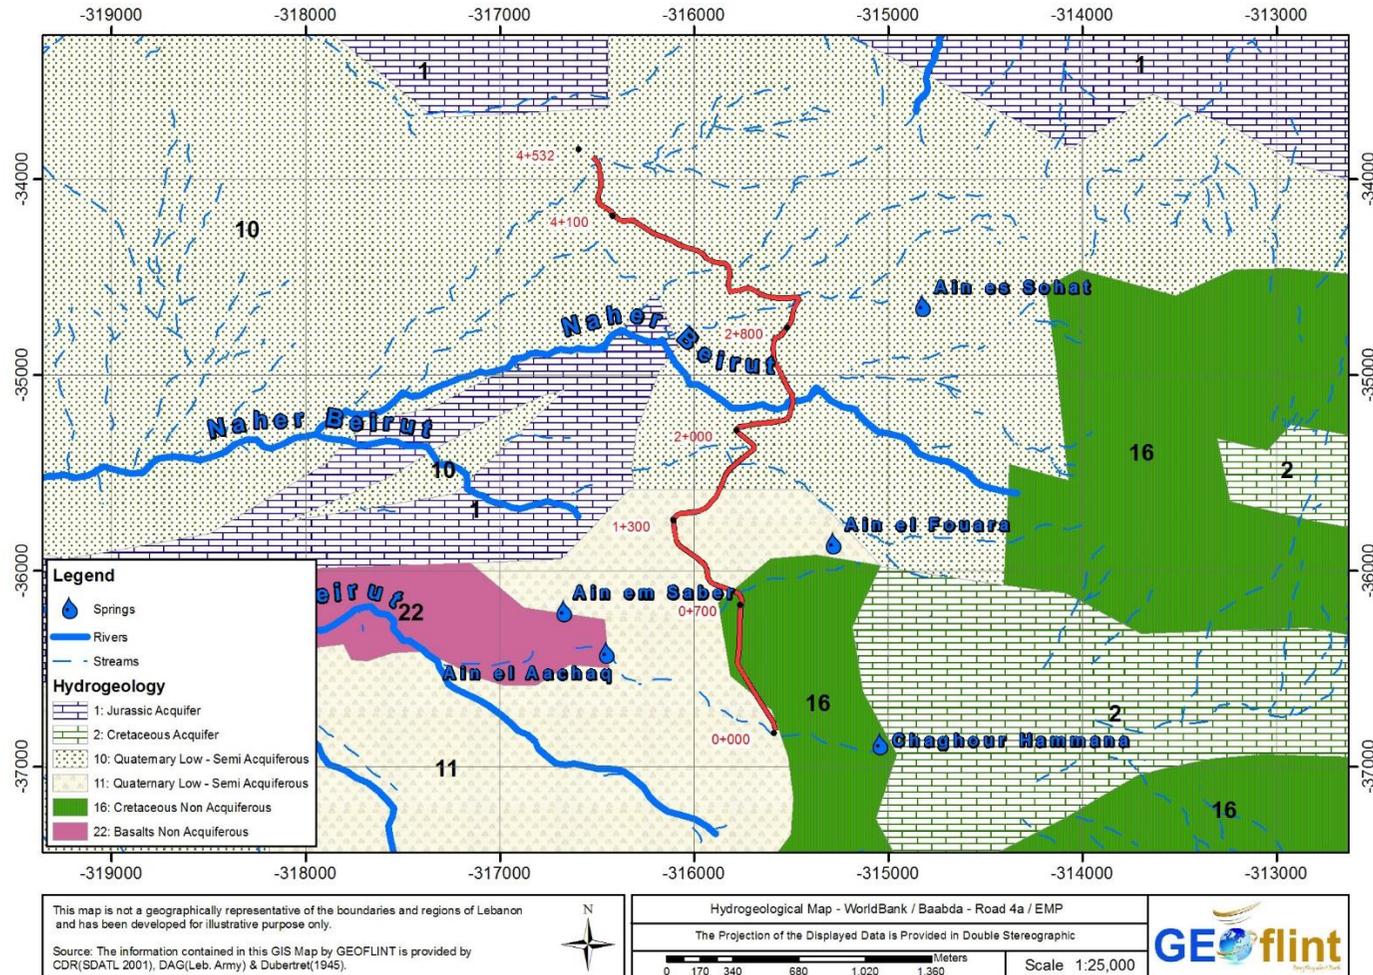
Figure G Hydrogeological map of Baabda R4a and its surrounding (map showing water potential of the subsurface). Refer to Table 4-4 for description of hydrogeology classes. Work stations are shown along the road alignment.

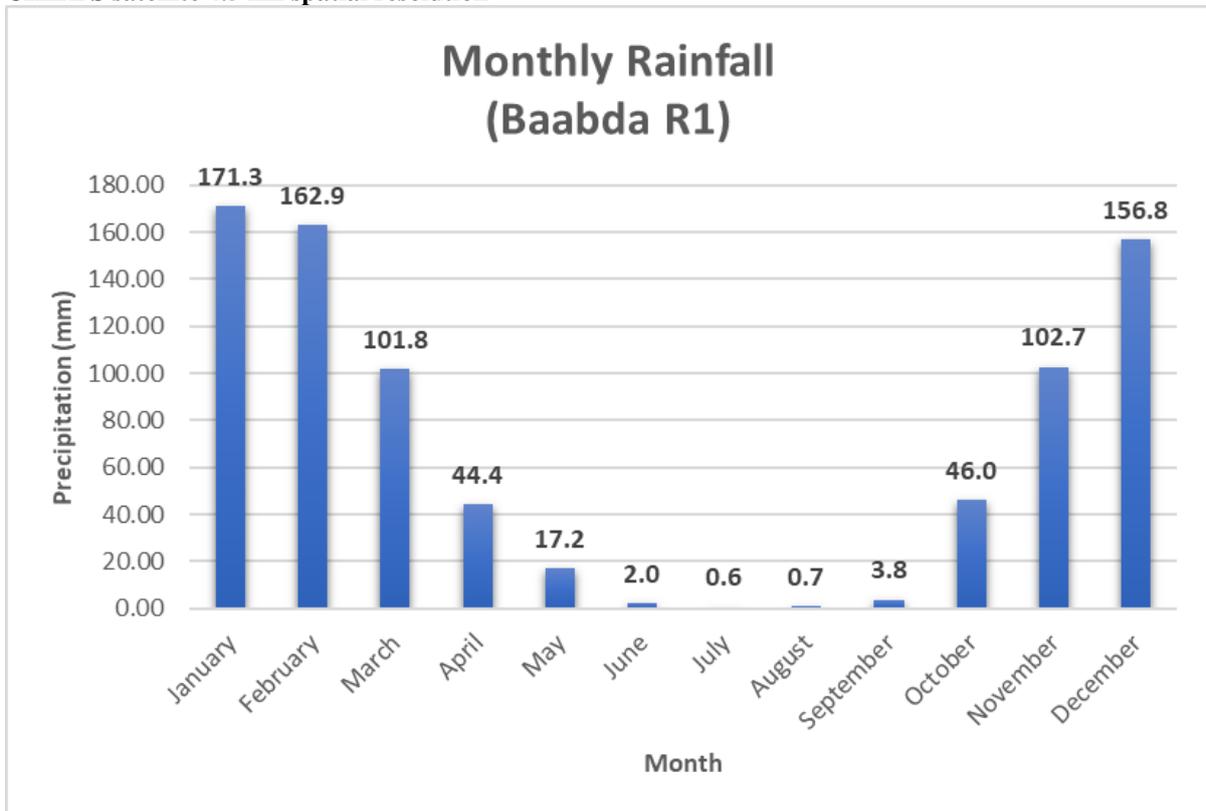
**Figure H Precipitations values along Baabda R1 alignment (period extending between 1996-2018)
CHIRPS satellite 4.5 km spatial resolution**

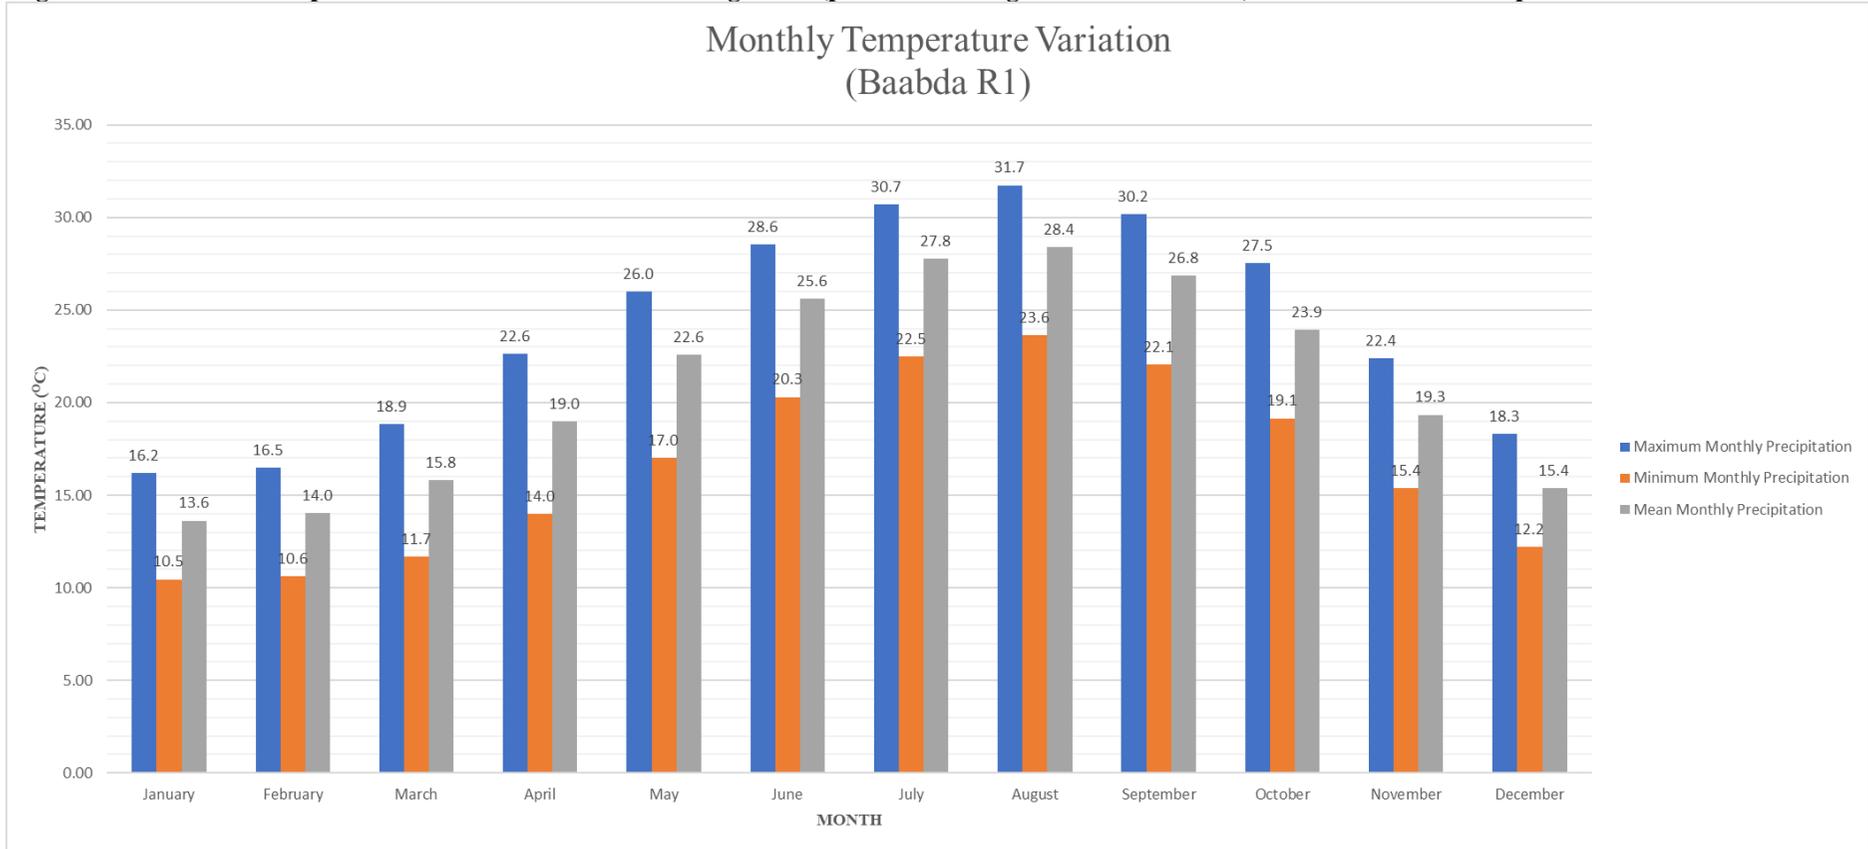
Figure I Land surface temperature variation for Baabda R1 alignment (period extending between 2000-2018) MODIS satellite 1km spatial resolution

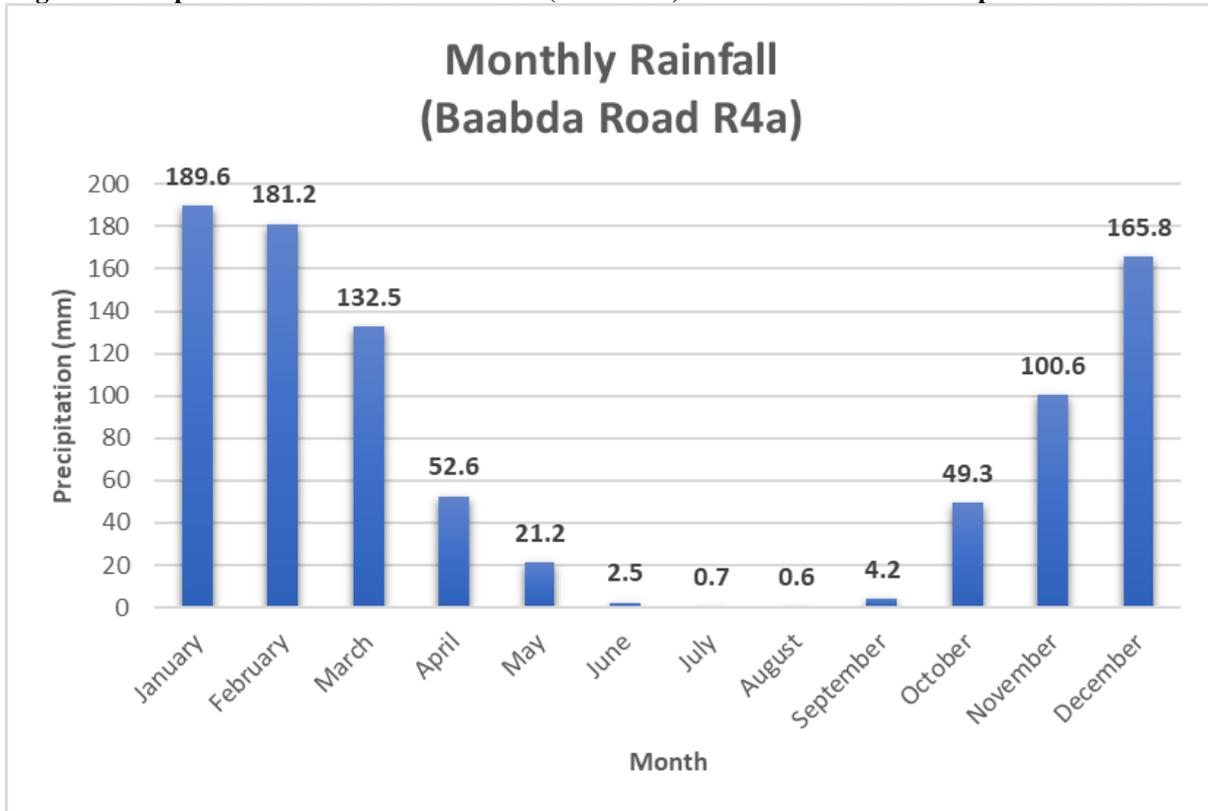
Figure J Precipitations values for Baabda R4a (1996-2018) CHIRPS satellite 4.5km spatial resolution
