Republic of Lebanon - Council for Development and Reconstruction

Road and Employment Project (REP)

Environmental and Social Management Plan (ESMP)
Final

LOT 2: Caza of Baabda

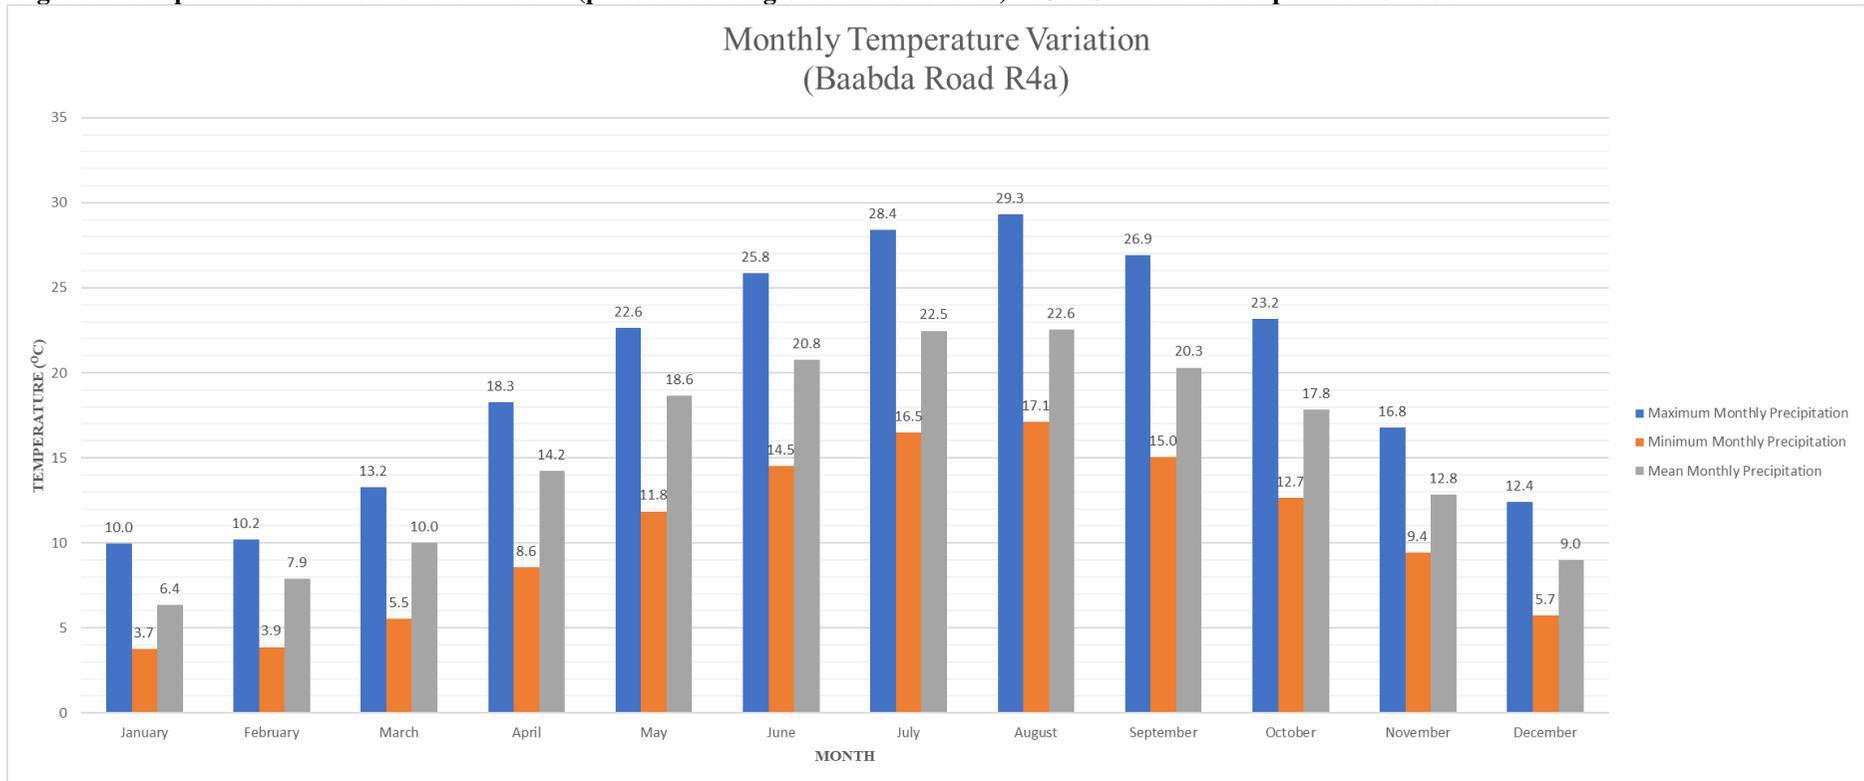
Figure K Temperature variation for Baabda R4a (period extending between 2000-2018) MODIS satellite 1km spatial resolution

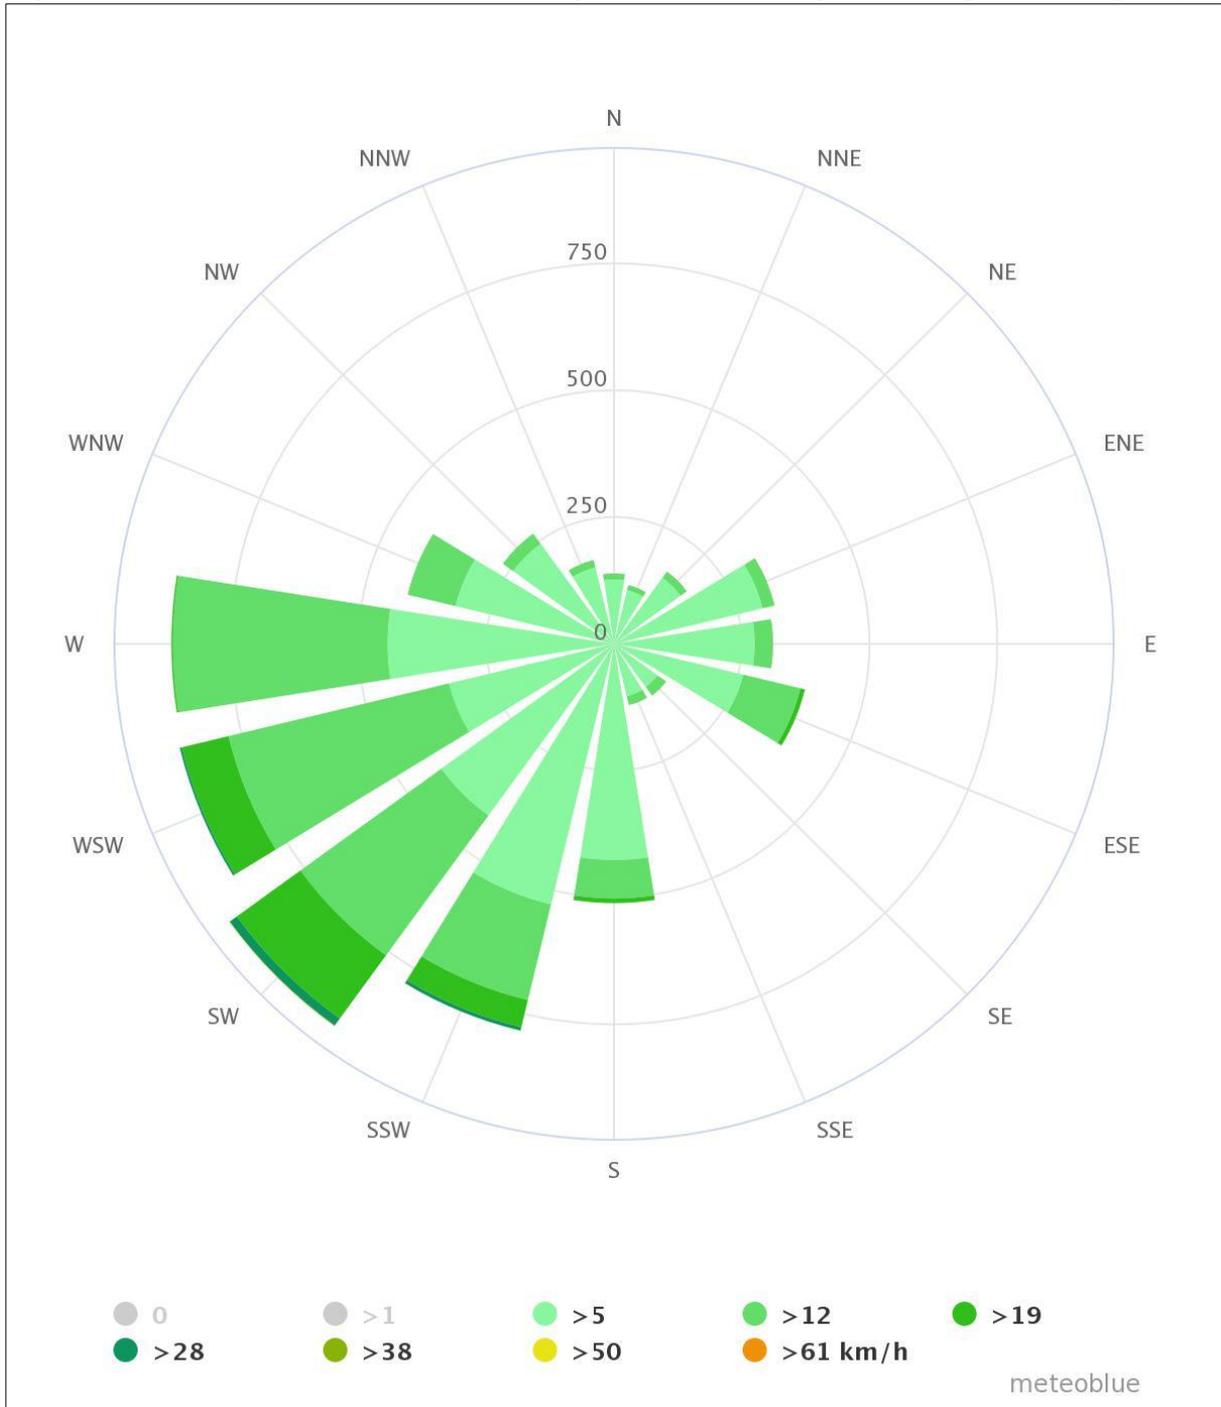
Figure L Wind rose for Baabda caza area showing wind direction along with wind speed and frequency

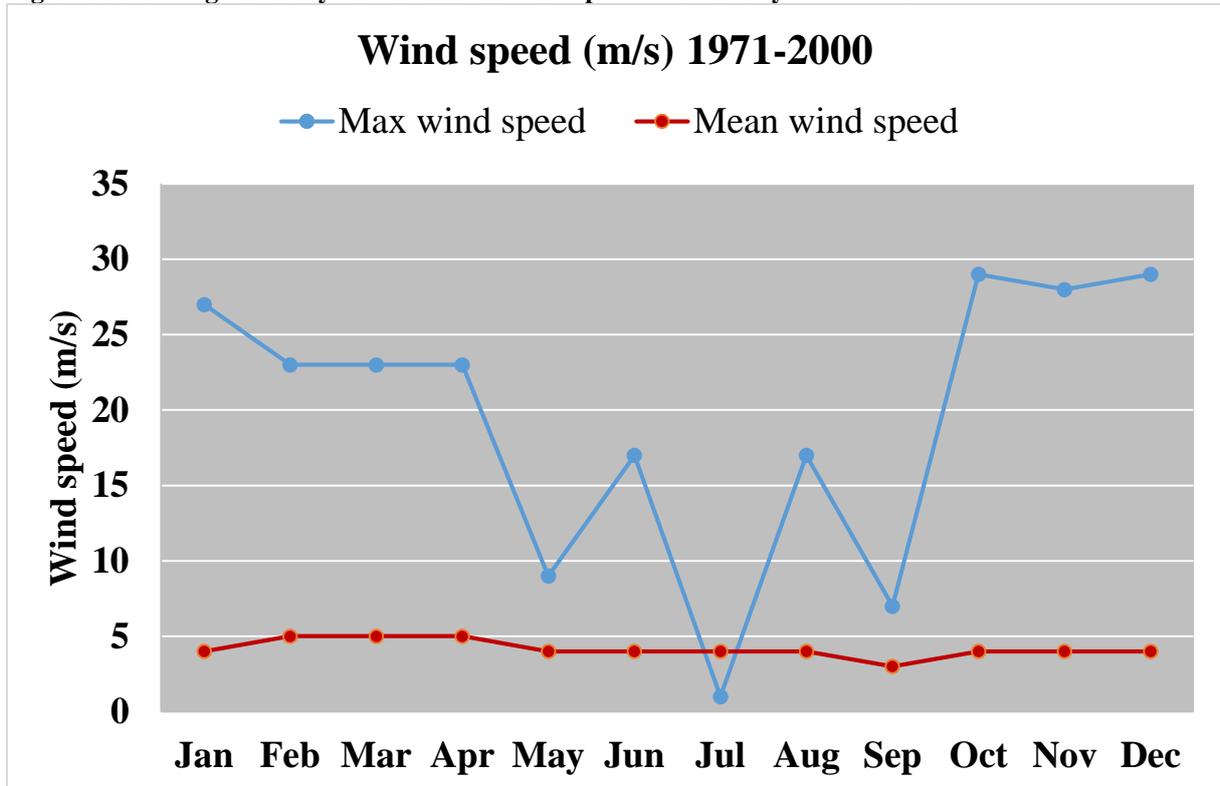
Figure M1 Average monthly and maximum wind speed at Dahr Baydar Station

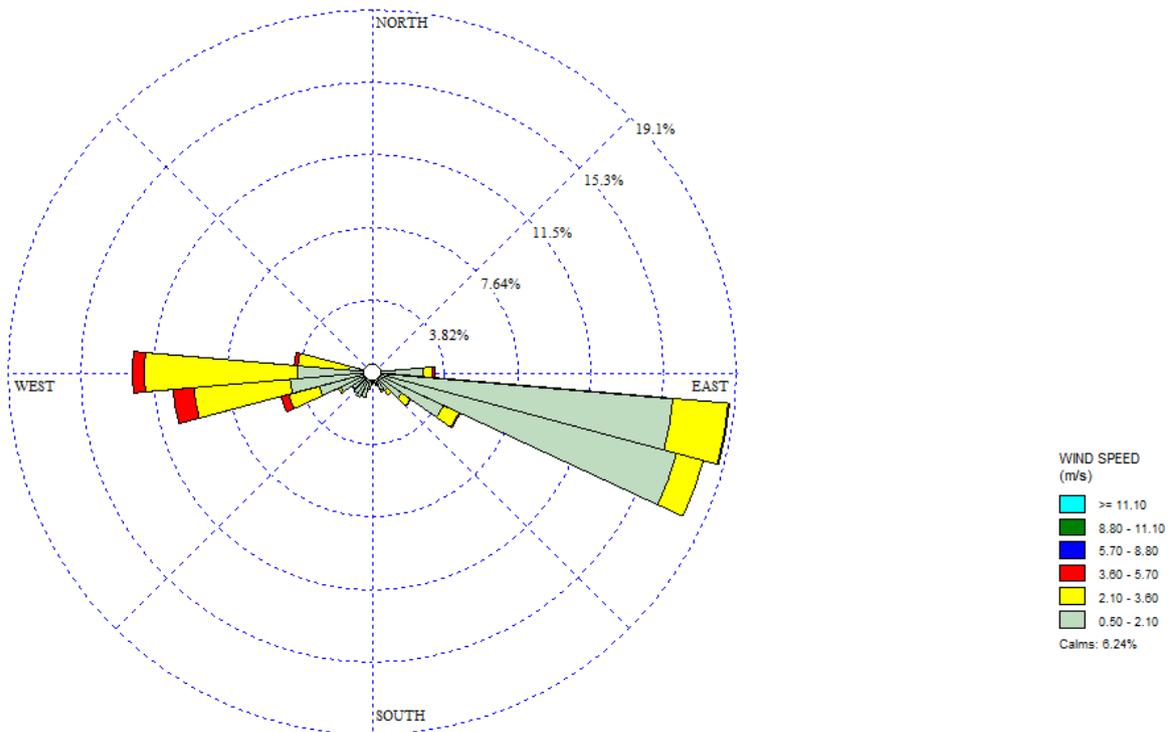
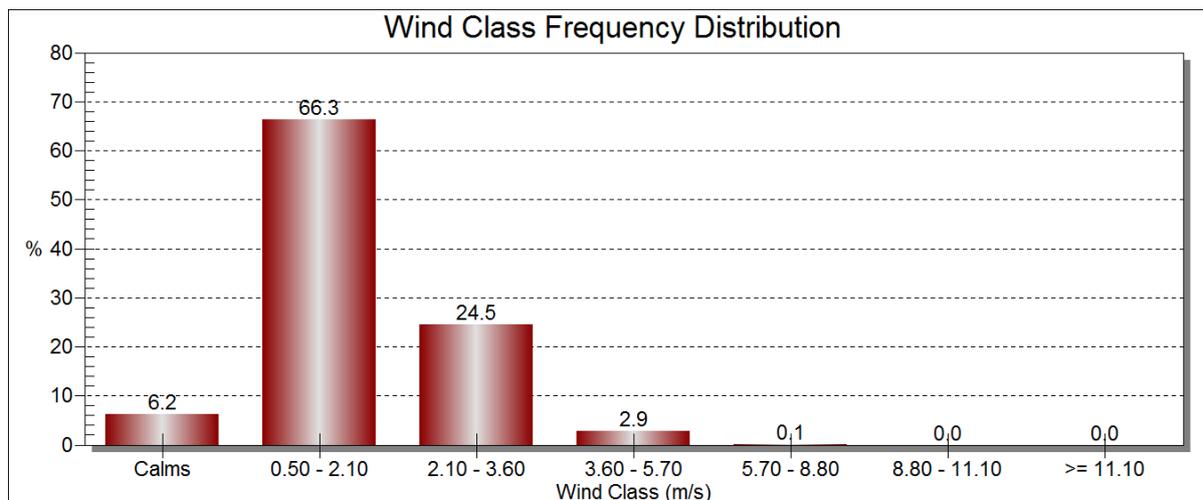
Figure N2 Average monthly and maximum wind speed at Hadath Station

Station # 1 - Hadath Station AQMS1, Beirut Dates: 6/1/2017 - 00:00 ... 2/27/2019 - 16:00

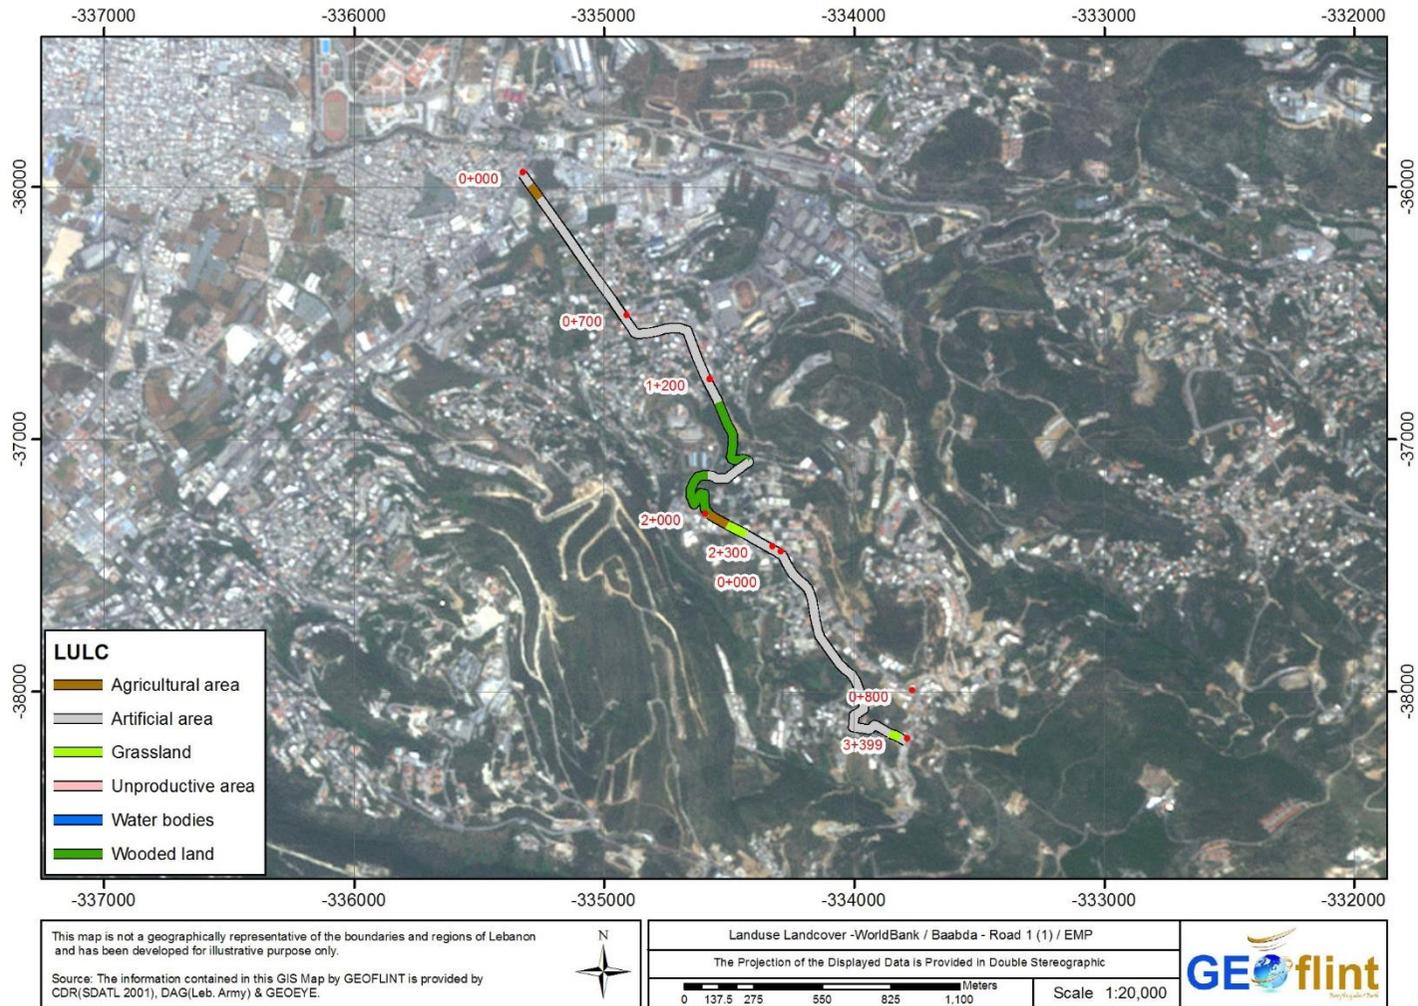
Figure O LULC map with work stations shown in red along Baabda R1 alignment (section 1)

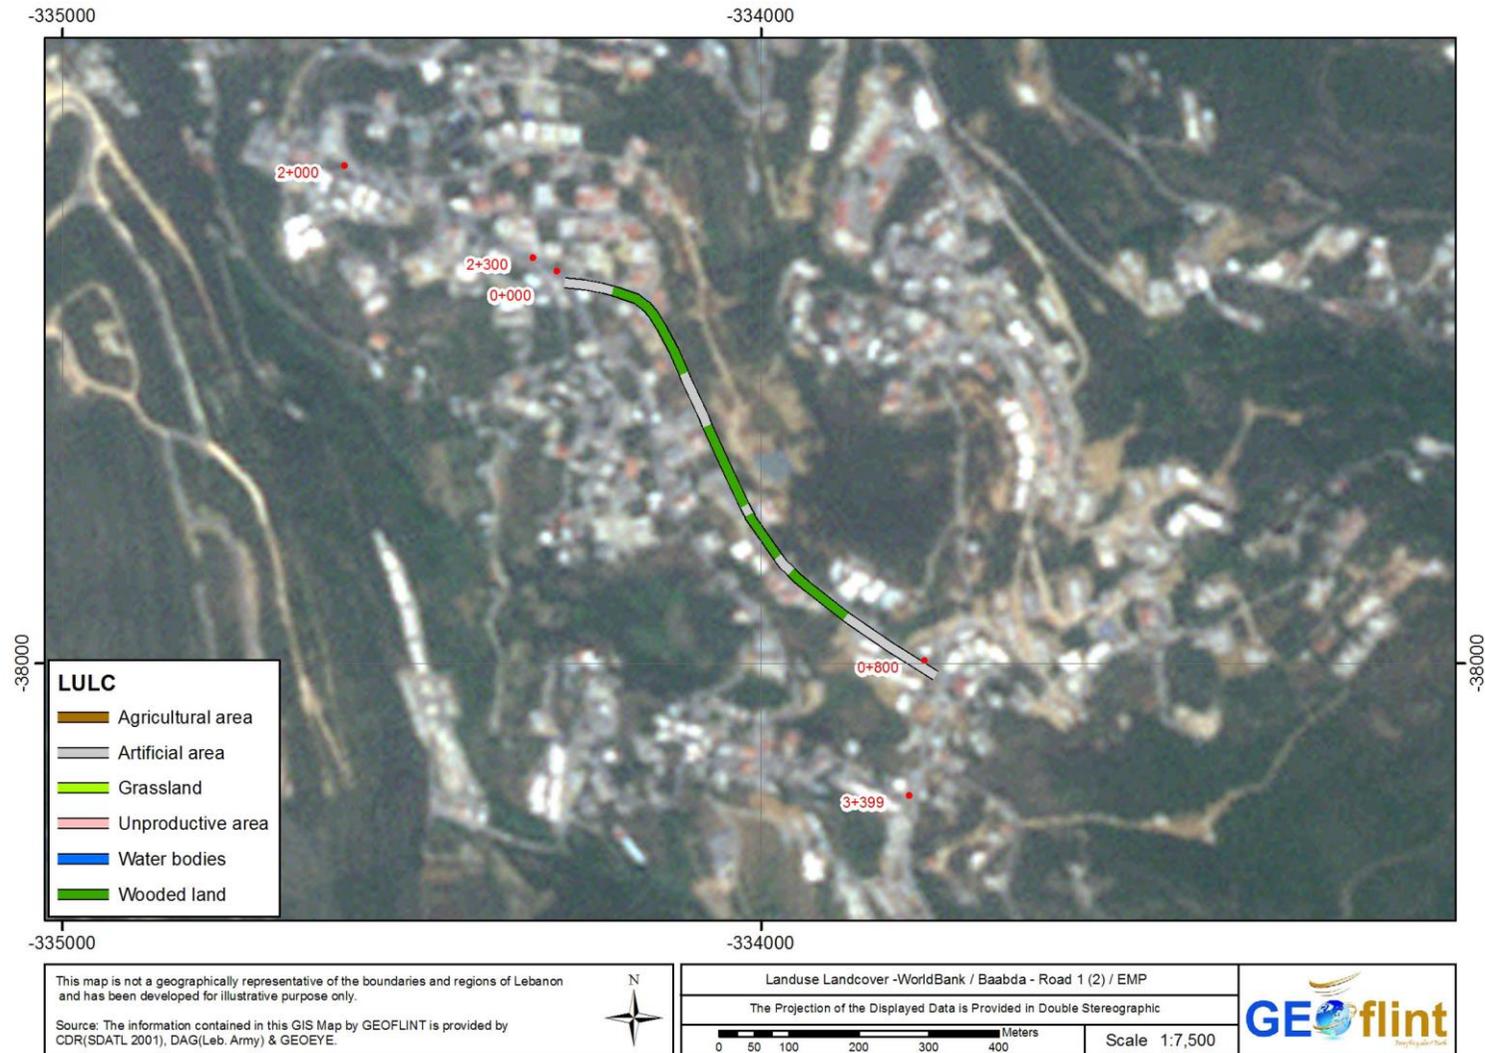
Figure P LULC map with work stations shown in red along Baabda R1 alignment (section 2)

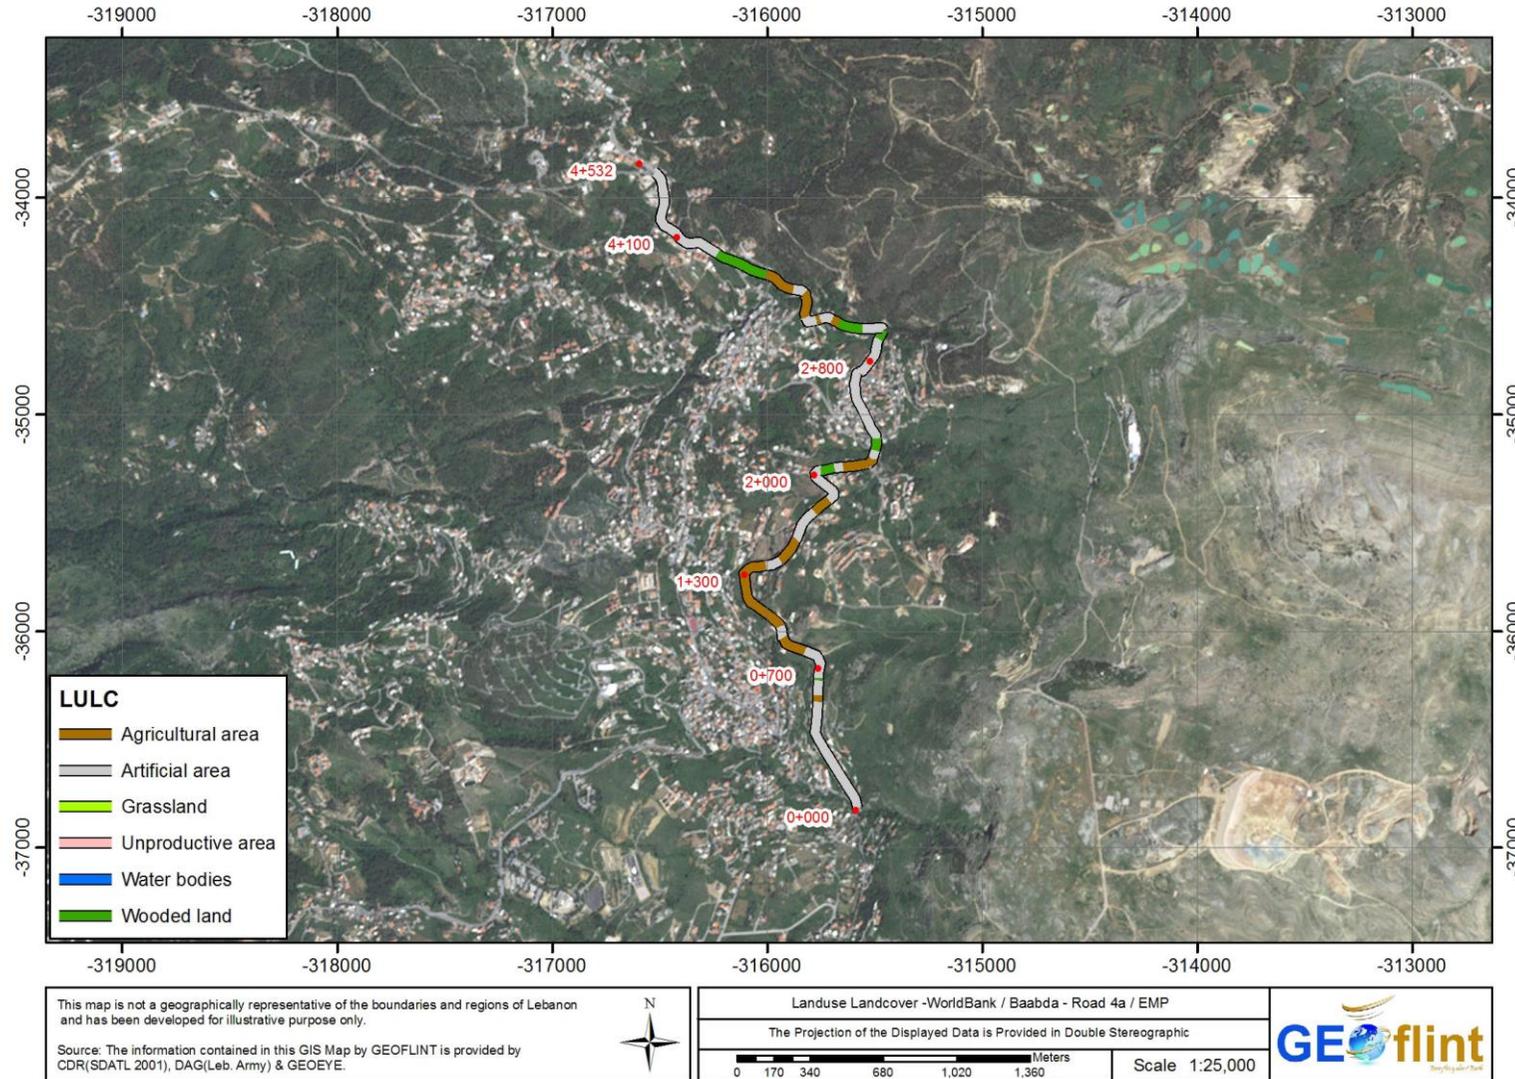
Figure Q LULC map with work stations shown in red along Baabda R4a alignment

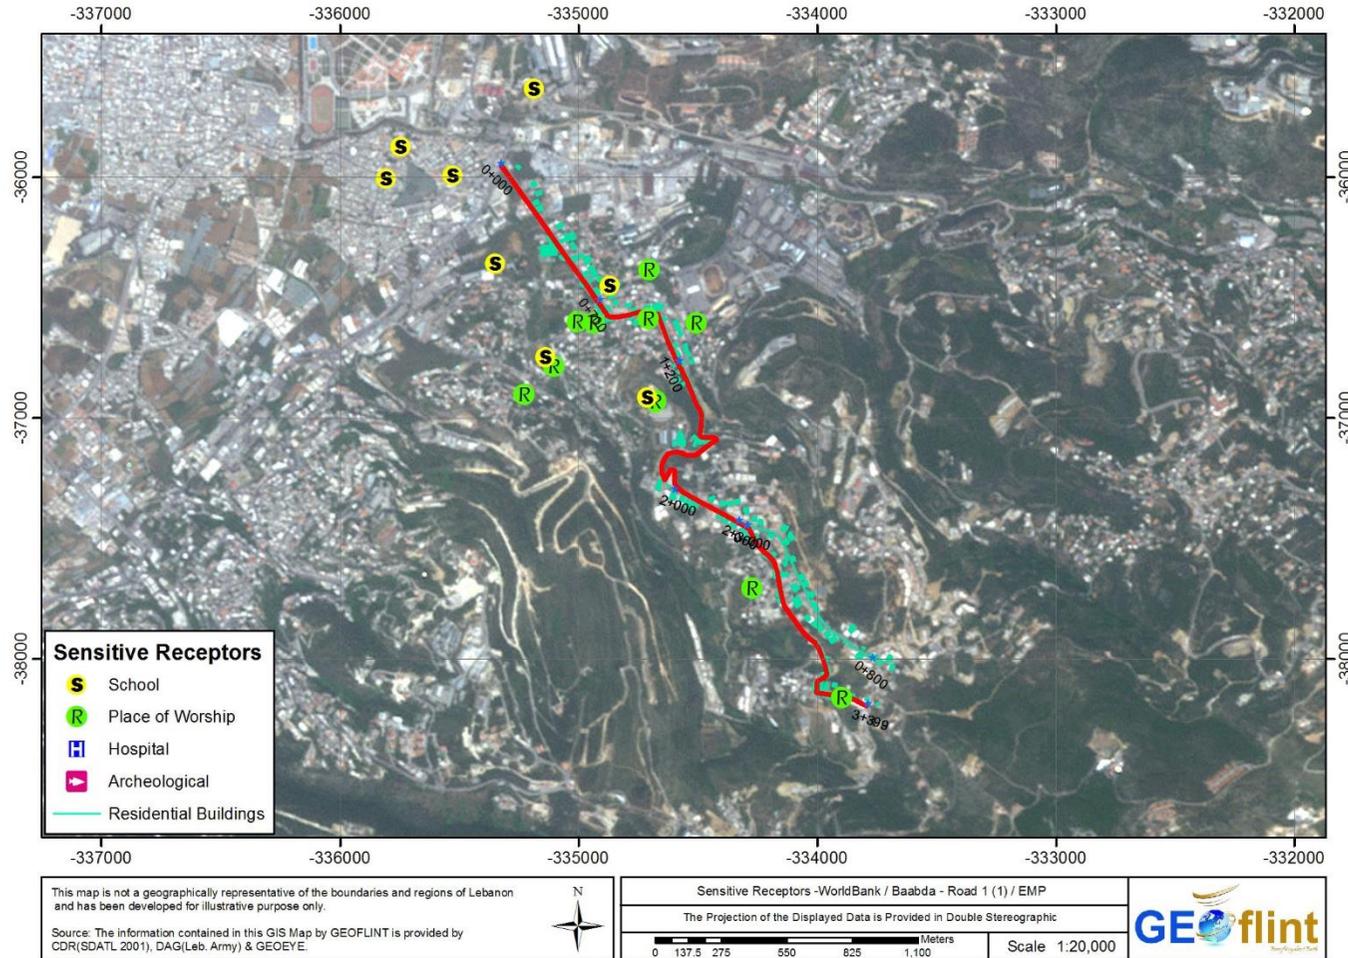
Figure R Closest sensitive receptors along Baabda R1 (section 1)

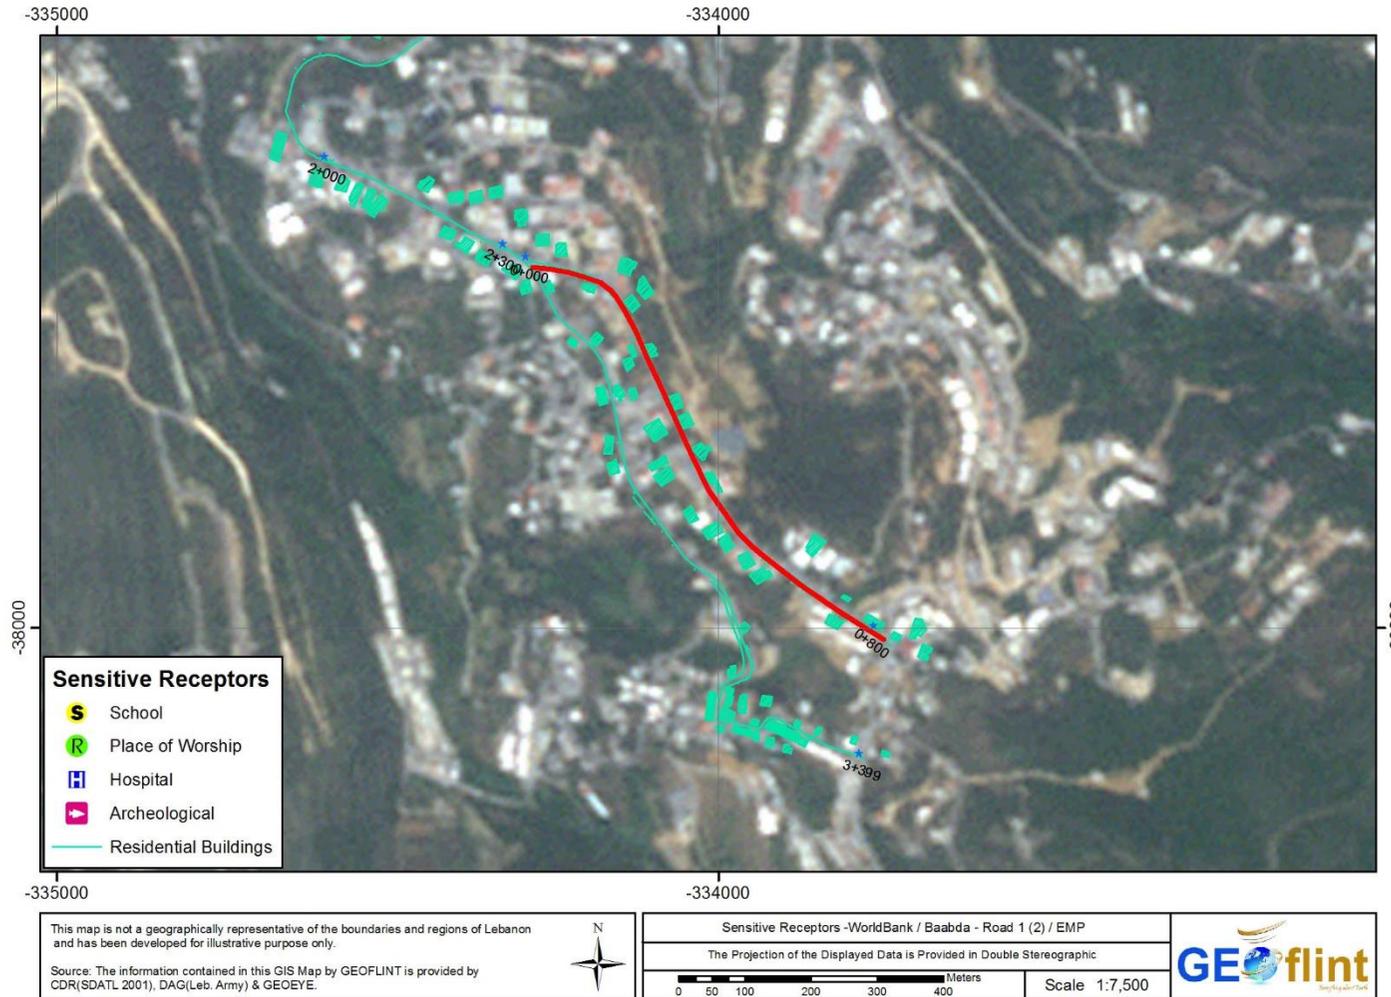
Figure S Closest sensitive receptors along Baabda R1 (section 2)

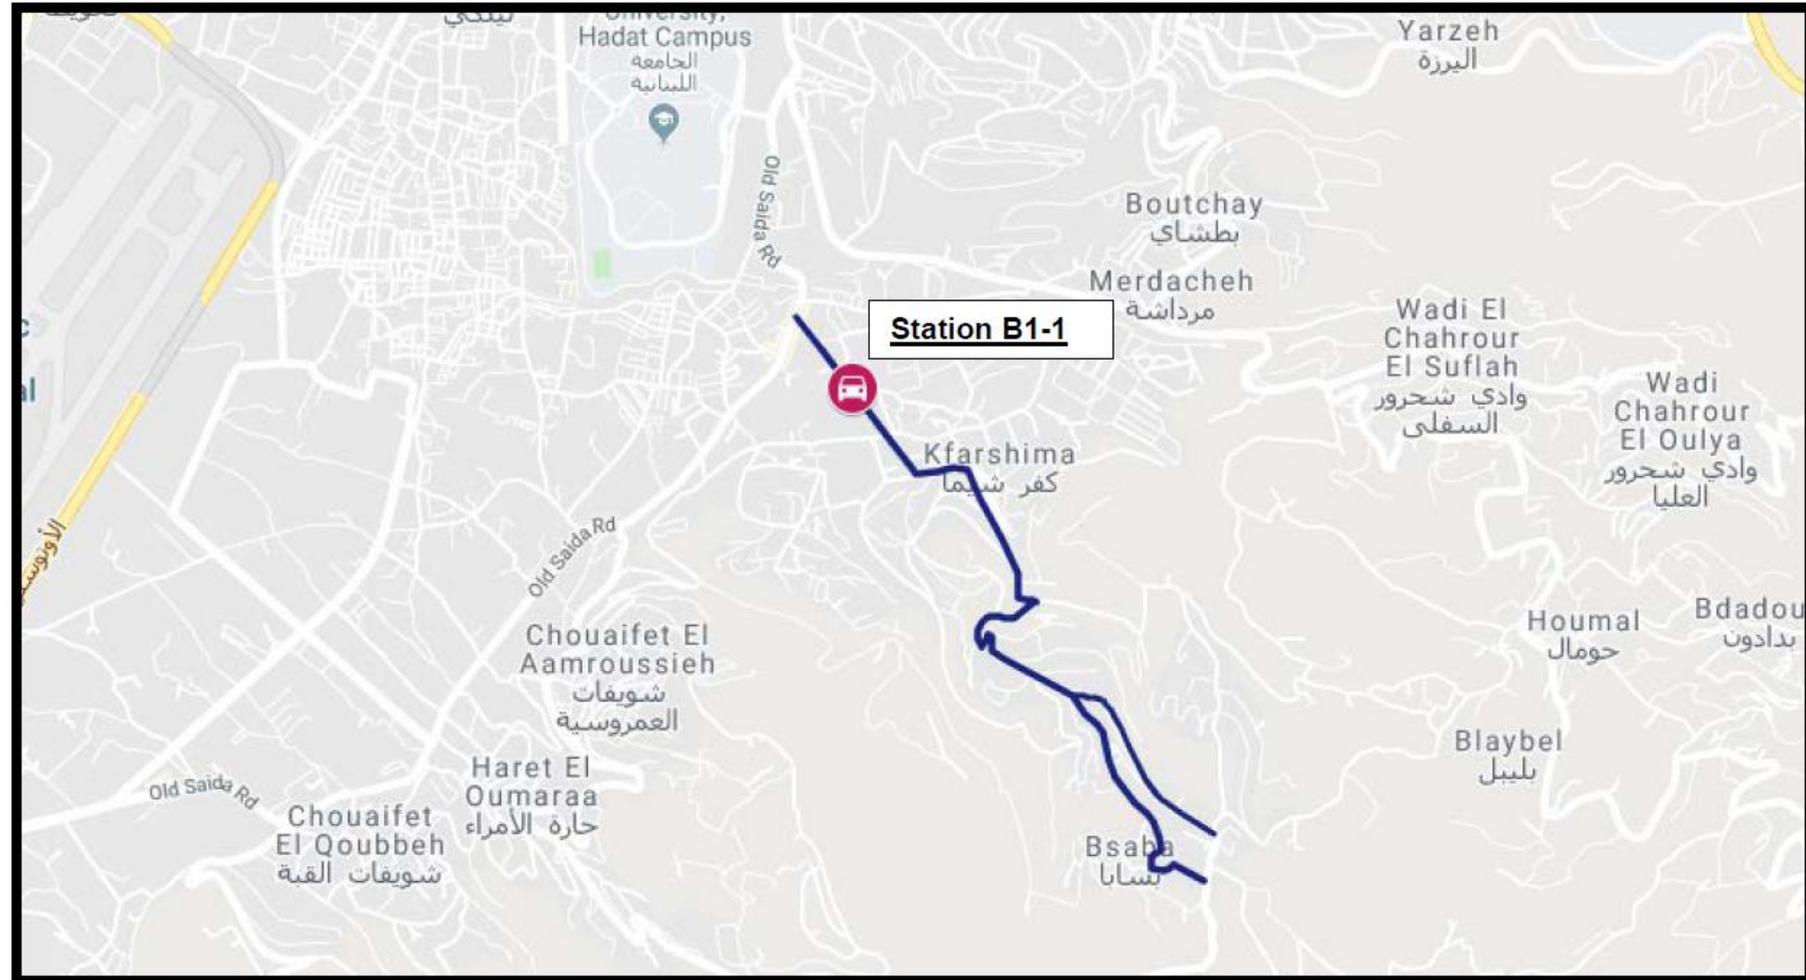
Figure U Location of ATC station for Baabda R1

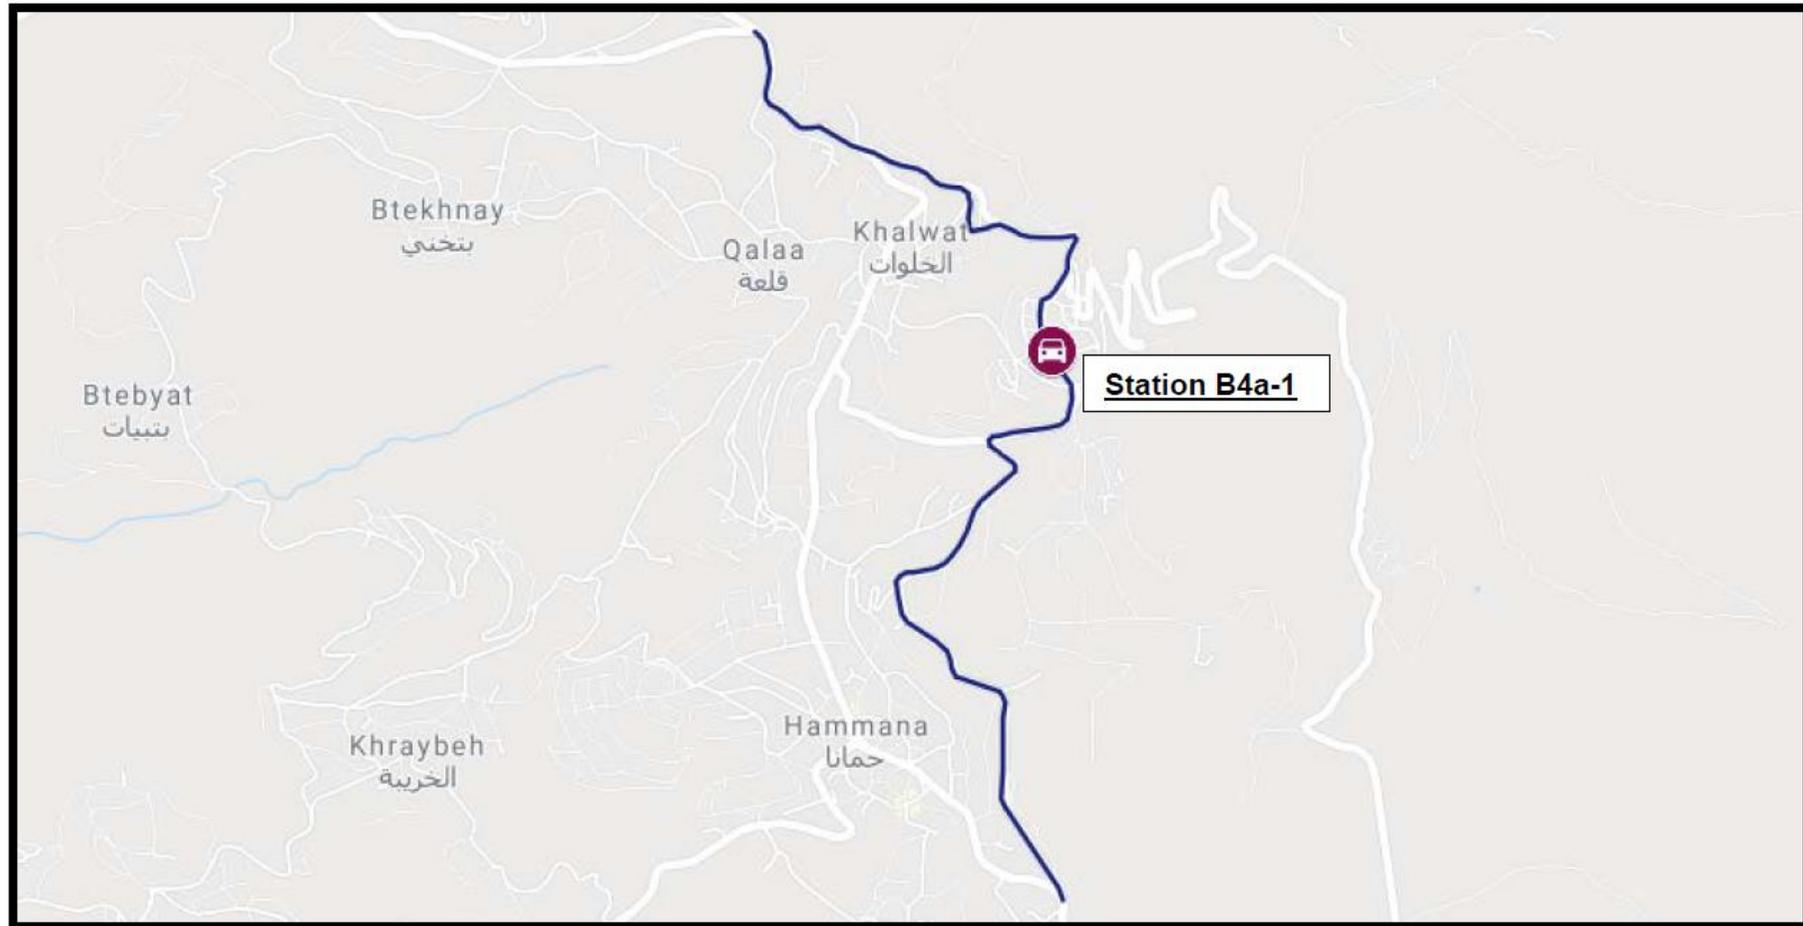
Figure V Location of ATC station for Baabda R4a
