Republic of Lebanon - Council for Development and Reconstruction

Road and Employment Project (REP)

Environmental and Social Management Plan (ESMP)

LOT 6: Caza of Baalbek

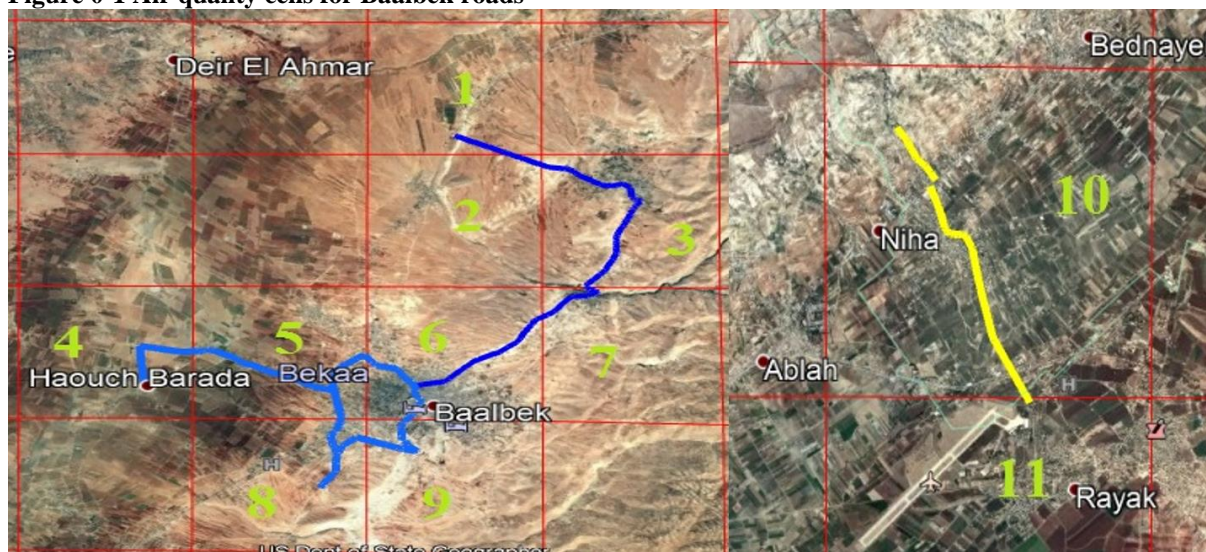
Figure 0-1 Air quality cells for Baalbek roads

Air quality is an essential component in assessing social wellbeing and health status of a community. Developing baseline information will help in comparing the impacts of the project relative to the existing conditions. Ambient air quality data was gathered from the UNDP project “Air quality assessment in an East Mediterranean country: the case of Lebanon” which is based at the Ministry of Environment. The UNDP/MoE monitors the criteria pollutants: Particulate Matter (PM), Ozone (O₃), Carbon monoxide (CO), Nitrogen dioxide (NO₂), Sulfur dioxide (SO₂) which are recognized by national and international organizations as good indicators of anthropogenic emissions.

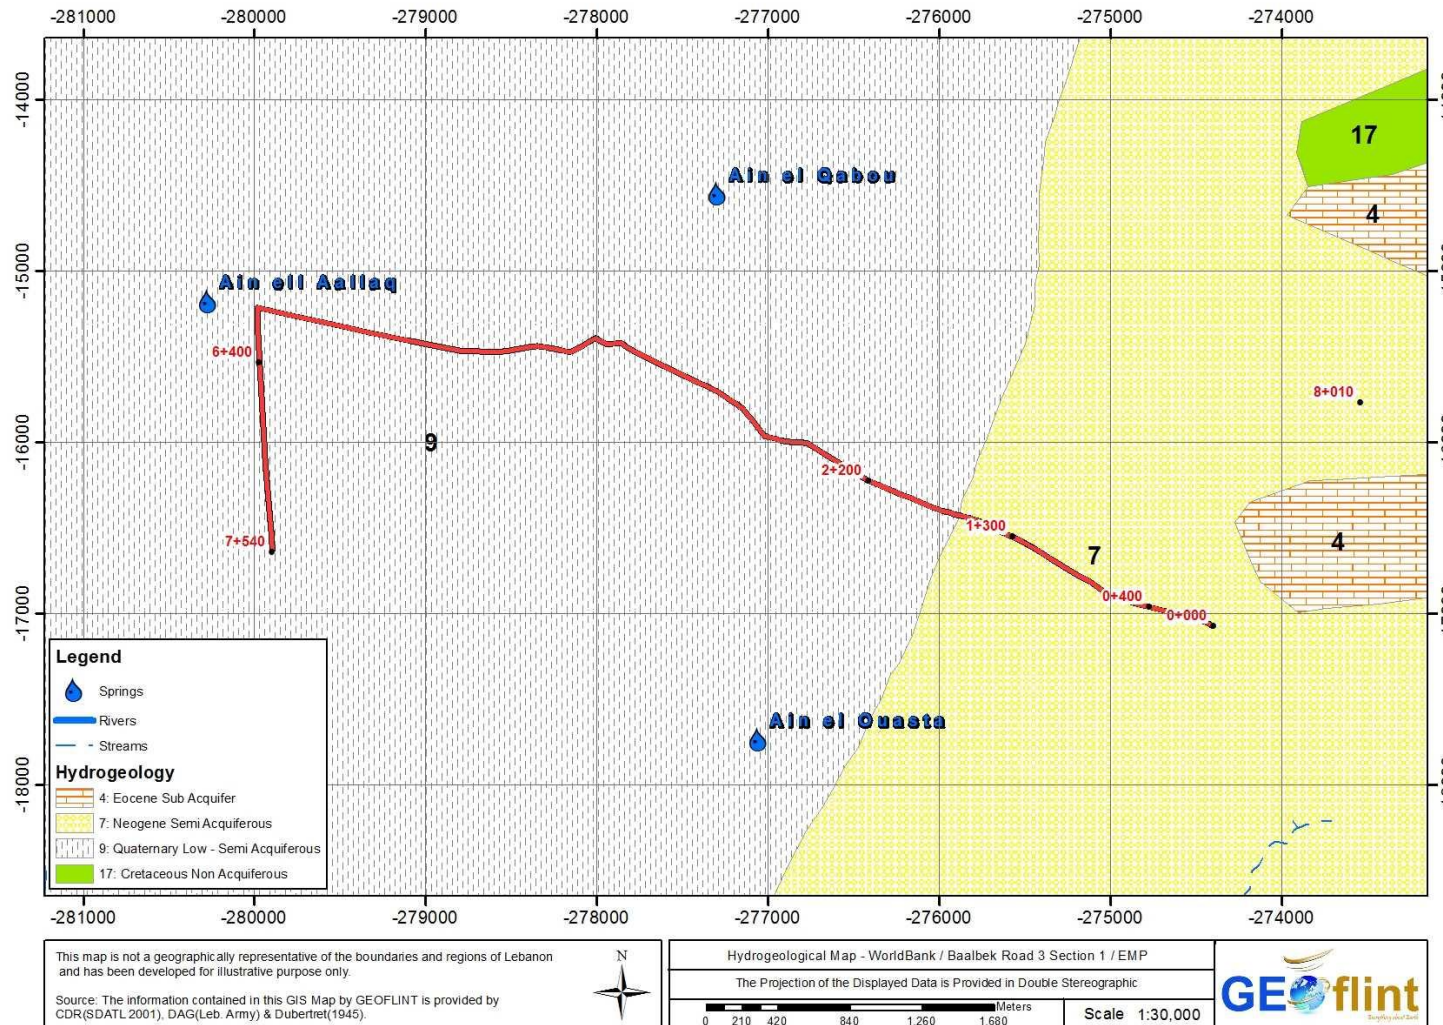
Figure M Hydrogeological map of Baalbek R3 section 1 and its surrounding (map showing water potential of the subsurface). Refer to Table 0-3 for description of hydrogeology classes. Work stations are shown along the road alignment.

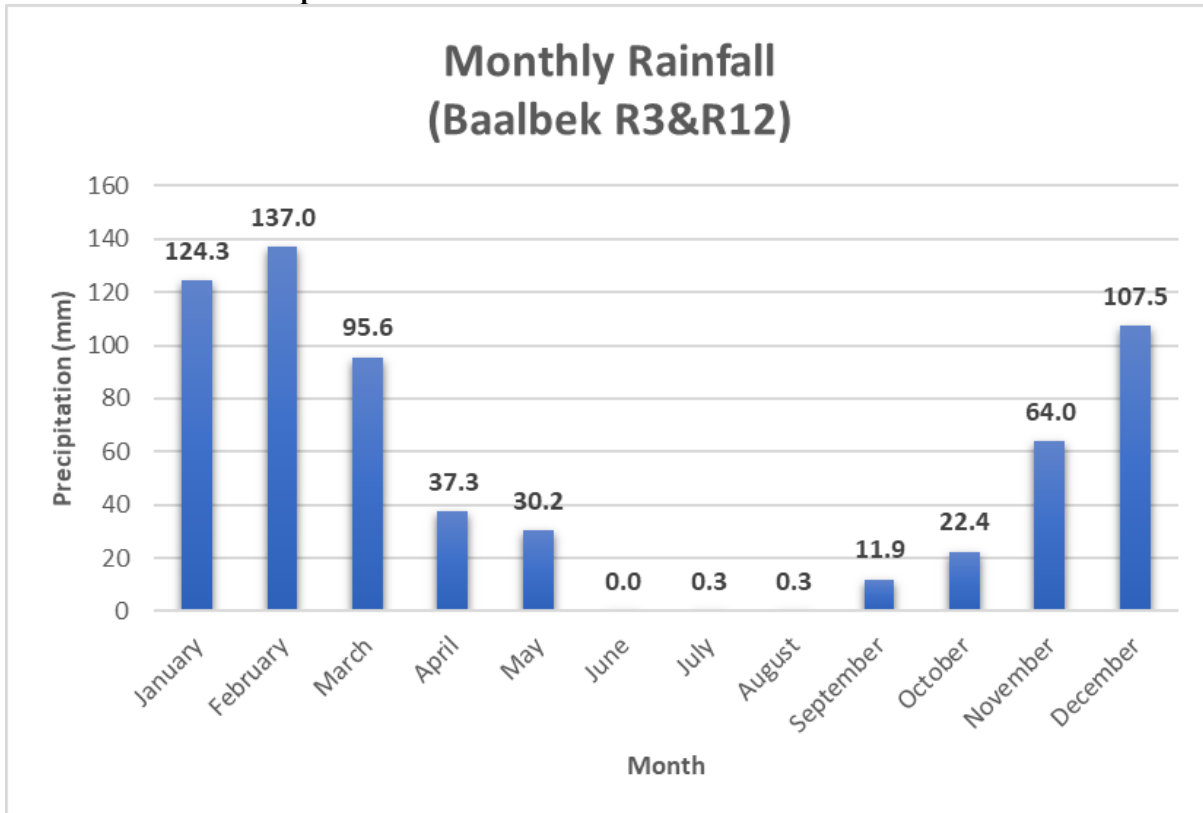
**Figure S Precipitations values along Baalbek R3 & R12 alignments (period extending between 1996-2018)
CHIRPS satellite 4.5 km spatial resolution**

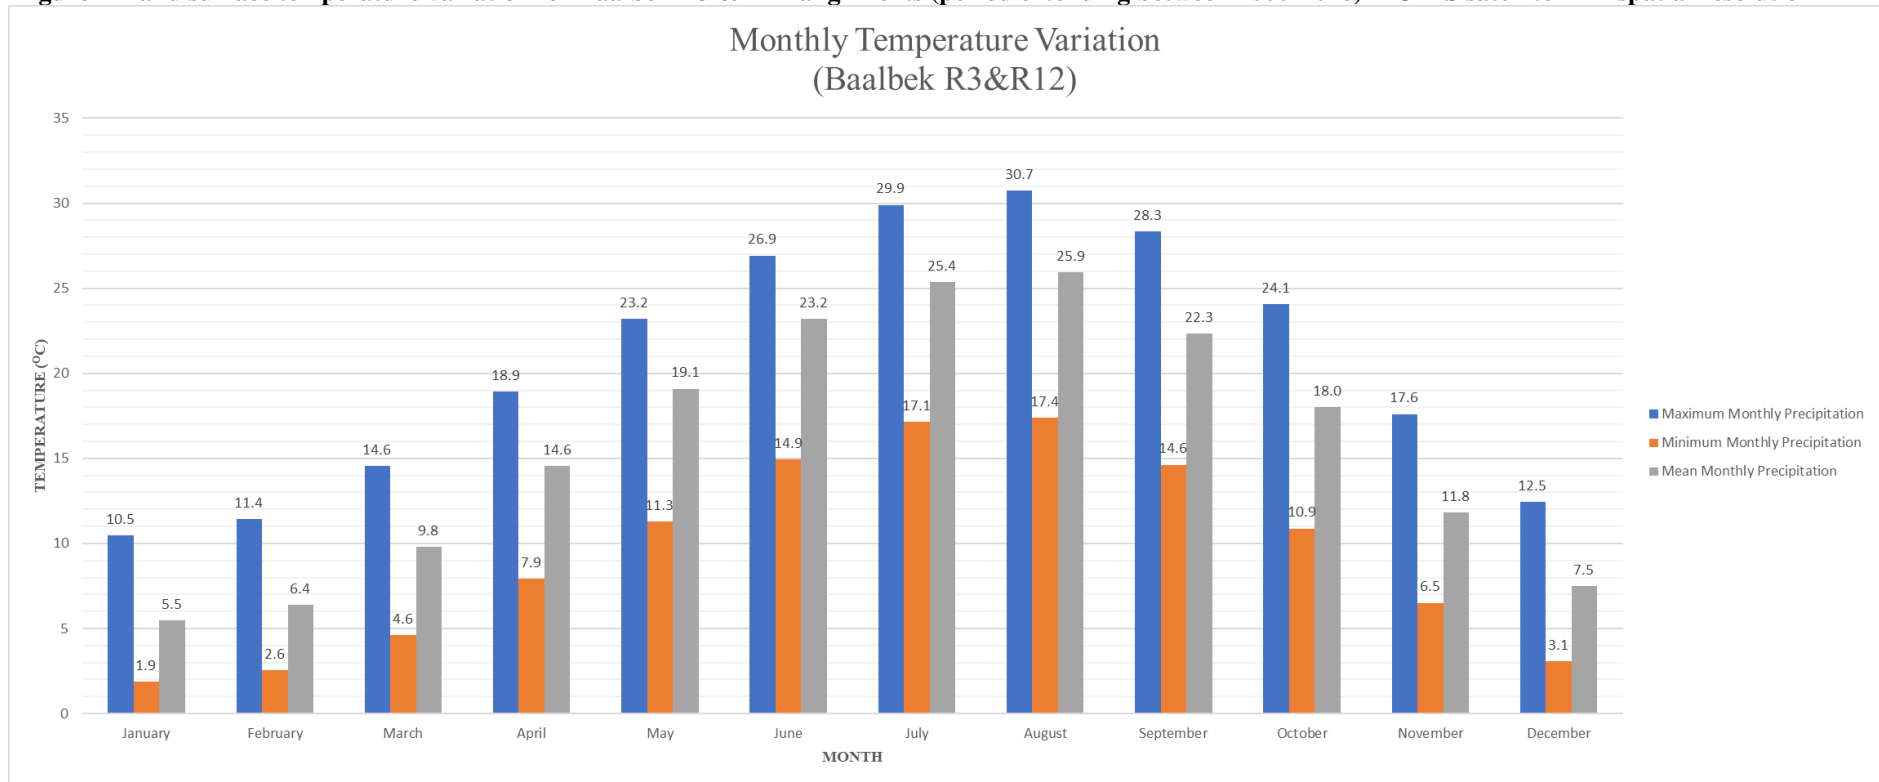
Figure T Land surface temperature variation for Baalbek R3 & R12 alignments (period extending between 2000-2018) MODIS satellite 1km spatial resolution

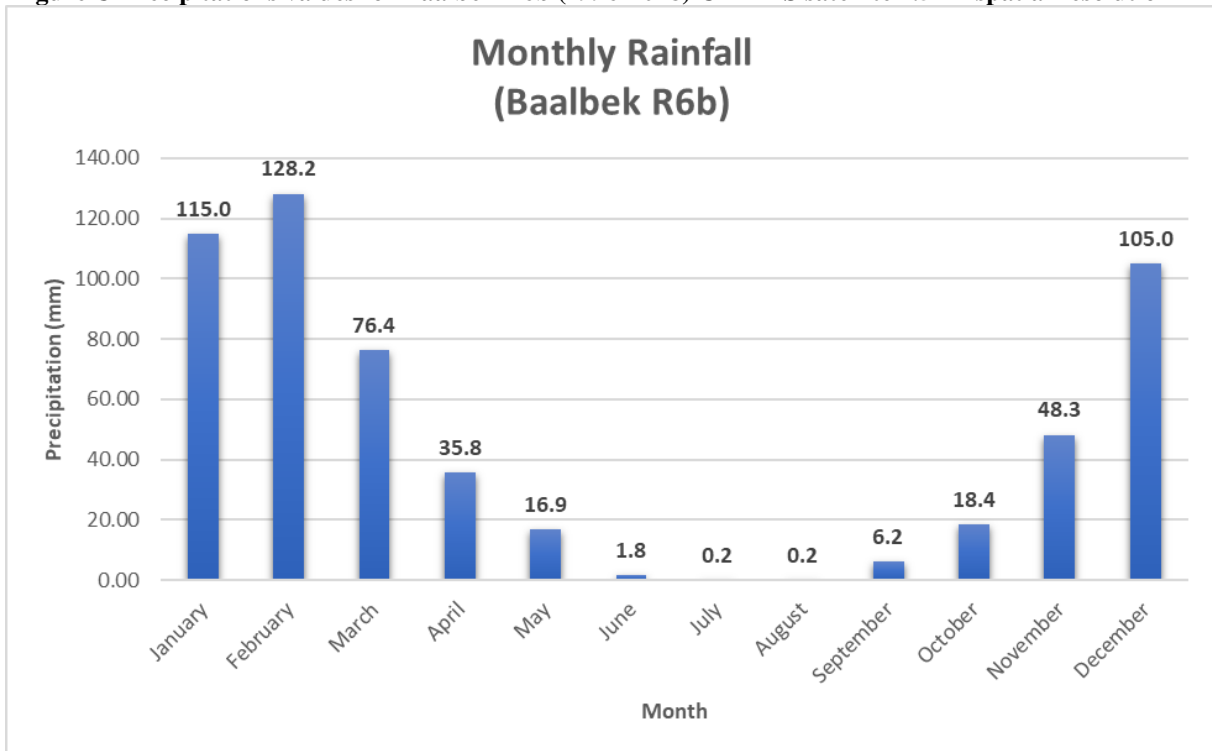
Figure U Precipitations values for Baalbek R6b (1996-2018) CHIRPS satellite 4.5km spatial resolution

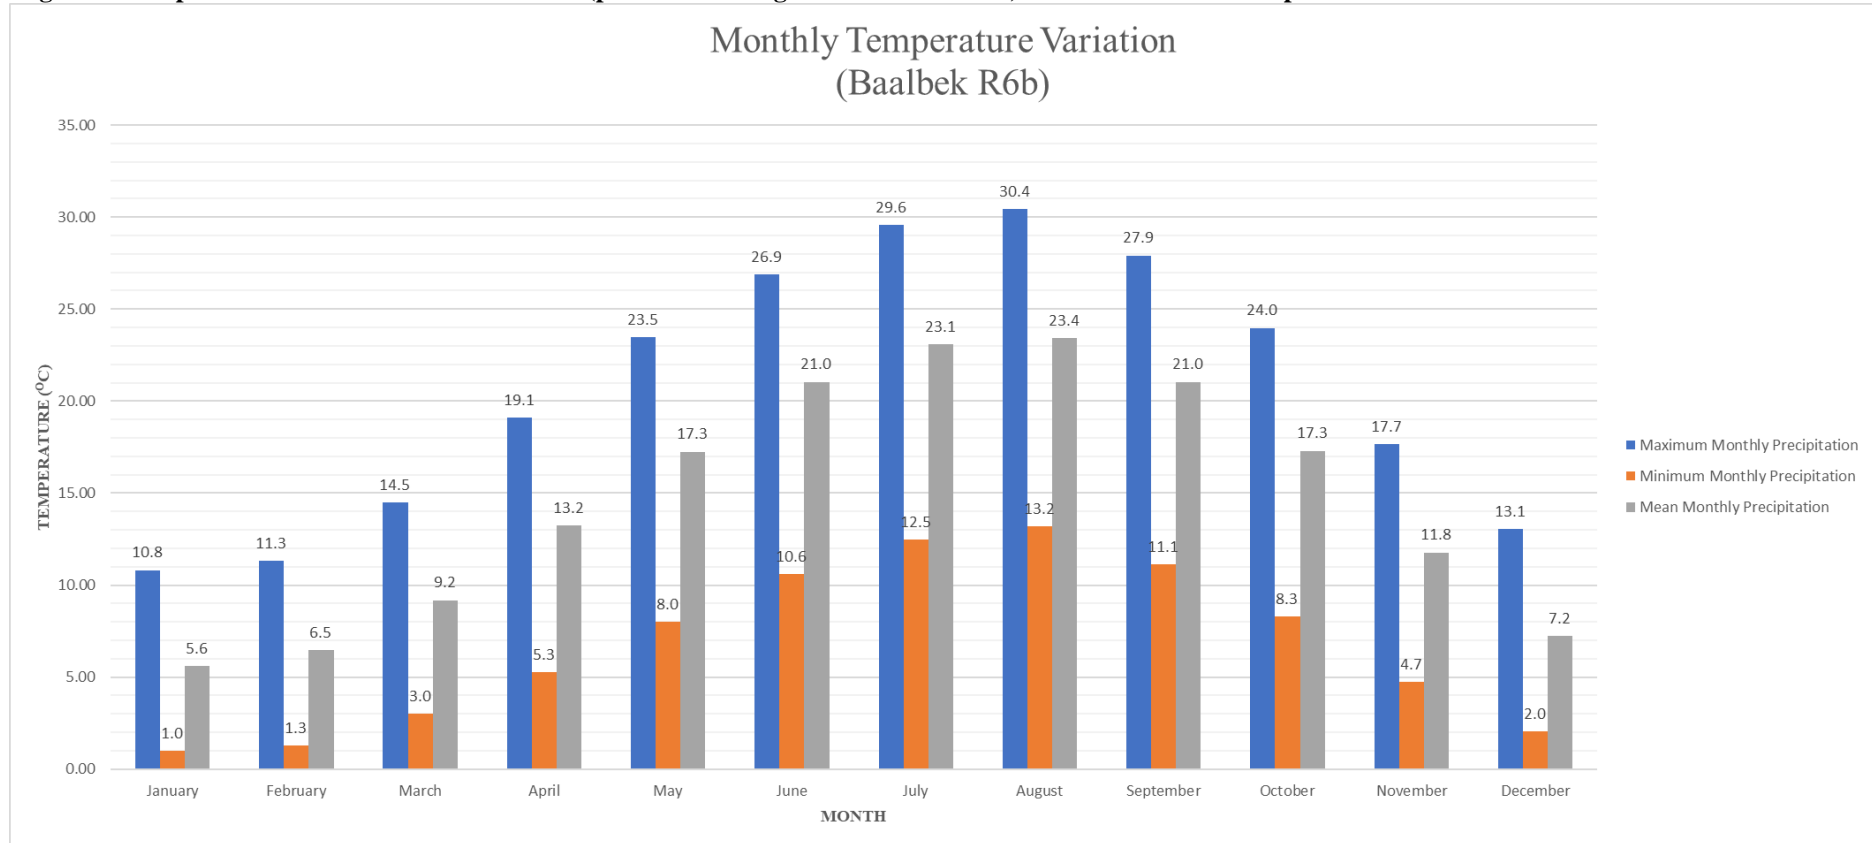
Figure V Temperature variation for Baalbek R6b (period extending between 2000-2018) MODIS satellite 1km spatial resolution
